**SARASOTA COUNTY
FLOODPLAIN MANAGEMENT PLAN UPDATE**

Sarasota County | June 2021

Sarasota County Floodplain Management Plan Committee
1001 Sarasota Center Blvd.
Sarasota, Florida 34240
June 2021

Jones Edmunds & Associates, Inc.
730 NE Waldo Road
Gainesville, Florida 32641
Certificate of Engineering Authorization #1841

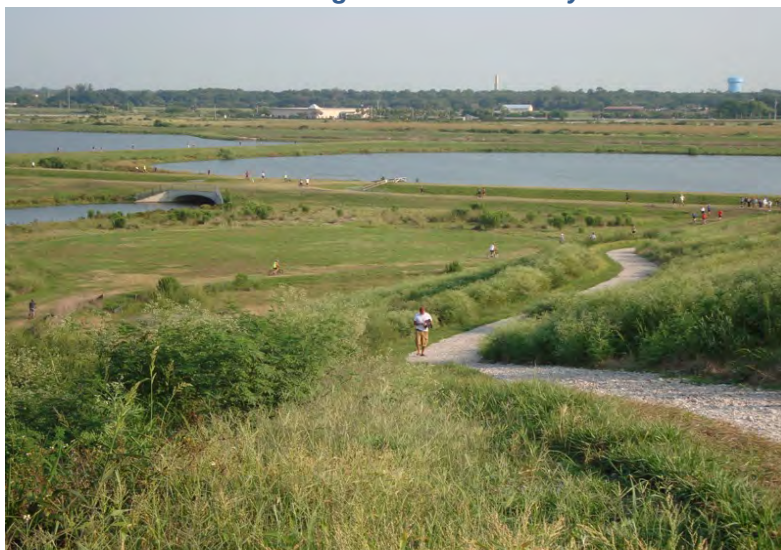
Figure 7-1 Celery Fields

The Celery Fields in Sarasota County provide multiple benefits, such as flood storage, wildlife habitat, and recreation.

Floodplains (such as the Celery Fields shown in Figure 7-1) provide areas that temporarily store floodwater. This helps to reduce downstream peak flood stages. In addition, the broad storage area diminishes the velocity of water flow, thus reducing erosion. In urbanized areas, natural floodplains can provide storage and/or result in less runoff that can be carried overland and lead to flooding in streets and neighborhoods.

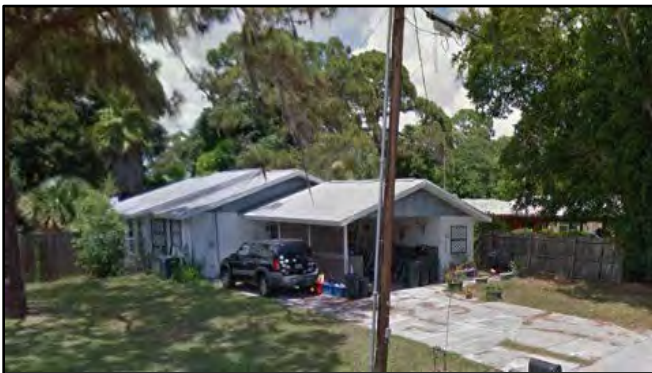
Figure 2: Slab on Grade Structure

This Repetitive Loss Area (RLA) is located inland, east of Sarasota Bay within the Catfish Creek watershed area. About 80% of the structures within this RLA are pre-FIRM and were constructed during the 1950s-1970s. Approximately 83% of the structures are minimally elevated slab-on-grade construction, with an average grade elevation at the structures of 12.4 feet NAVD. These slab-on-grade structures are typically at minimal risk of flooding, and the RLA is located within FEMA Zone X (shaded), outside of the special flood hazard area (SFHA). Tables 1 and 4 provide a summary of the structures within this RLA.

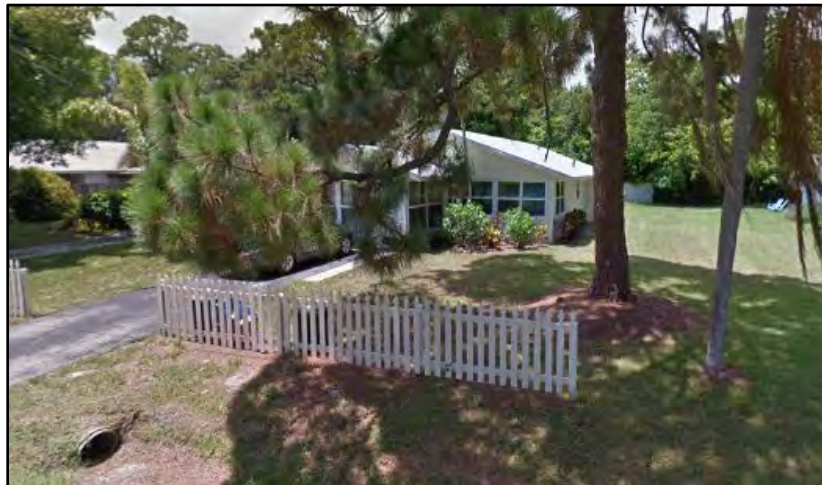
Figure 4: Average Wood Frame, Slab on Grade Structure

Composition	Foundation Type
83%	Slab on grade
6%	Elevated slab on stem wall with fill
11%	Elevated on post/piles or walls
Composition	Frame Type
61%	Wood frame
39%	Concrete block/masonry
Composition	Number of Stories
89%	Single story
11%	Two story
Composition	Flood Zones
100%	Within Zone X (shaded)

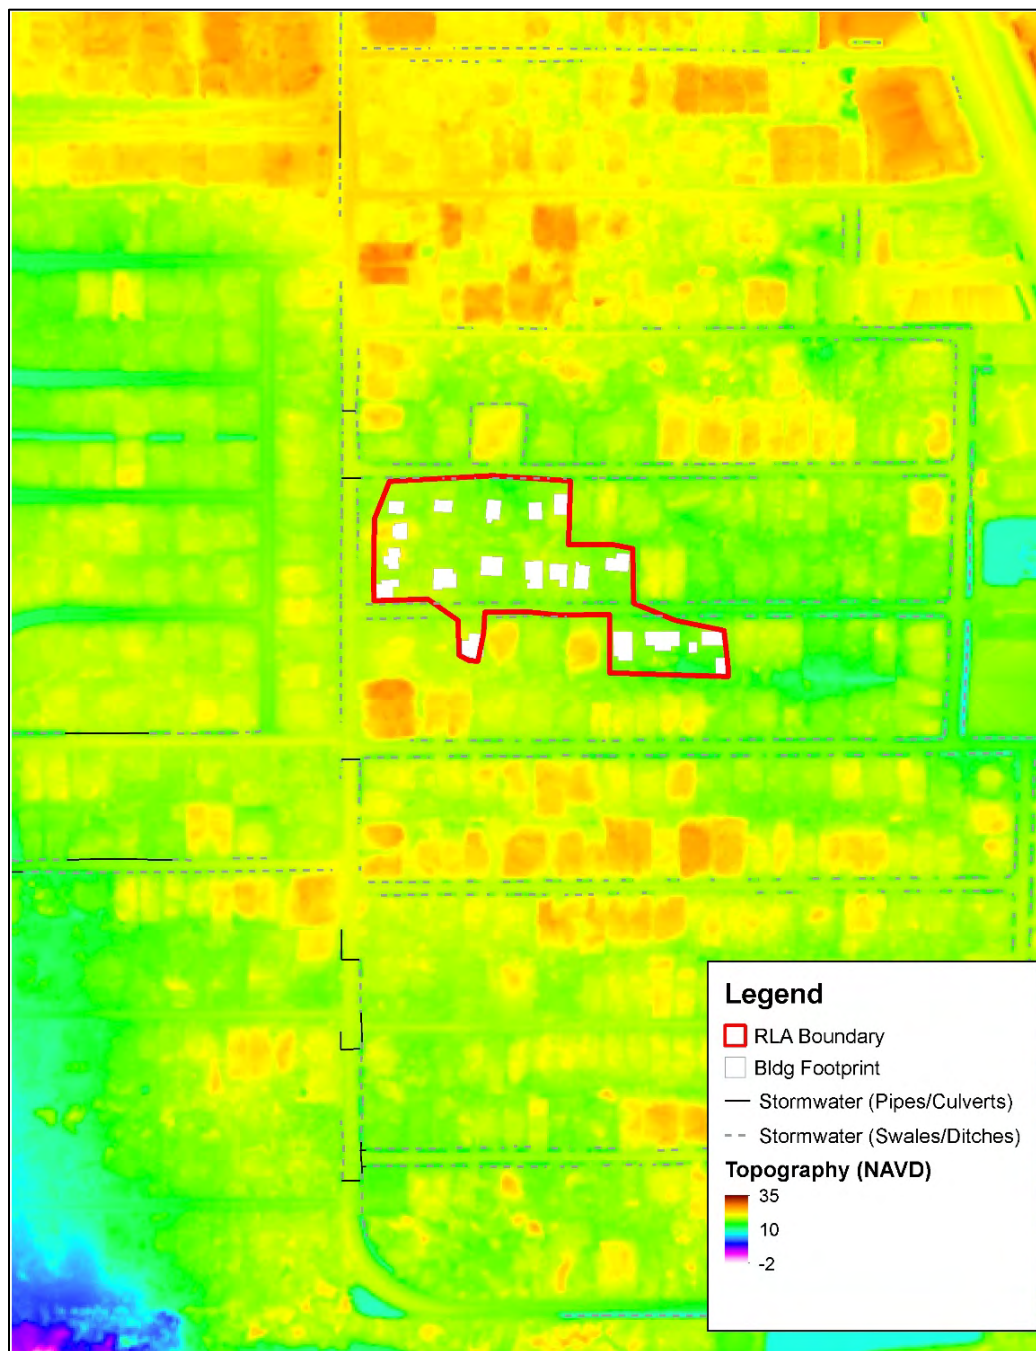
Review of insurance claims data reveals that flood damage coincides with storm events with 9 to 11 inches or more of rainfall, coincident with high tides and high winds. These effects have likely caused flood inundation from excessive rainfall runoff and stormwater drainage from these low elevation areas. This RLA is characterized by low-lying areas. Figure 5 provides spatial context for the structures within the RLA in terms of topography, drainage infrastructure, and existing grades at the base of each structure.

Figure 5: Topography, Drainage, and Existing Grades at Base of Structures

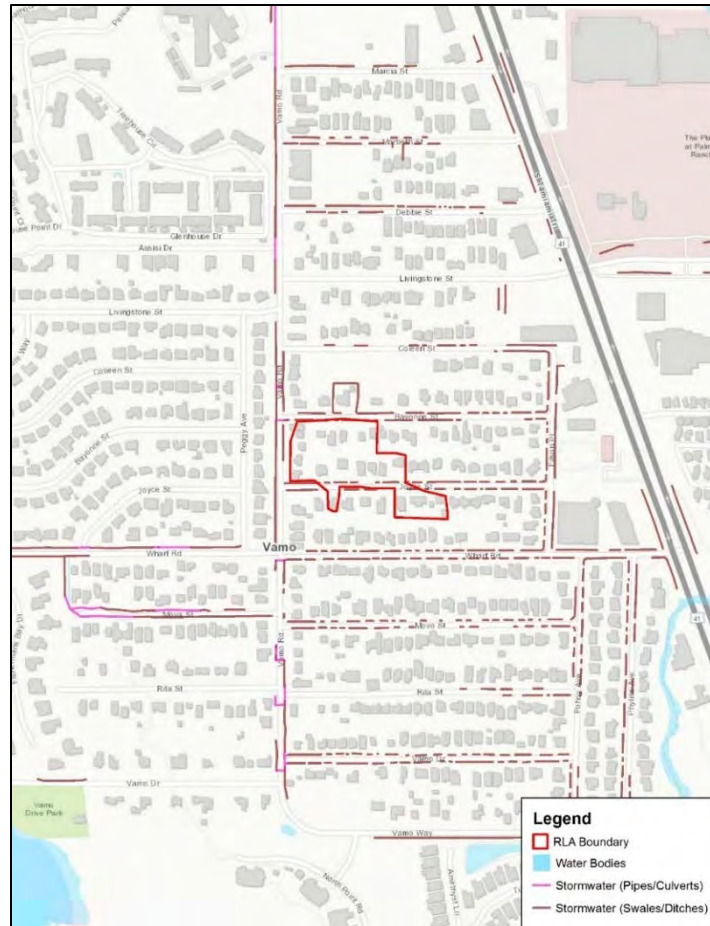
Figure 6: Distribution of Stormwater System Infrastructure

The stormwater utility infrastructure within the RLA is primarily limited to roadside swales with runoff pooling and moving down along the street and over lower elevated properties. The average elevation of existing grades is 12.4 feet NAVD. This RLA is located outside of the high risk SFHA. The extremely low elevations of the pre-FIRM structures make it unlikely stormwater improvements alone would mitigate flood risk to these structures.

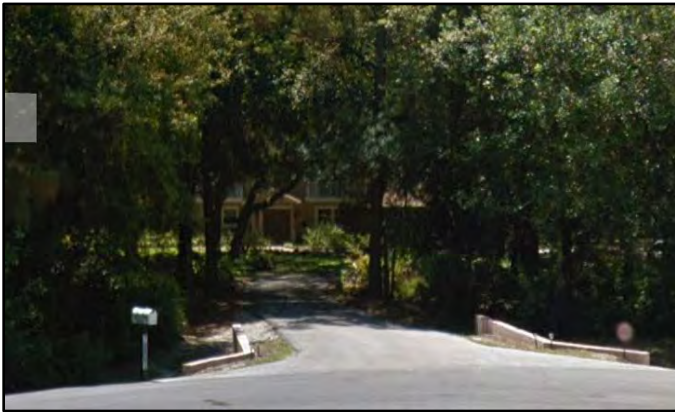
Figure 2: Slab on Grade Structure

This Repetitive Loss Area (RLA) is situated inland east of SR-72 in the Cowpen Slough watershed. This area borders Cowpen Slough Creek and is subject to overbank flooding. Most of the structures within this area were constructed in the 1970s and 1990s, with foundations that are primarily concrete slab-on-grade and have an average grade elevation of 23.6 feet NAVD. The RLA is located within FEMA Zone A and X, with most of the structures in Zone A, making them at moderate risk of flooding. Tables 1 and 4 provide a summary of the structures within this RLA.

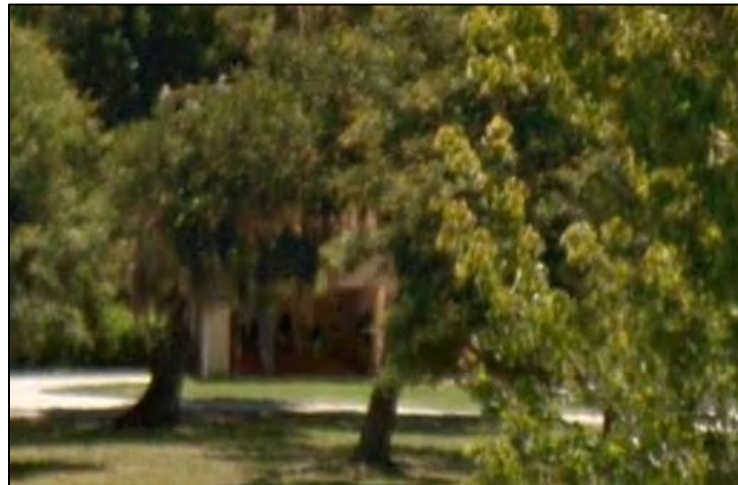
Figure 4: Average Concrete Block, Slab on Grade Structure

Composition	Foundation Type
75%	Slab on grade
12.5%	Raised Slab on Grade
12.5%	Elevated slab on stem wall with fill
Composition	Frame Type
12%	Wood frame
88%	Concrete block/masonry
Composition	Number of Stories
67%	Single story
33%	Two story
Composition	Flood Zones
84%	Within SFHA Zone A
16%	Within Zone X
16%	Within CFHA Zone AH

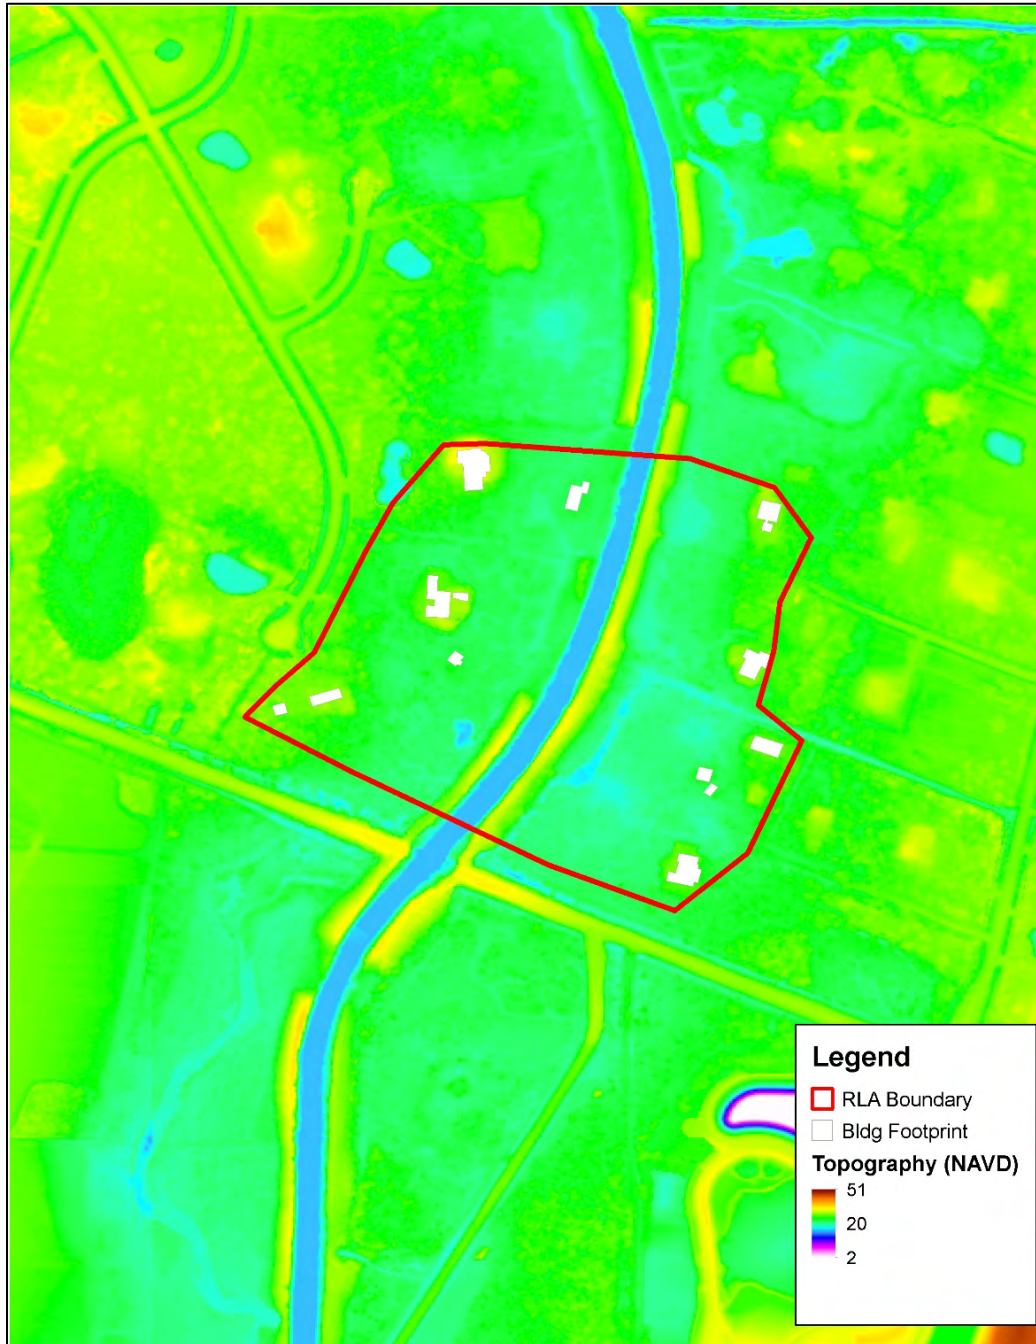
Review of insurance claims data reveals flood damage coincides with storm events with 6 inches or more of rainfall. The adjoining creek overtops during large rain events. The topography map below indicates elevated areas (berms) on the back side of some properties along the creek. Figure 5 provides spatial context for the structures within the RLA in terms of topography, drainage infrastructure, and existing grades at the base of each structure.

Figure 5: Topography, Drainage, and Existing Grades at Base of Structures

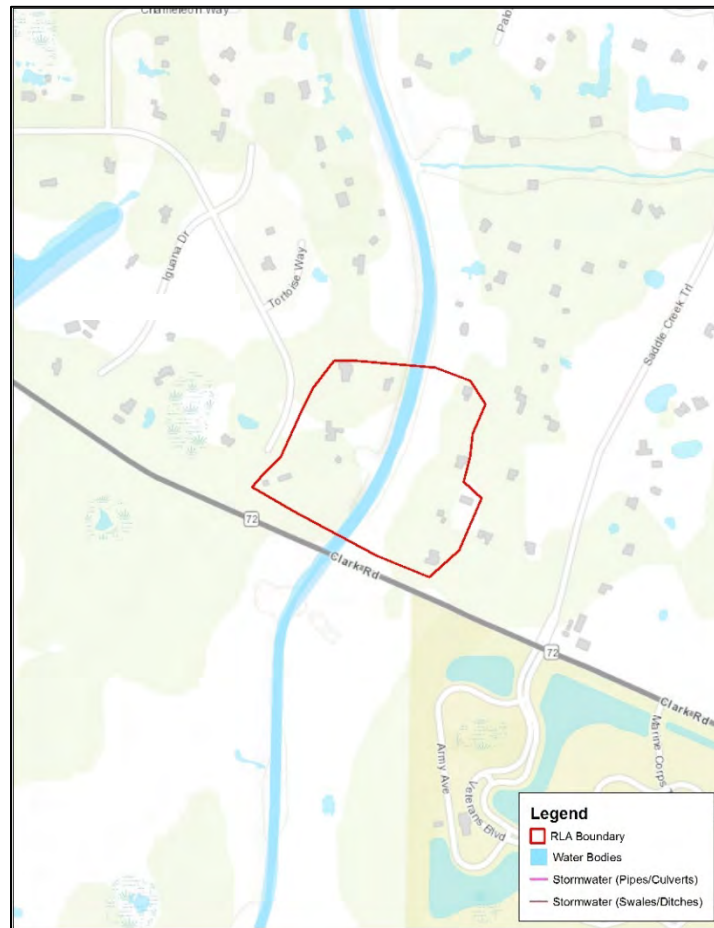
Figure 6: Distribution of Stormwater System Infrastructure

The stormwater utility infrastructure within the RLA is limited to roadside swales for conveyance of stormwater, with runoff pooling and moving down along the street and sheet-flowing to the creek or retention pond. Because the average elevation of existing grades, 23.6 feet NAVD, is relatively high compared to surrounding topography, and flooding occurs when Cowpen Slough Creek overtops its banks, stormwater improvements in this area are not warranted for mitigation for flooding.

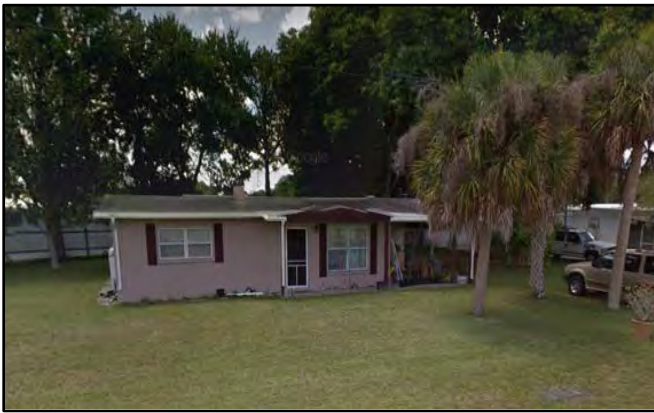
Figure 2: Slab on Grade Structure

This Repetitive Loss Area (RLA) is situated on a peninsula adjacent to Shakett Creek to the West. Most of the residential structures within this area are pre-FIRM, built before the initial Flood Insurance Rate Maps (FIRMs) for Sarasota County. They have foundations that are concrete slab-on-grade with an average grade of 3.1 feet NAVD. Since 100% of the structures are within SFHA, AE-10 Flood Zone, these older, slab-on-grade structures are at risk of flooding, particularly during high tides, as shown in Figure 3. Tables 1 and 4 provide a summary of the structures within this RLA.

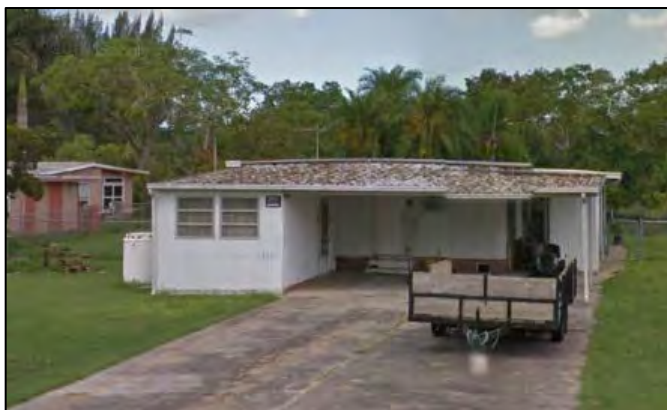
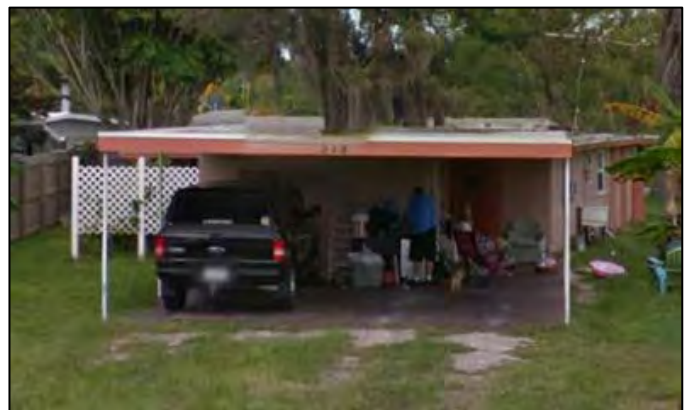
Figure 4: Average Slab on Grade Structures

Composition	Foundation Type
60%	Slab on grade
10%	Elevated slab on stem wall with fill
30%	Elevated on post/piles or walls
Composition	Frame Type
30%	Wood frame
50%	Concrete block/masonry
20%	Manufactured Home
Composition	Number of Stories
90%	Single story
10%	Two story
Composition	Flood Zones
100%	Within SFHA Zone AE
15.4%	Within CFHA Zone AE

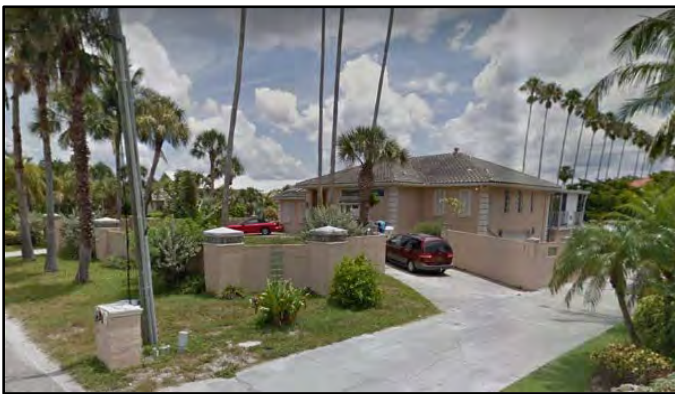
Figure 2: Structure Elevated on Stemwall Structure

This Repetitive Loss Area (RLA) is situated on a portion of the peninsula separating Blackburn Bay to the east and the Gulf of Mexico to the west. This is a narrow peninsula, subject to tidal action, waves, and surge from Blackburn Bay, as well as coastal influences from the Gulf of Mexico. Most of the structures within this area were constructed before the 1990s, with concrete slab-on-grade foundations elevated above an average grade of 2.8 feet NAVD. Newer structures are on a stemwall. Since 100% of the structures are within the SFHA Zone AE-10, the older, slab-on-grade structures are at risk of flooding. Tables 1 and 4 provide a summary of the structures within this RLA.

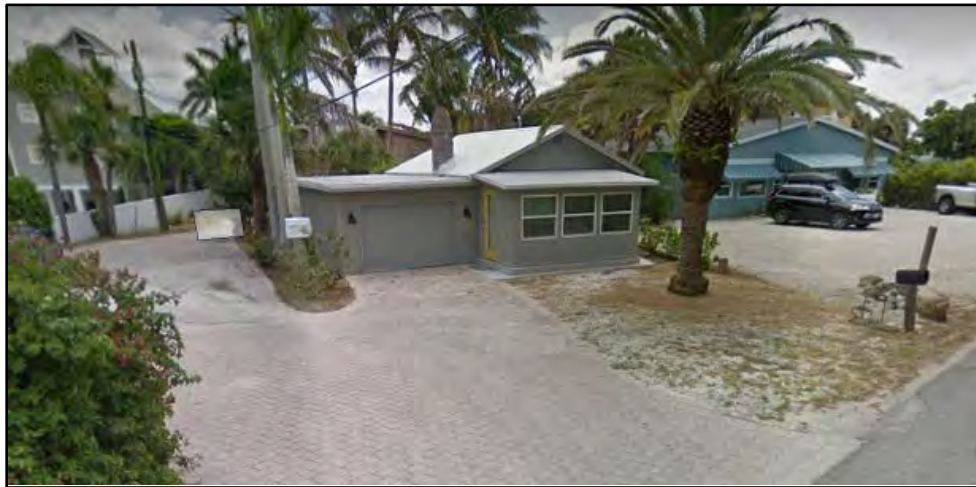
Figure 4: Slab on Grade Structures

Composition	Foundation Type
11%	Raised Slab on grade
44%	Elevated slab on stem wall with enclosure
45%	Elevated on post/piles or walls
Composition	Frame Type
22%	Wood frame
78%	Concrete block/masonry
Composition	Number of Stories
66%	Single story
17%	Two story
17%	Three story or greater
Composition	Flood Zones
100%	Within SFHA Zone AE

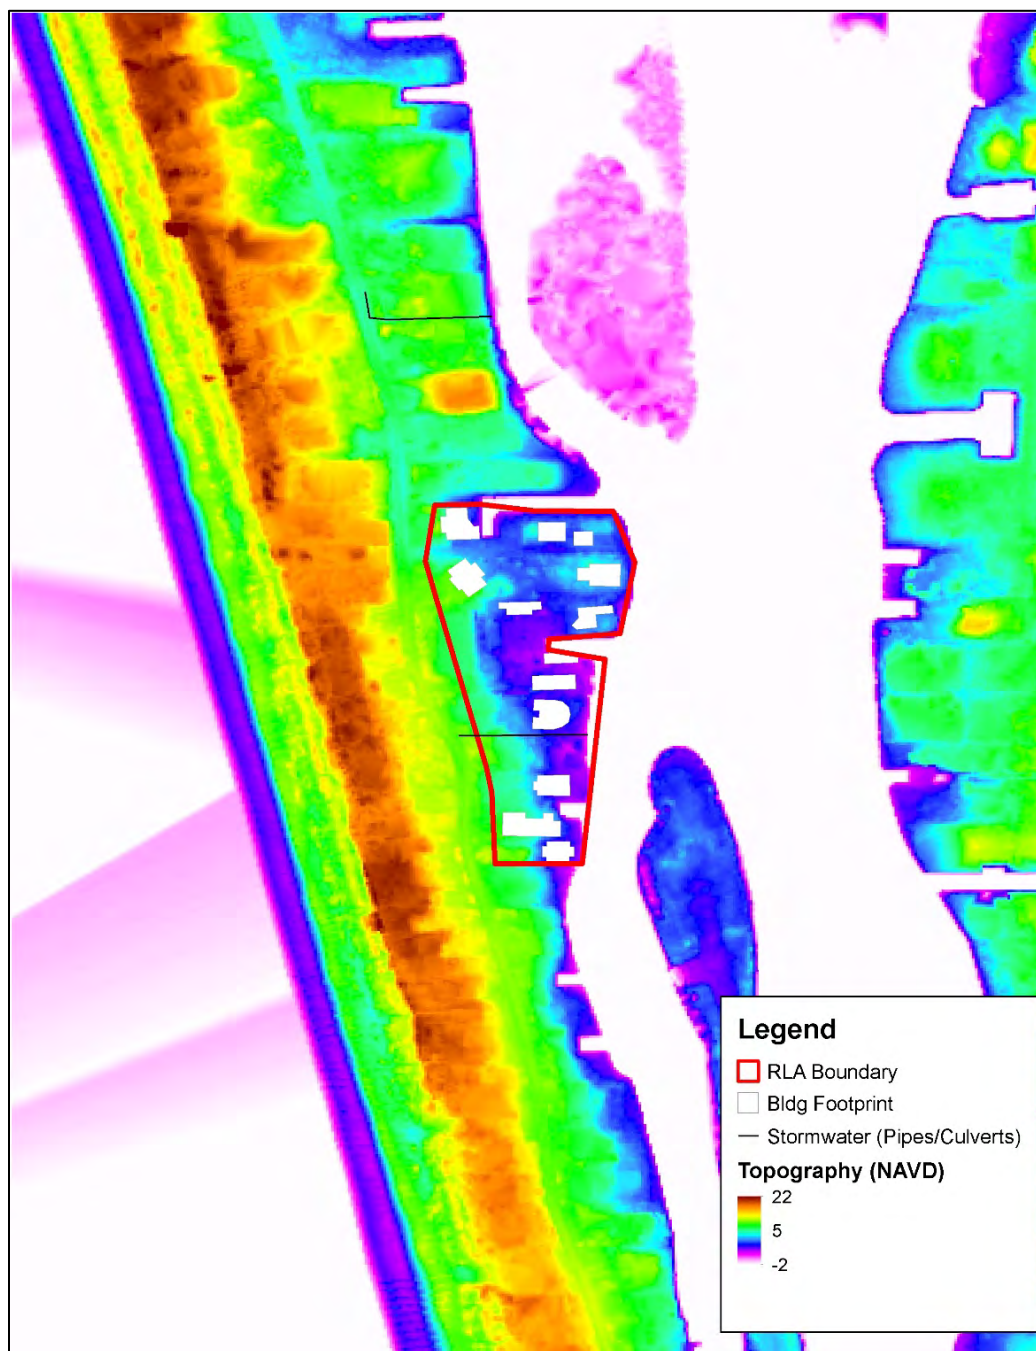
Review of insurance claims data reveals that flood damage coincides with storm events with 15 to 20 inches or more of rainfall, unusually high tides and high winds. These effects have likely caused flood inundation from the bay and prevent normal rainfall runoff and stormwater drainage from these low elevation areas into the bay. The extremely low elevations of the pre-FIRM structures make it unlikely stormwater improvements alone would mitigate flood risk to these structures. Figure 5 provides spatial context for the structures within the RLA in terms of topography, drainage infrastructure, and existing grades at the base of each structure.

Figure 5: Topography, Drainage, and Existing Grades at Base of Structures

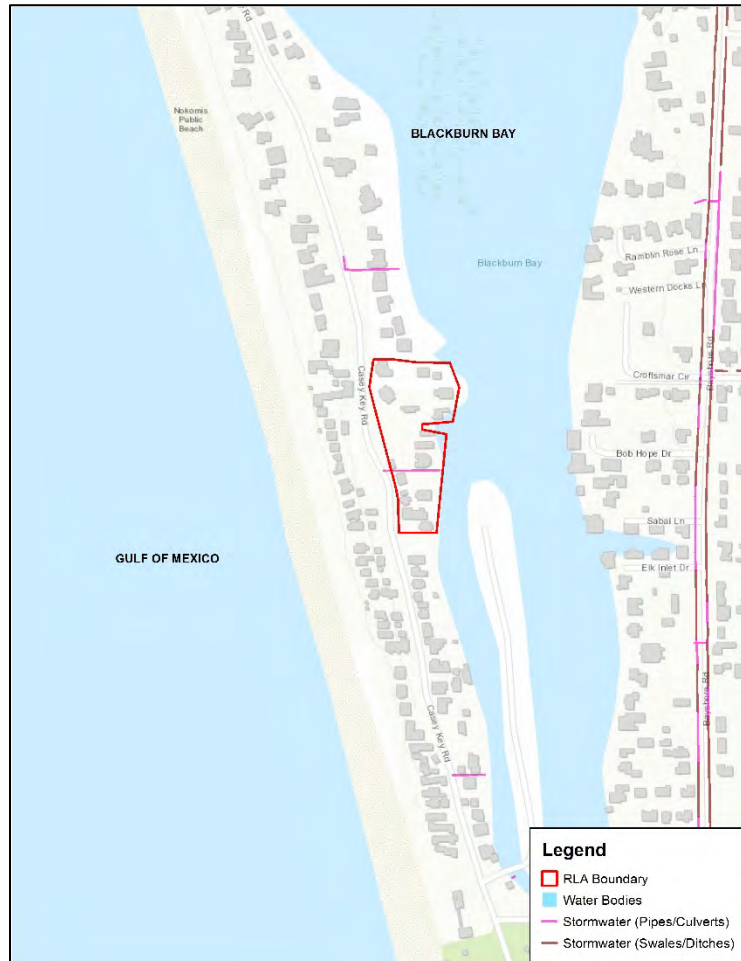
Figure 6: Distribution of Stormwater System Infrastructure

The stormwater utility infrastructure within the RLA is limited to one outfall structure and sheet-flow directly into Blackburn Bay. There are no swales or stormwater pipes for conveyance of stormwater along Casey Key Road, with runoff pooling and moving down along the street toward the outfall structure; however, no connection was observed leading to the County's stormwater infrastructure or the outfall. The average elevation of existing grades (2.8 feet NAVD) versus the Base Flood Elevation (BFE) (10 feet NAVD), suggests that stormwater improvements may provide some mitigation for flooding from major storm events.

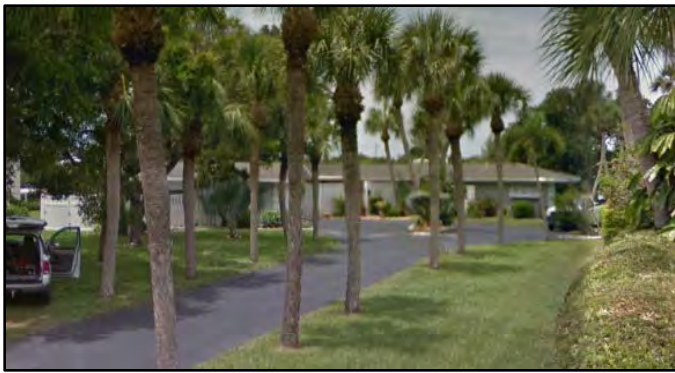
Figure 2: Slab on Grade Structure

This Repetitive Loss Area (RLA) is situated on a portion of the peninsula separating Blackburn Bay from Casey Key and the mainland south of Albee Rd. This area is subject to tidal action, waves, and surge from the Blackburn Bay, as well as coastal influences from the Gulf of Mexico from the western side of the narrow peninsula. The structures within this area were primarily constructed in the early 1990s, with concrete slab-on-grade foundations, elevated above an average grade of 2.1 feet NAVD. Since 100% of the structures are within the SFHA Zone AE-12, these slab-on-grade structures are at risk of flooding. Tables 1 and 4 provide a summary of the structures within this RLA.

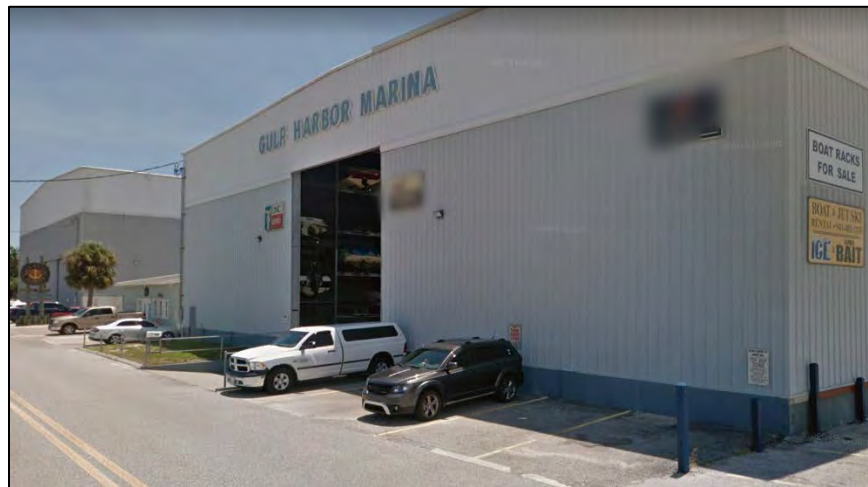
Figure 4: Slab on Grade Structure

Composition	Foundation Type
40%	Slab on grade
60%	Elevated on post/piles or walls
Composition	Frame Type
60%	Wood frame
40%	Concrete block/masonry
Composition	Number of Stories
67%	Single story
33%	Two story
Composition	Flood Zones
100%	Within SFHA Zone AE

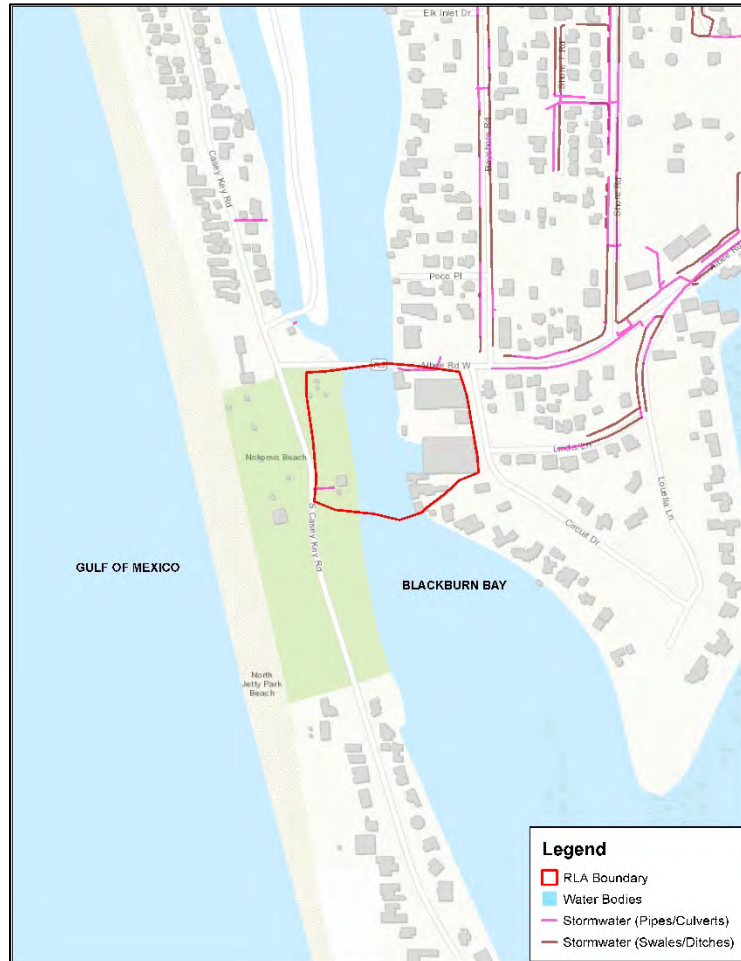
Figure 6: Distribution of Stormwater System Infrastructure

The stormwater utility infrastructure within the RLA is limited to two outfall structures to discharge points at Blackburn Bay. There are no swales or stormwater pipes for conveyance of stormwater along Circuit Dr., with runoff pooling and moving down along the street and over lower elevated properties. The average elevation of existing grades (2.1 feet NAVD) versus the Base Flood Elevation (BFE) (12 feet NAVD), indicates stormwater improvements along with the other recommended mitigation strategies in this RLA would provide mitigation for flooding from major storm events.

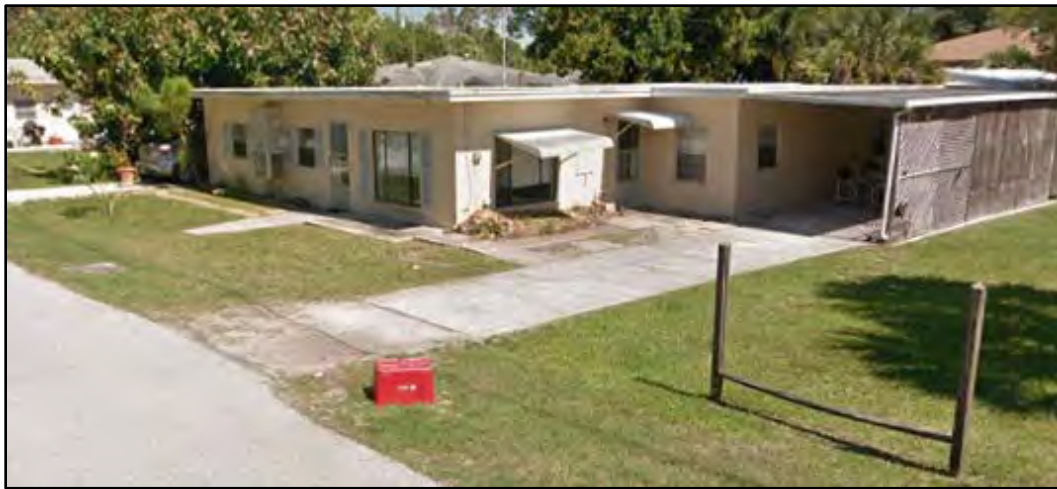
Figure 4: Average Slab on Grade Structure

Composition	Foundation Type
85%	Slab on grade
15%	Elevated foundation walls with enclosure
Composition	Frame Type
0%	Wood frame
100%	Concrete block/masonry
Composition	Number of Stories
92%	Single story
8%	Two story
Composition	Flood Zones
100%	Within SFHA Zone AE

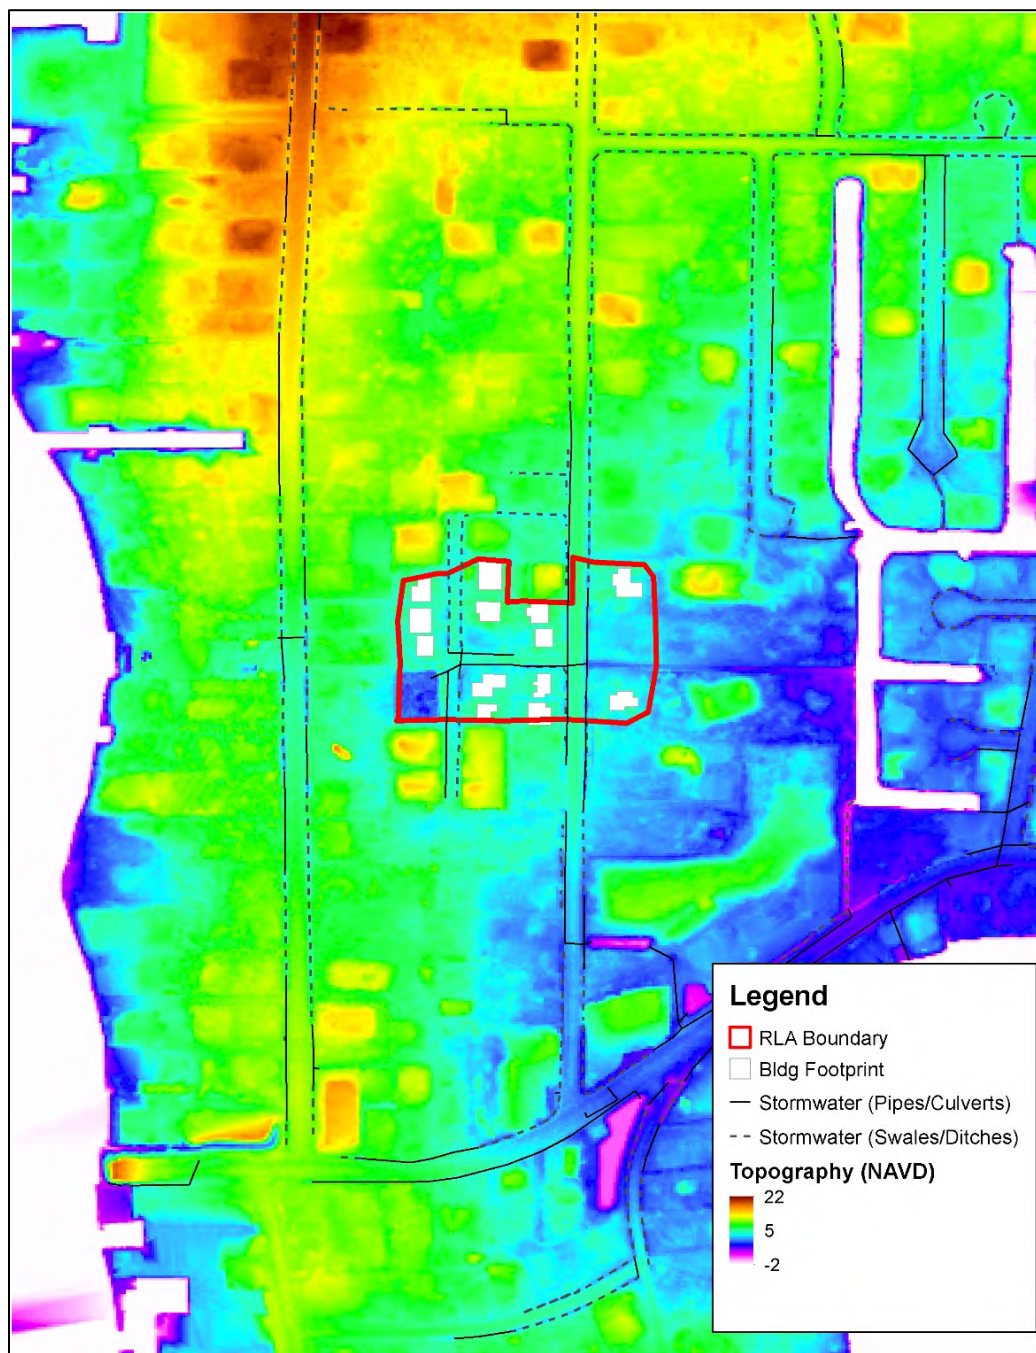
Review of insurance claims data reveals that flood damage coincides with storm events with 6 inches or more of rainfall, unusually high tides and high winds. These effects have likely caused flood inundation from the bays and prevented normal rainfall runoff and stormwater drainage from these low elevation areas into the bays. The extremely low elevations of the pre-FIRM structures make it unlikely stormwater improvements alone would mitigate flood risk to these structures. Figure 5 provides spatial context for the structures within the RLA in terms of topography, drainage infrastructure, and existing grades at the base of each structure.

Figure 5: Topography, Drainage, and Existing Grades at Base of Structures

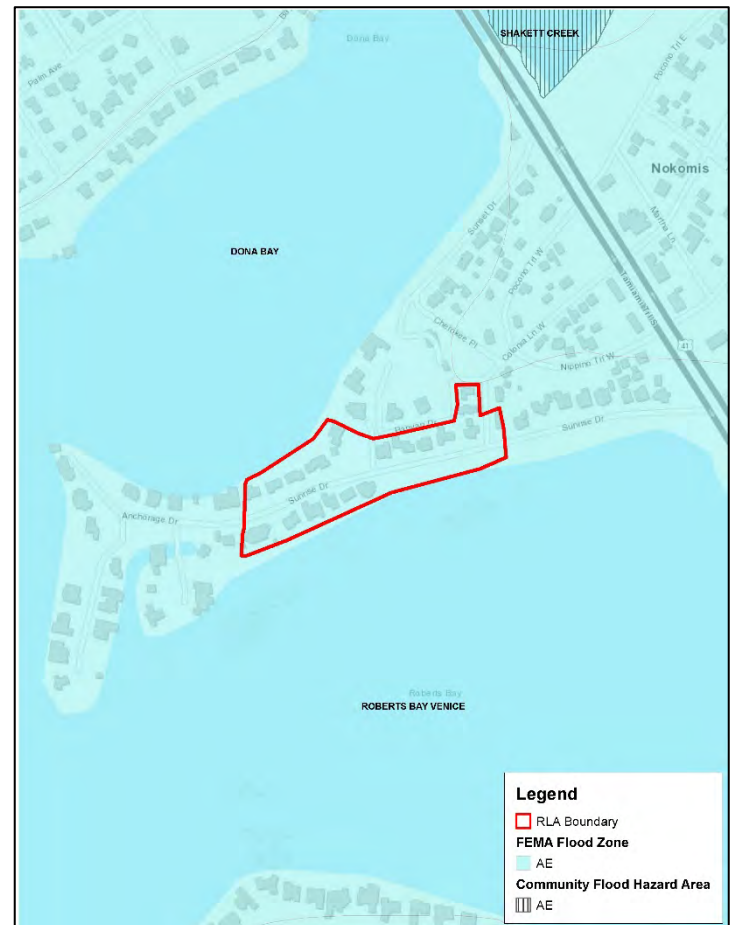
Figure 3: Spatial Distribution of Structures vs Flood Zone

This Repetitive Loss Area (RLA) is situated on a portion of the peninsula separating Dona and Roberts Bays just to the east of Bird Island and just west of US-41. This is the narrowest and lowest section of the peninsula at the confluence of the two bays, subject to tidal action, waves, and surge from the north (Dona Bay) and south (Roberts Bay), as well as coastal influences from the Gulf of Mexico through Venice Inlet less than one mile to the west. Most of the structures within this area were constructed in the 1950s, with concrete slab-on-grade foundations, elevated above an average grade of 2.6 feet NAVD. Since 100% of the structures are within SFHA Zone AE-11, these older, slab-on-grade structures are at risk of flooding. Most of the structures are situated in a low "bowl" area when compared to surrounding properties, which likely accounts for some flooding from stormwater runoff particularly during high tides, as shown in Figure 3. Tables 1 and 4 provide a summary of the structures within this RLA.

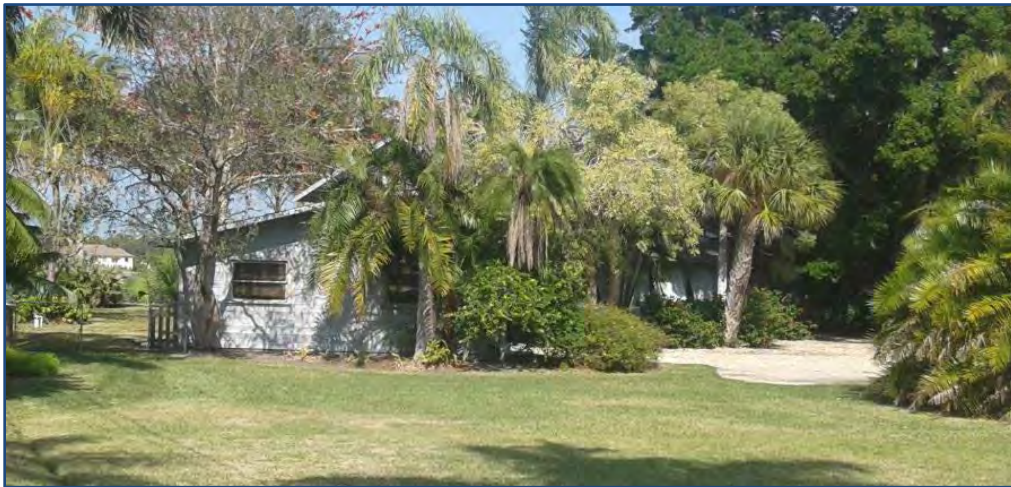
Figure 4: Average Wood Frame, Slab on Grade Structure

Composition	Foundation Type
60%	Slab on grade
10%	Elevated slab on stem wall with fill
30%	Elevated on post/piles or walls
Composition	Frame Type
30%	Wood frame
70%	Concrete block/masonry
Composition	Number of Stories
75%	Single story
15%	Two story
10%	Three story or greater
Composition	Flood Zones
100%	Within SFHA Zone AE

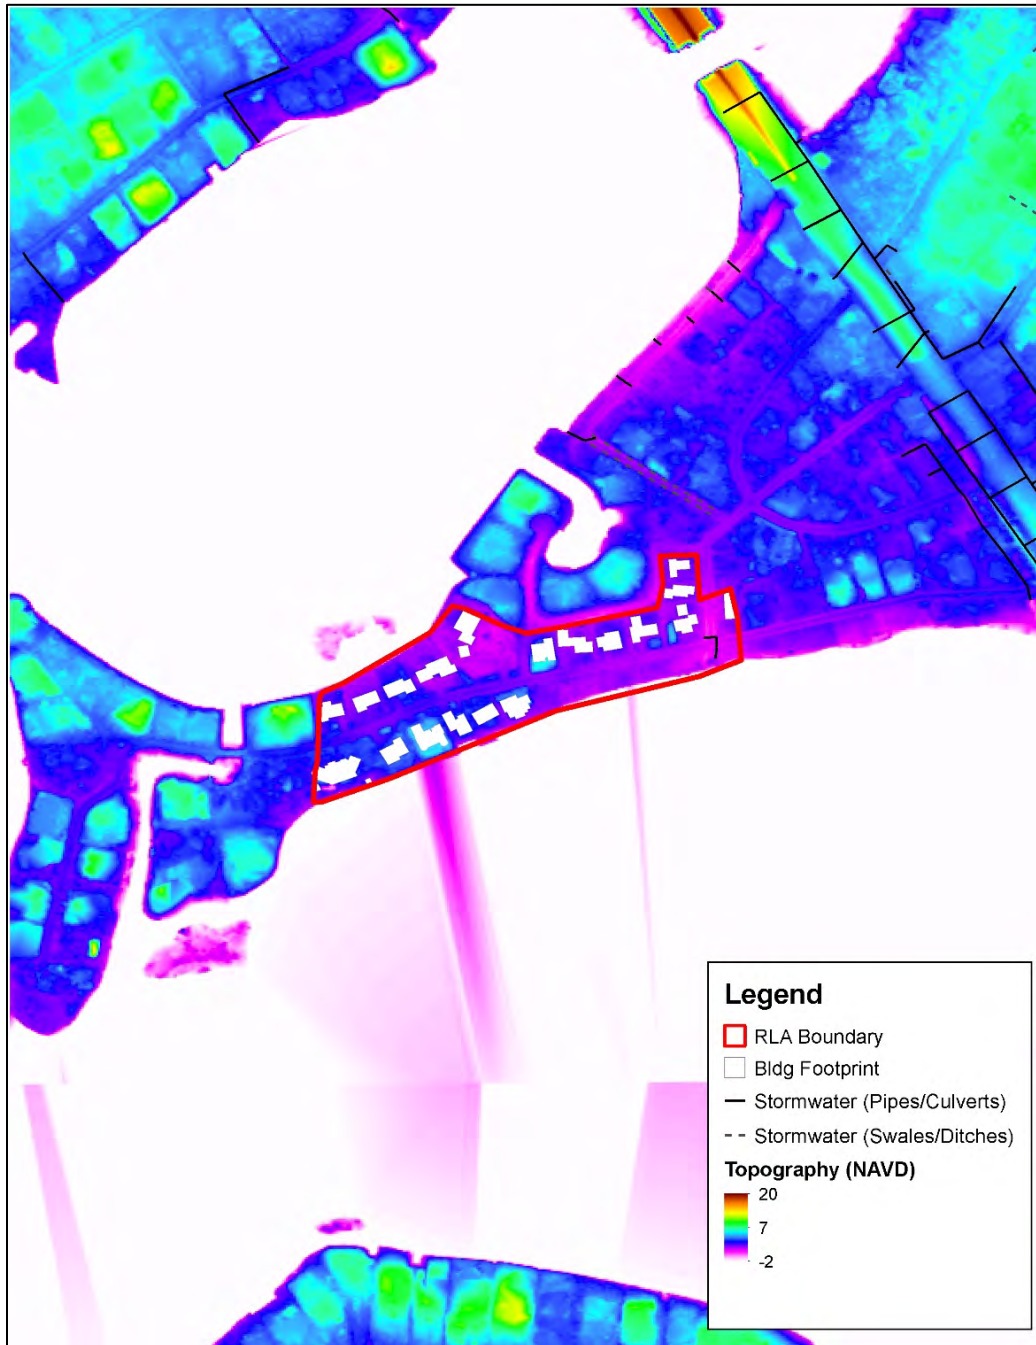
Review of insurance claims data reveals that flood damage coincides with storm events with 6 inches or more of rainfall, unusually high tides and high winds. These effects have likely caused flood inundation from the bays and prevented normal rainfall runoff and stormwater drainage from these low elevation areas into the bays. The extremely low elevations of the pre-FIRM structures make it unlikely stormwater improvements alone would mitigate flood risk to these structures. Figure 5 provides spatial context for the structures within the RLA in terms of topography, drainage infrastructure, and existing grades at the base of each structure.

Figure 5: Topography, Drainage, and Existing Grades at Base of Structures

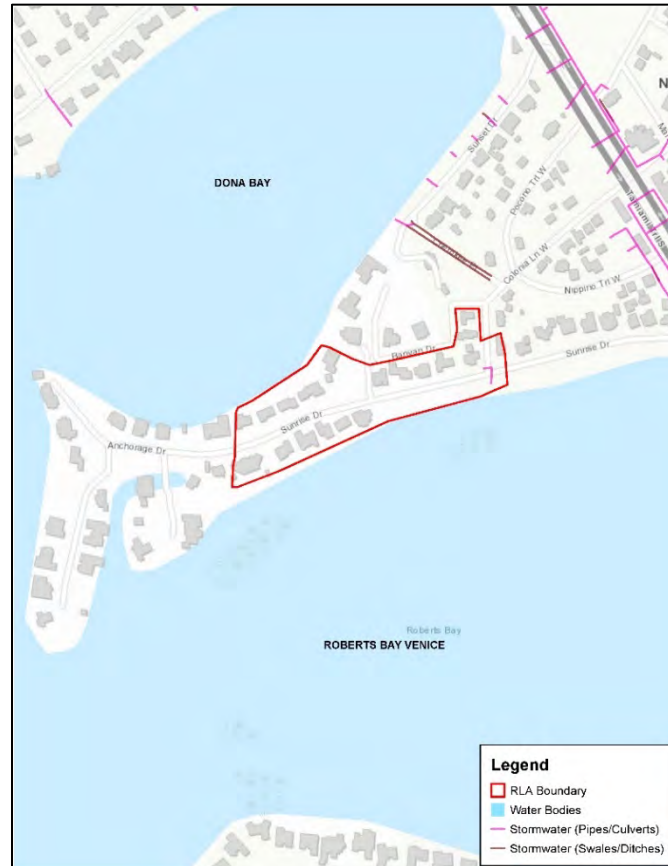
Figure 6: Distribution of Stormwater System Infrastructure

The stormwater utility infrastructure within the RLA is limited to a couple drop structures leading to a single Roberts Bay outfall (spillway) at the intersection of Sunrise Dr. and Colonia Ln. There are no swales or pipes for conveyance of stormwater along Sunrise Dr., with runoff pooling and moving down along the street and over lower elevated properties toward the spillway outfall, and "outward" from the street to the lower elevated properties to the north and south. There is a street drain at the driveway of 404 Sunrise Dr., but no connection was observed leading to the County's stormwater infrastructure or the spillway outfall. Some low-level flooding as described by the resident survey response may be reduced through the expansion of the stormwater infrastructure to include Sunrise Dr. However, with the average elevation of existing grades (2.6 feet NAVD) versus the Base Flood Elevation (BFE) (11 feet NAVD), such improvements would not provide mitigation for flooding from major storm events.

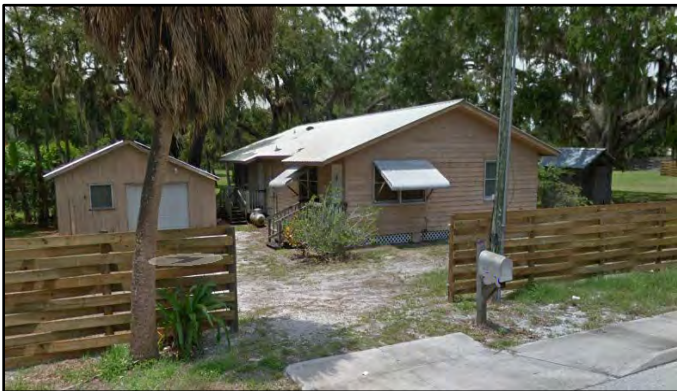
Figure 2: Slab on Grade, Wood Frame Structure

This Repetitive Loss Area (RLA) is situated on a riverine shoreline in a residential neighborhood east of Sarasota Bay. Most of the structures within this area were constructed in the 1970s, with concrete slab-on-grade foundations, elevated 12.9 feet above the Base Flood Elevation (BFE) of the adjacent special flood hazard area (SFHA). Since the structures are within the CFHA Zone AE, as well as the FEMA Zone Shaded X, these older, slab-on-grade structures are at a greater risk of coastal influences and overtopping of banks from the adjacent riverine area, as opposed to regular storm event flooding. Tables 1 and 4 provide a summary of the structures within this RLA.

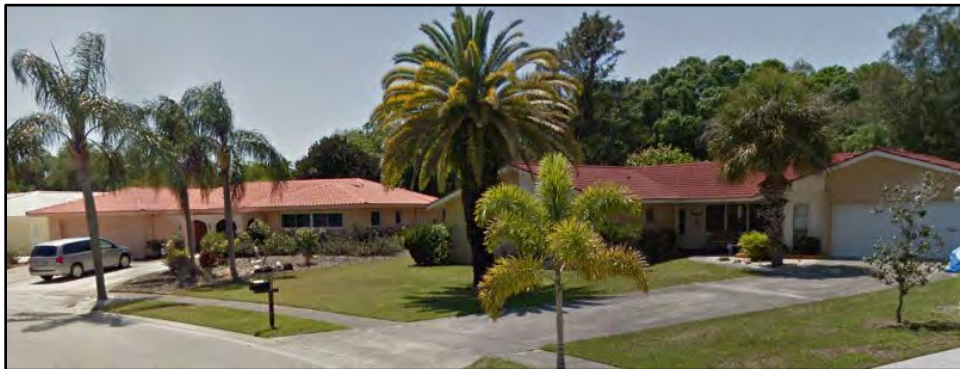
Figure 4: Average Slab on Grade Structure

Composition	Foundation Type
93%	Slab on grade
7%	Elevated on posts/piles
Composition	Frame Type
11%	Wood frame
89%	Concrete block/masonry
Composition	Number of Stories
100%	Single story
Composition	Flood Zones
75.6%	Within Zone Shaded X
24.4%	Within Zone X
6.7%	Within CFHA Zone AE

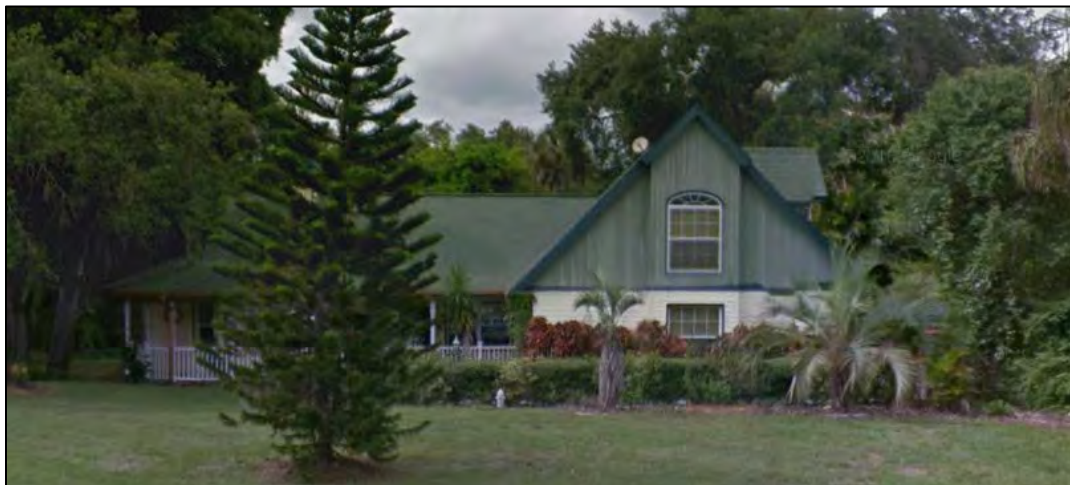
Figure 4: Average Slab on Grade Structure

Composition	Foundation Type
78%	Slab on grade
11%	Elevated on stem walls
11%	Elevated on posts/piles
Composition	Frame Type
44%	Wood frame
56%	Concrete block/masonry
Composition	Number of Stories
73%	Single story
27%	Two story
0%	Three story or greater
Composition	Flood Zones
55%	Within SFHA Zone AE
45%	Within Zone Shaded X
13%	Within CFHA Zone AE

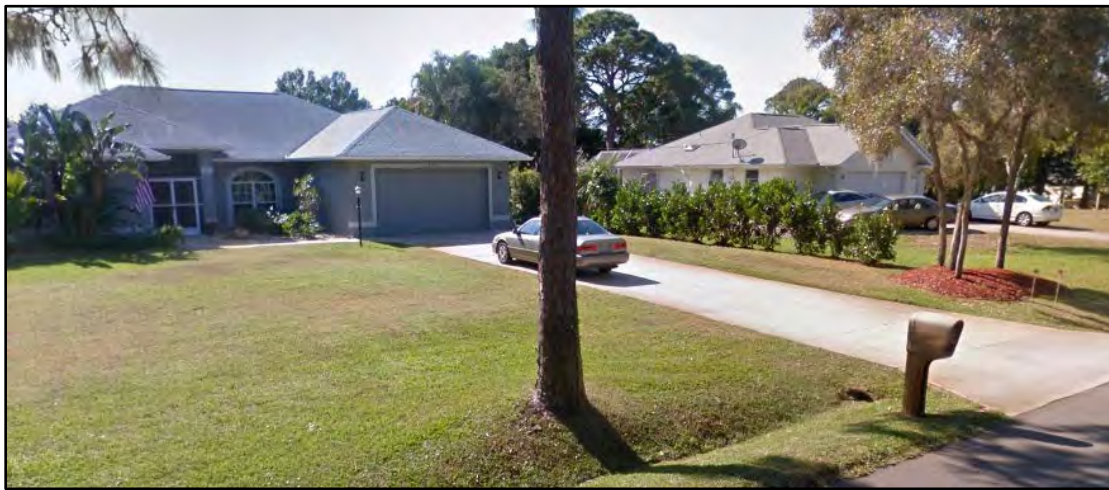
Figure 4: Average Raised Slab on Grade Structure

Composition	Foundation Type
100%	Slab on grade
Composition	Frame Type
8%	Wood frame
92%	Concrete block/masonry
Composition	Number of Stories
100%	Single story
Composition	Flood Zones
100%	Within SFHA Zone AE

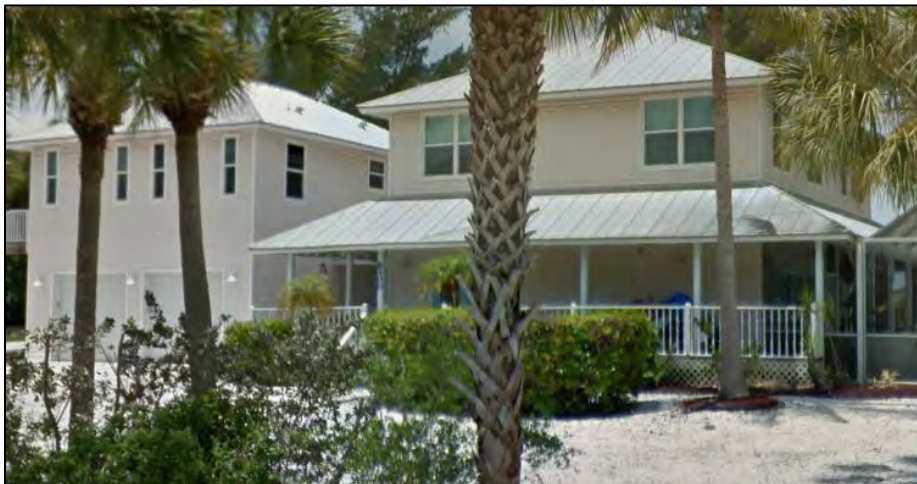
Figure 4: Average Elevated on Post Structure

Composition	Foundation Type
11%	Elevated on posts/piles
89%	Undetermined due to heavy vegetation/no access to property
Composition	Frame Type
22%	Wood frame
78%	Concrete block/masonry
Composition	Number of Stories
67%	Single story
33%	Two story
Composition	Flood Zones
100%	Within SFHA Zone AE
