**SARASOTA COUNTY
FLOODPLAIN MANAGEMENT PLAN UPDATE**

Sarasota County | June 2021

Sarasota County Floodplain Management Plan Committee
1001 Sarasota Center Blvd.
Sarasota, Florida 34240
June 2021

Jones Edmunds & Associates, Inc.
730 NE Waldo Road
Gainesville, Florida 32641
Certificate of Engineering Authorization #1841

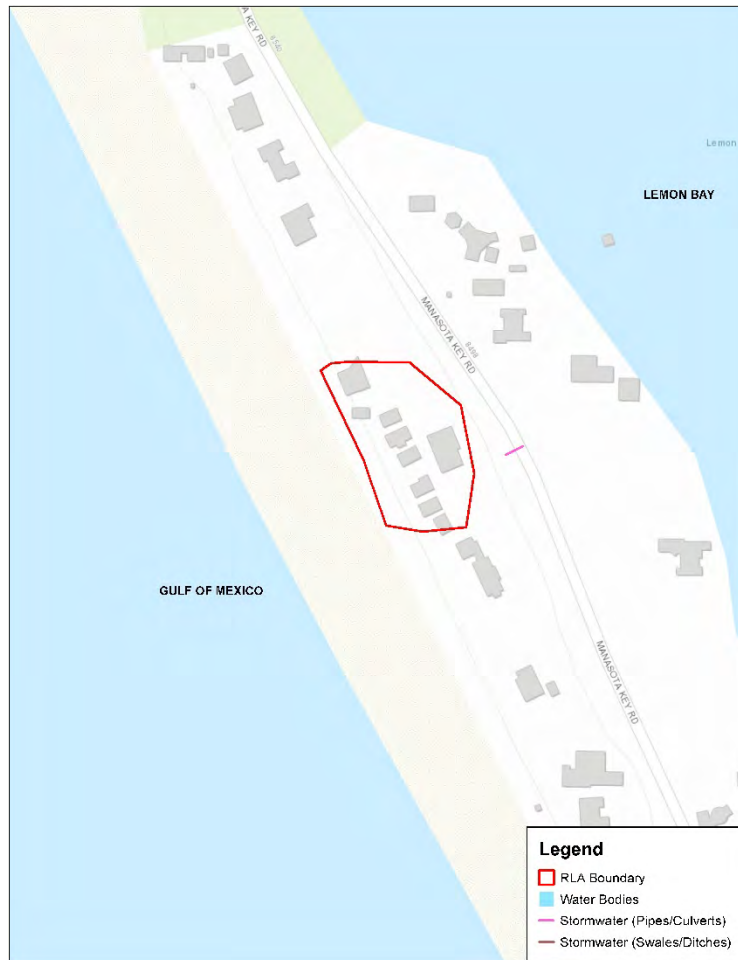
Figure 6: Distribution of Stormwater System Infrastructure

The stormwater utility infrastructure within the RLA is limited to one catch basin that outfalls to Lemon Bay. There are no swales or pipes for conveyance of stormwater along Manasota Key Rd, with runoff pooling and moving down along the street and over lower elevated properties toward the outfall structure. No connection was observed leading to the County's stormwater infrastructure. The average elevation of existing grades (11.2 feet NAVD) versus the Base Flood Elevation (BFE) (10 feet NAVD), does not warrant stormwater infrastructure improvements to provide mitigation for flooding from major storm events; flooding will primarily be from storm surge and heavy rain events.

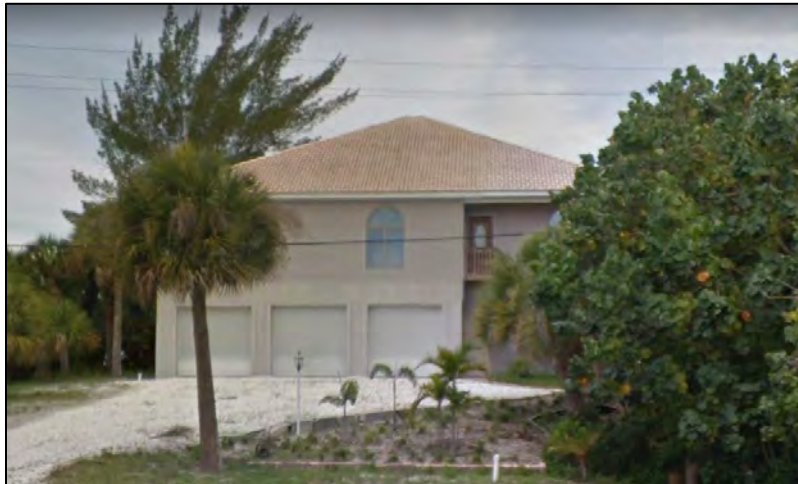
Figure 4: Elevated Structures

Composition	Foundation Type
40%	Slab on grade
40%	Elevated foundation walls with enclosure
20%	Undetermined due to heavy vegetation/ no access to property
Composition	Frame Type
100%	Concrete block/masonry
Composition	Number of Stories
83%	Single story
17%	Two story
Composition	Flood Zones
100%	Within SFHA Zone AE

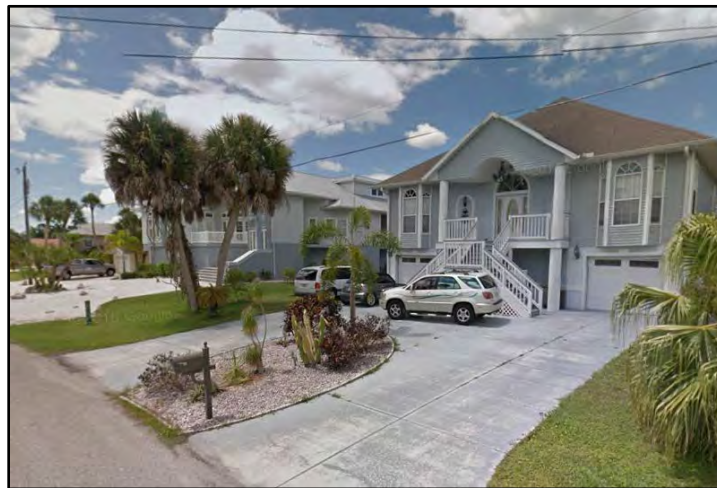
Figure 4: Average Elevated Foundation Wall with Enclosure Structure

Composition	Foundation Type
64%	Slab on grade
27%	Elevated foundation walls with enclosure
9%	Elevated on Posts/Piles
Composition	Frame Type
100%	Concrete block/masonry
Composition	Number of Stories
68%	Single story
32%	Two story
Composition	Flood Zones
41%	Within SFHA Zone AE
59%	Within SFHA Zone VE

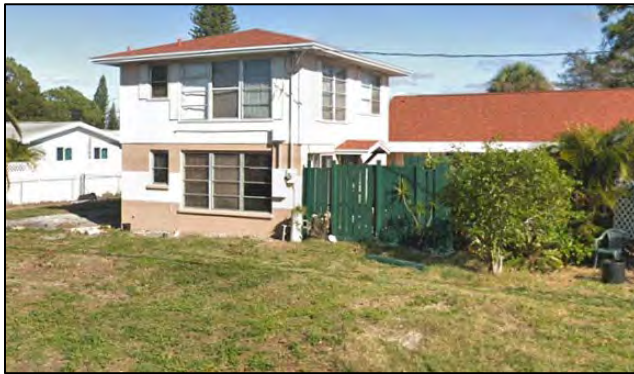
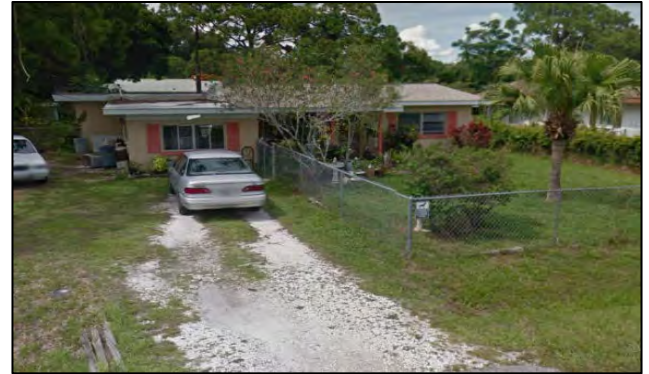
Figure 4: Average Slab on Grade Structure

Composition	Foundation Type
100%	Slab on grade
0%	Elevated foundation walls with enclosure
Composition	Frame Type
6%	Wood frame
94%	Concrete block/masonry
Composition	Number of Stories
94%	Single story
6%	Two story
Composition	Flood Zones
100%	Within SFHA Zone AE

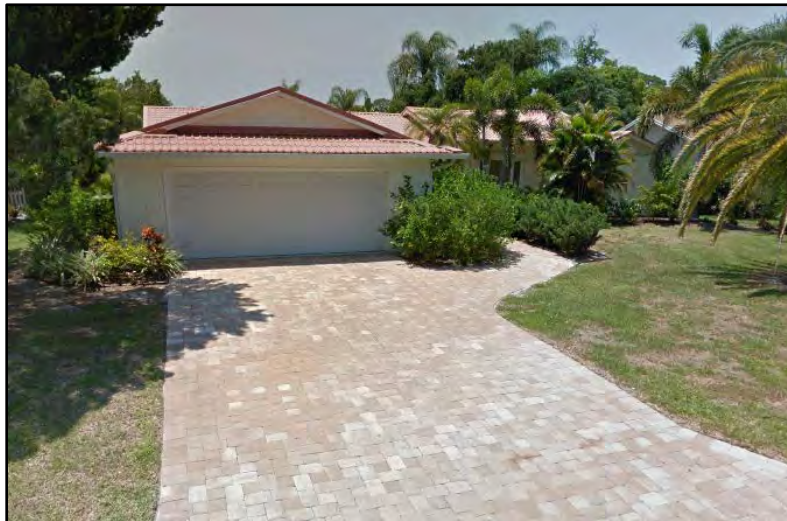
Figure 4: Average Slab on Grade Structure

Composition	Foundation Type
100%	Slab on grade
0%	Elevated foundation walls with enclosure
Composition	Frame Type
55%	Wood frame
45%	Concrete block/masonry
Composition	Number of Stories
67%	Single story
33%	Two story
Composition	Flood Zones
89%	Within Zone Shaded X
11%	Within SFHA Zone AE

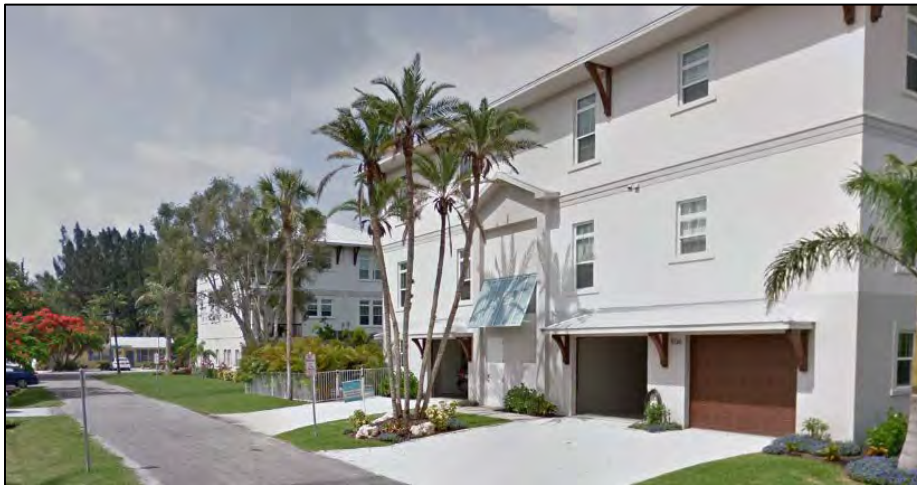
Figure 4: Average Wood Frame, Slab on Grade Structure

Composition	Foundation Type
52%	Slab on grade
25%	Elevated foundation walls with enclosure
14%	Elevated posts/piles
9%	Undetermined due to vegetation/access
Composition	Frame Type
26%	Wood frame
74%	Concrete block/masonry
Composition	Number of Stories
51%	Single story
33%	Two story
16%	Three story or greater
Composition	Flood Zones
100%	Within SFHA Zone AE

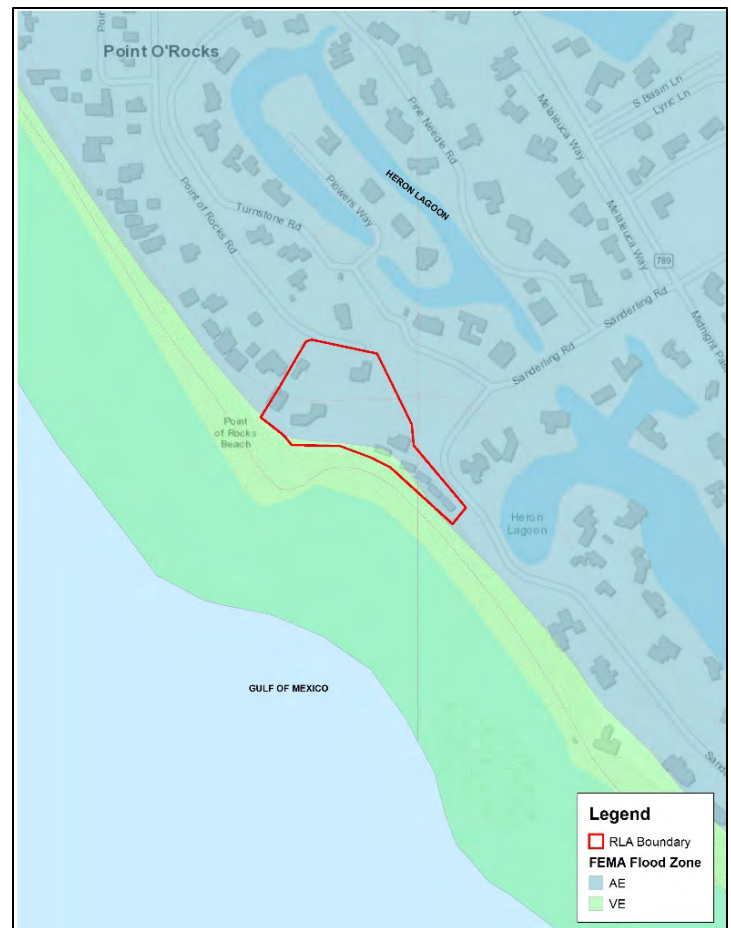
Figure 3: Spatial Distribution of Structures vs Flood Zone

This Repetitive Loss Area (RLA) is located directly parallel to the Gulf of Mexico on the west and is subject to tidal action, waves, and surge from both the Gulf of Mexico and Little Sarasota Bay. Most of the structures within this area were constructed in the 1960s, with an average Finished Floor Elevation (FFE) of 8.7 feet NAVD. The structures are located within SFHA Zones AE-10, AE-11 or VE-14, and are at risk of flooding. Tables 1 and 4 provide a summary of the structures within this RLA.

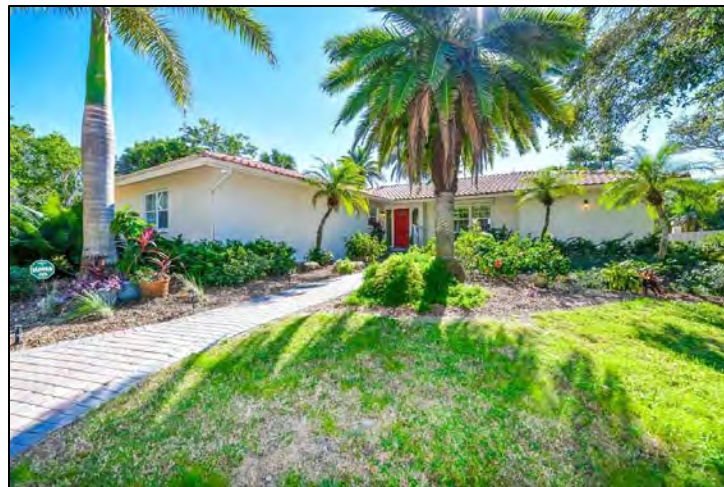
Figure 4: Raised Slab on Grade Structures

Composition	Foundation Type
67%	Raised/Slab on grade
22%	Elevated foundation walls with enclosure
11%	Undetermined due to no access/ intense vegetation
Composition	Frame Type
67%	Wood frame
33%	Concrete block/masonry
Composition	Number of Stories
67%	Single story
22%	Two story
11%	Three story or greater
Composition	Flood Zones
80%	Within SFHA Zone AE
20%	Within SFHA Zone VE

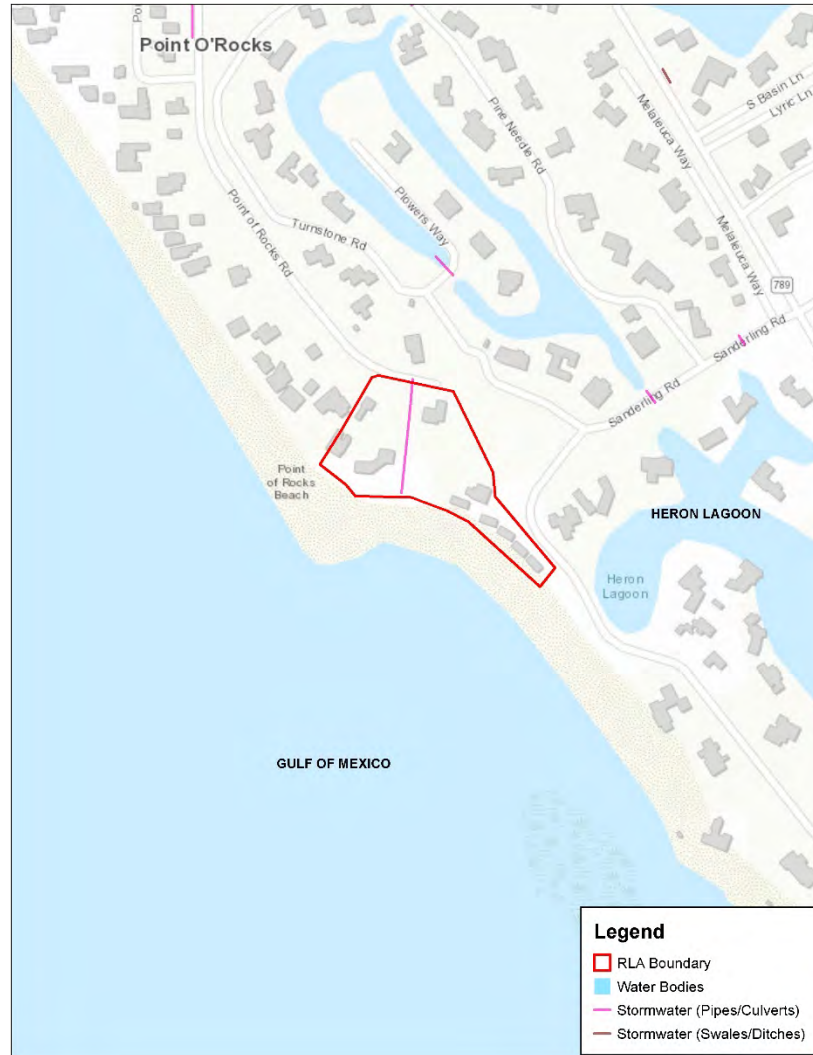
Figure 4: Distribution of Stormwater System Infrastructure

The stormwater utility infrastructure within the RLA is limited to one curb inlet located at the end of Point of Rocks Rd before discharging to an outfall structure and into the Gulf of Mexico. The properties in this RLA located on Sanderling Rd. are a condominium, which is responsible for maintaining its own stormwater onsite. Elevating the structures on Sanderling Dr. would help combat flooding but the structures in this area will likely still flood due to coastal influences. Therefore, stormwater infrastructure improvements would likely not provide mitigation for flooding from major storm events.

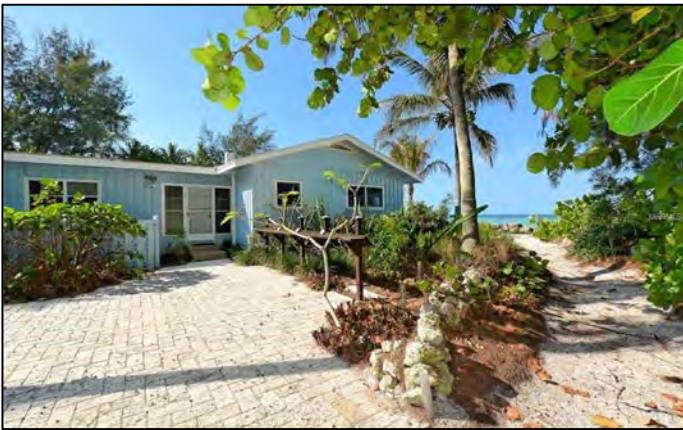
Figure 2: Stemwall with Slab Structure

This Repetitive Loss Area (RLA) is located on a portion of an island between the Gulf of Mexico to the west and Heron Lagoon on the east. All the structures in this RLAA are constructed on waterfront lots. This area is subject to tidal action, waves, and surge from the Gulf of Mexico, Heron Lagoon, and coastal influences from the nearby Little Sarasota Bay. Most of the structures within this area were constructed in the 1950s and 1960s, with concrete slab-on-grade foundations, above an average grade of 3.6 feet NAVD. The structures are within SFHA Zone AE and Zone VE, and are at a high risk of flooding and storm surge. Tables 1 and 4 provide a summary of the structures within this RLA.

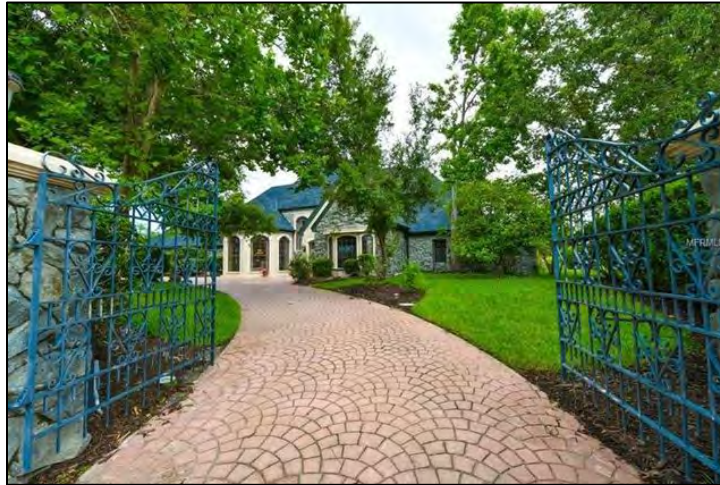
Figure 4: Slab on Grade Structures

Composition	Foundation Type
62%	Slab on grade
29%	Elevated foundation walls with enclosure
9%	Stemwall w/ Slab
Composition	Frame Type
52%	Wood frame
48%	Concrete block/masonry
Composition	Number of Stories
67%	Single story
33%	Two story
Composition	Flood Zones
92%	Within SFHA Zone AE
8%	Within SFHA Zone VE

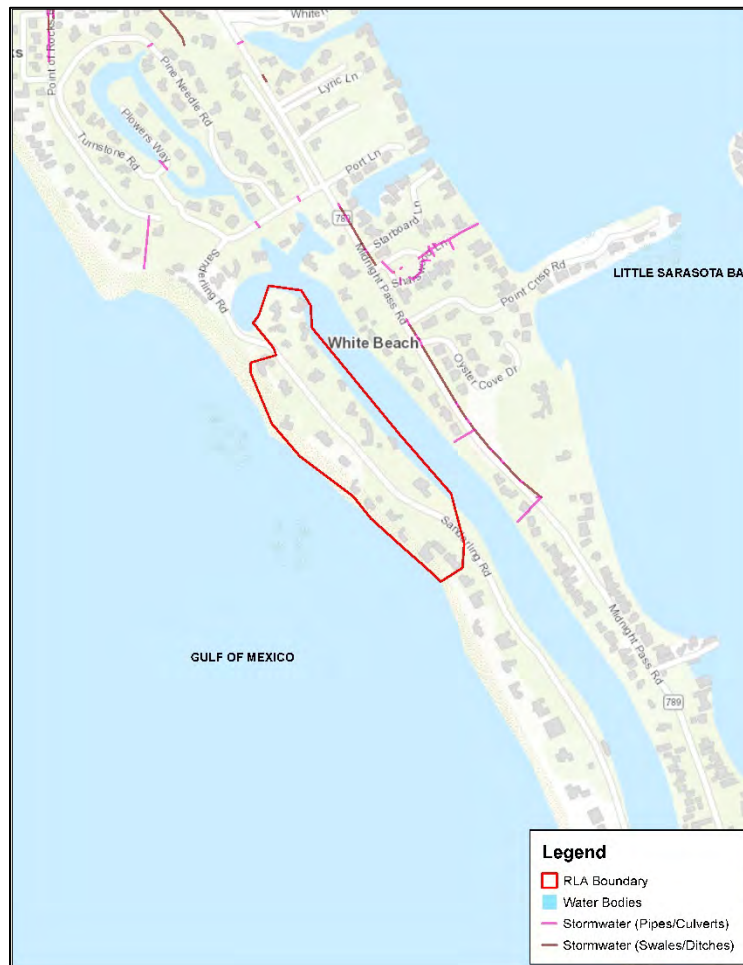
Figure 6: Distribution of Stormwater System Infrastructure

There was no stormwater utility infrastructure identified within this RLA; however due to the close proximity to the Gulf of Mexico and risk of storm surge/high tides and excessive rainfalls, it is very unlikely that construction of stormwater infrastructure would provide adequate mitigation for flooding from major storm events.

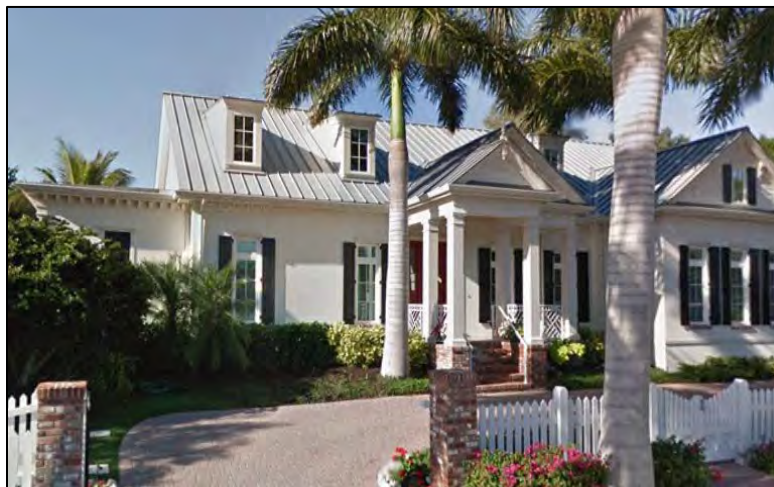
Figure 4: Average Raised Slab on Grade Structure

Composition	Foundation Type
45%	Slab on grade
43%	Elevated foundation walls with enclosure
4%	Elevated on posts/piles
2%	Stem wall w/ slab
6%	Undetermined due to vegetation/access
Composition	Frame Type
36%	Wood frame
64%	Concrete block/masonry
Composition	Number of Stories
49%	Single story
42%	Two story
9%	Three story or greater
Composition	Flood Zones
100%	Within SFHA Zone AE

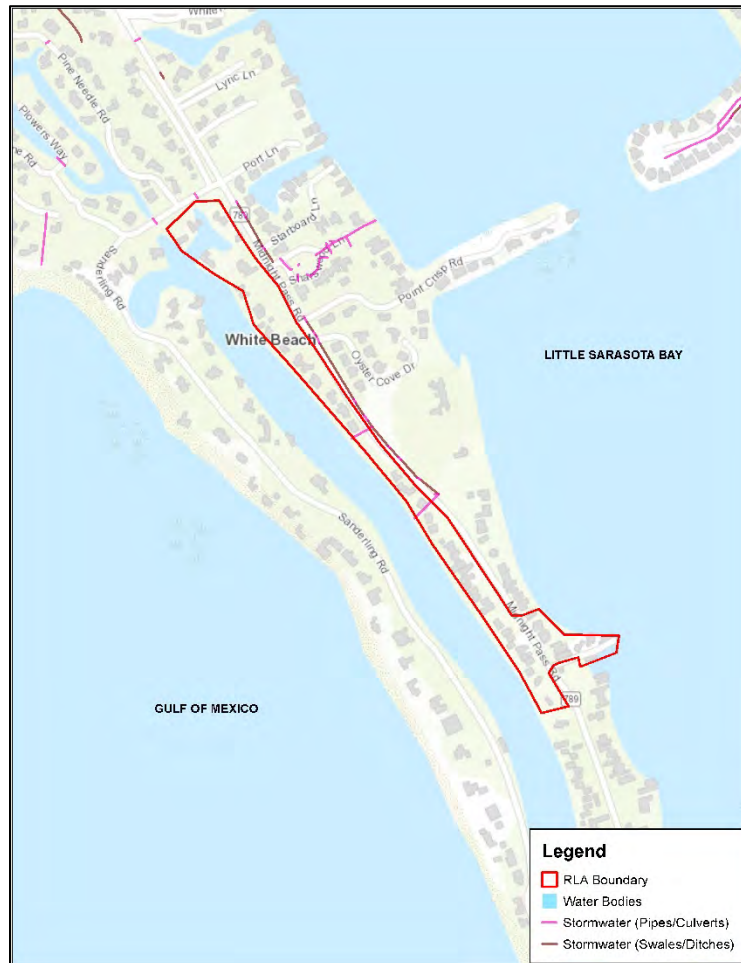
Figure 6: Distribution of Stormwater System Infrastructure

The stormwater utility infrastructure within the RLA includes roadside swales and pipes for conveyance of stormwater along Midnight Pass Rd., with runoff discharging out two (2) outfall structures into Heron Lagoon. Some flooding was described by the resident survey response which was noted to be caused by the drainage system during regular storm events. Expansion of the stormwater infrastructure in this area may provide some mitigation for flooding from major storm events, but not complete mitigation due to the proximity to the Gulf of Mexico, Heron Lagoon, and Little Sarasota Bay.

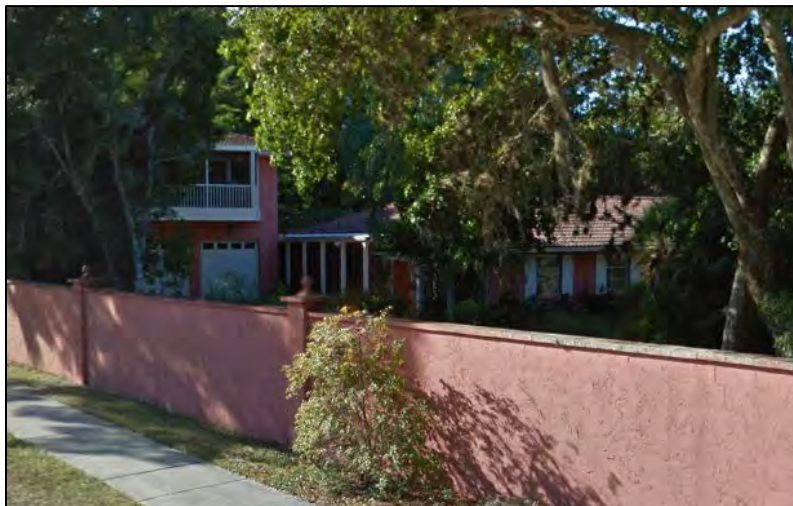
Figure 2: Slab on Grade Structure

This Repetitive Loss Area (RLA) is located on a portion of an island between Little Sarasota Bay to the east and the Gulf of Mexico to the west, with Heron Lagoon in the middle. Over 80% of the structures in this RLA are constructed on waterfront lots. This area is subject to tidal action, waves, and surge from the Little Sarasota Bay, Heron Lagoon, and the Gulf of Mexico. Most of the structures within this area were constructed in the 1950s and 1960s, with concrete slab-on-grade foundations, minimally above an average grade of 3.2 feet NAVD. Most of the structures are within SFHA Zone AE- 10, and are at a high risk of flooding and storm surge. Tables 1 and 4 provide a summary of the structures within this RLA.

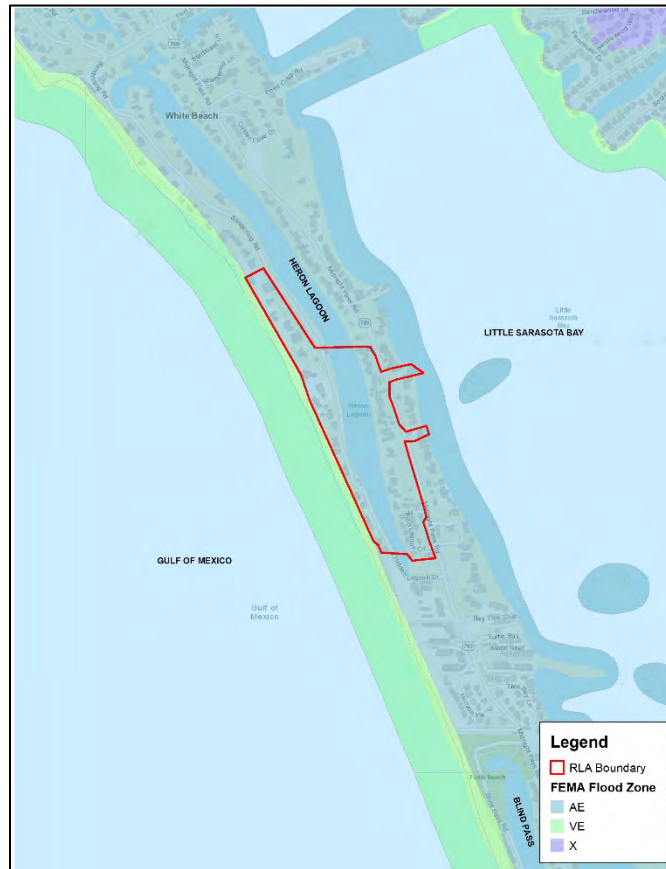
Figure 3: Spatial Distribution of Structures vs Flood Zone

Total	Repetitive Loss Data
79	Total Structures in Repetitive Loss Area
8	Total Repetitive Loss Structures in this Area
45	Properties w/Active Insurance Policies
3	Mitigated RL & SRL Properties
5	Unmitigated RL & SRL Properties
60	Insurance Claims (since 1978)
\$869.2	Total Insurance Claims (in thousands)
\$14.5	Average Insurance Claim (in thousands)

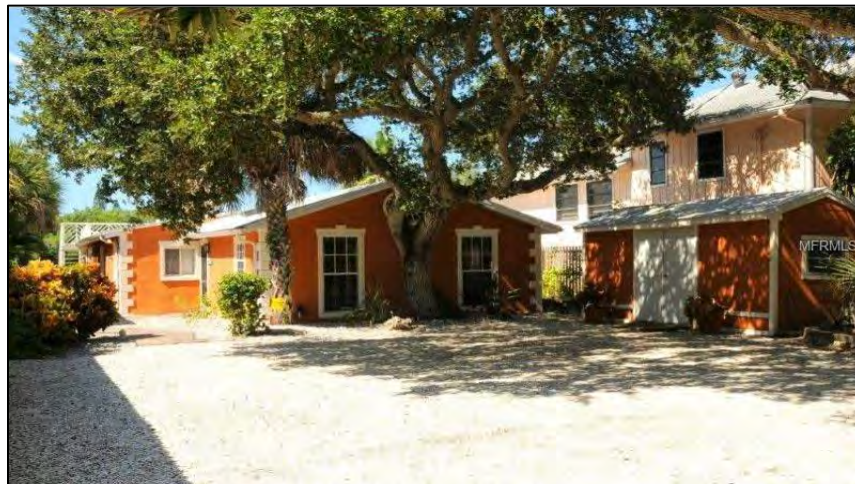
Figure 4: Average Slab on Grade Structures

Composition	Foundation Type
51%	Slab on grade
24%	Elevated foundation walls with enclosure
6%	Elevated on posts/piles
1%	Slab on stem wall
18%	Undetermined due to vegetation/access
Composition	Frame Type
48%	Wood frame
52%	Concrete block/masonry
Composition	Number of Stories
58%	Single story
28%	Two story
14%	Three story or greater
Composition	Flood Zones
100%	Within SFHA Zone AE
2.5%	Within SFHA Zone VE

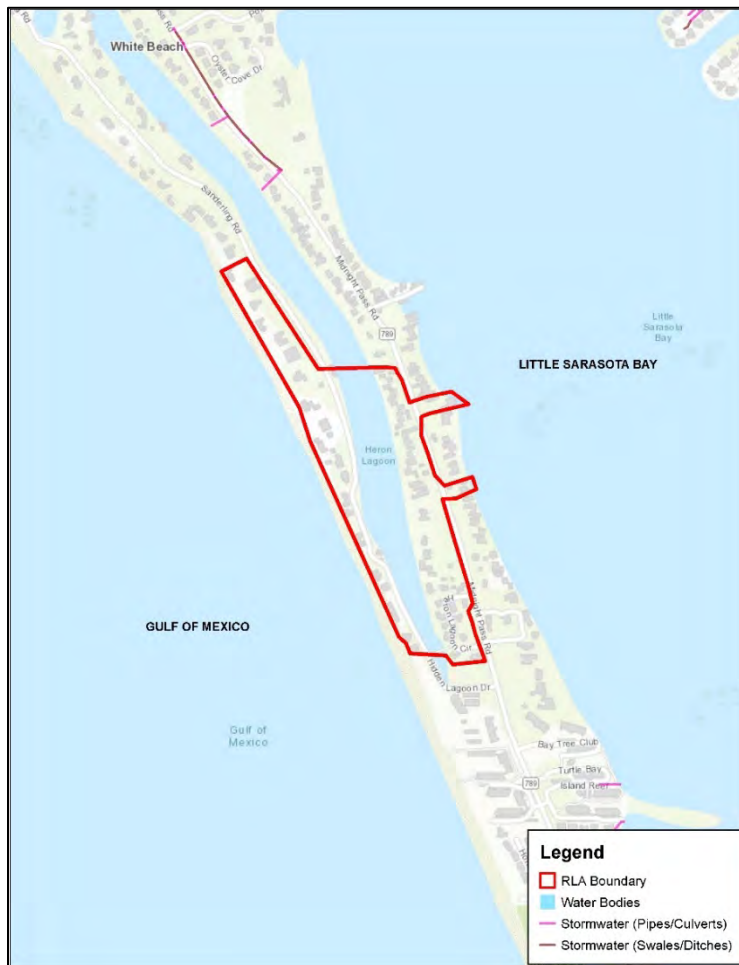
Figure 6: Distribution of Stormwater System Infrastructure

There was no stormwater utility infrastructure identified within this RLA; however due to the location in proximity to the Gulf of Mexico and risk of storm surge/high tides, it is very unlikely that construction of stormwater infrastructure would provide adequate mitigation for flooding from major storm events.

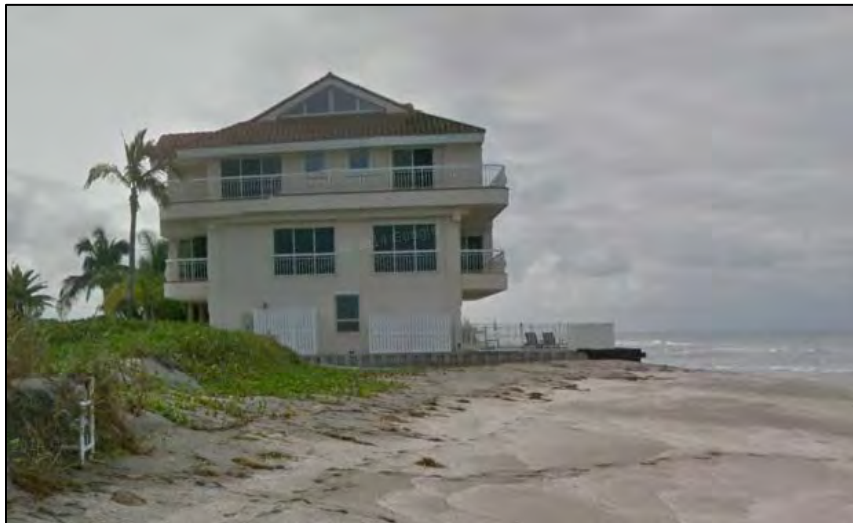
Figure 2: Elevated Coastal Structure

This Repetitive Loss Area (RLA) is located on a portion of an island between Little Sarasota Bay to the east and the Gulf of Mexico to the west. This area is subject to tidal action, waves, and surge from Little Sarasota Bay and coastal influences from the Gulf of Mexico. Most of the structures within this area were constructed on waterfront lots during various times in the past 50 years, many with concrete slab-on-grade foundations or elevated on foundation walls. All of the structures are within SFHA Zone AE or VE (see Figure 3), and these structures are at a high risk of flooding and storm surge. Tables 1 and 4 provide a summary of the structures within this RLA.

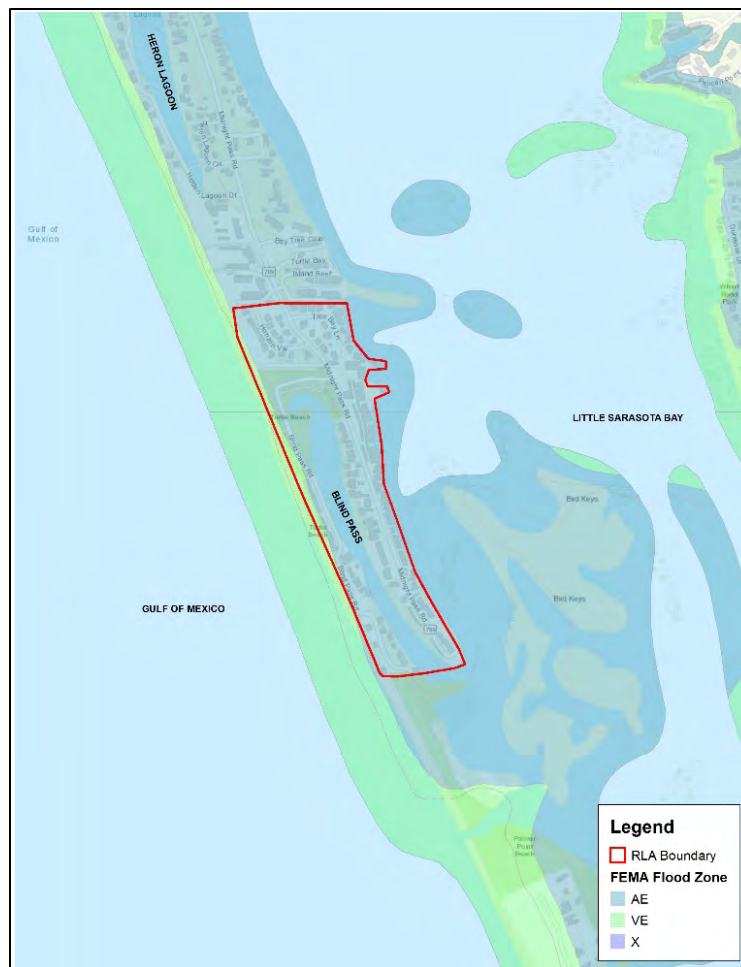
Figure 3: Spatial Distribution of Structures vs Flood Zone

Total	Repetitive Loss Data
127	Total Structures in Repetitive Loss Area
5	Total Repetitive Loss Structures in this Area
73	Properties w/Active Insurance Policies
1	Mitigated RL & SRL Properties
4	Unmitigated RL & SRL Properties
68	Insurance Claims (since 1978)
\$1,201.5	Total Insurance Claims (in thousands)
\$17.67	Average Insurance Claim (in thousands)

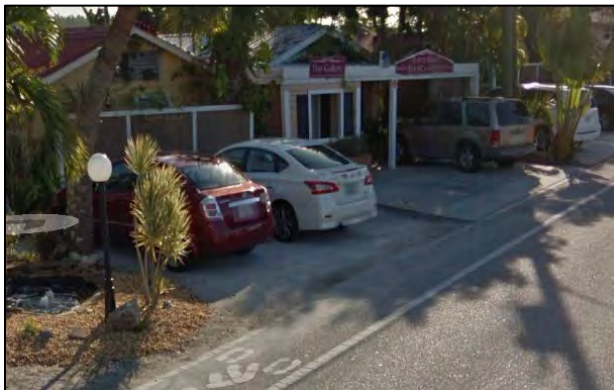
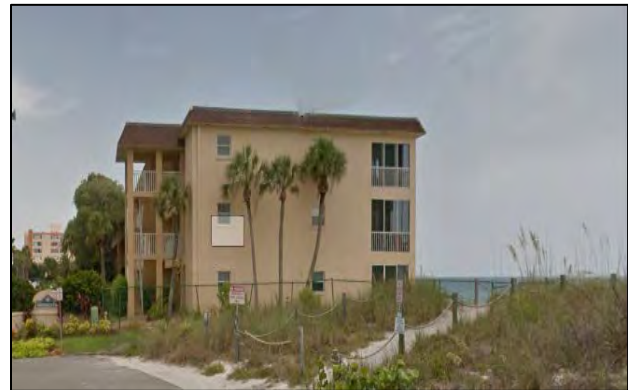
Figure 4: Average Wood Frame Slab on Grade Structure, and Coastal Beachfront Concrete Block Structure

Composition	Foundation Type
33%	Slab on grade
52%	Elevated foundation walls with enclosure
7%	Elevated on posts/piles
3%	Stem wall with slab
5%	Undetermined due to vegetation/access
Composition	Frame Type
37%	Wood frame
63%	Concrete block/masonry
Composition	Number of Stories
24%	Single story
47%	Two story
29%	Three story or greater
Composition	Flood Zones
100%	Within SFHA Zone AE
1.6%	Within SFHA Zone VE

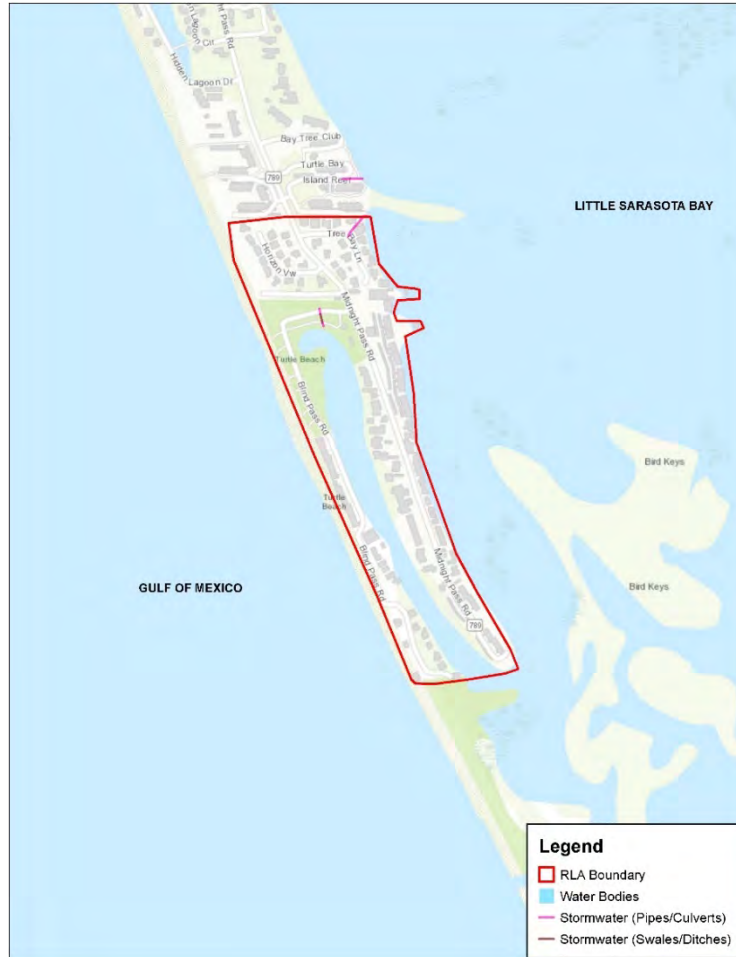
Figure 6: Distribution of Stormwater System Infrastructure

The stormwater utility infrastructure within the RLA includes two (2) outfall structures, one on Blind Pass Rd. and one on Tree Bay Ln., both discharging to Little Sarasota Bay. There were no roadside swales or pipes for conveyance of stormwater located during the field investigation. Some minor yard flooding was described in the resident survey response for regular storm events. Expansion of the stormwater infrastructure in this area may provide some mitigation for flooding from major storm events, but not full mitigation due to the proximity to the Gulf of Mexico and Little Sarasota Bay.

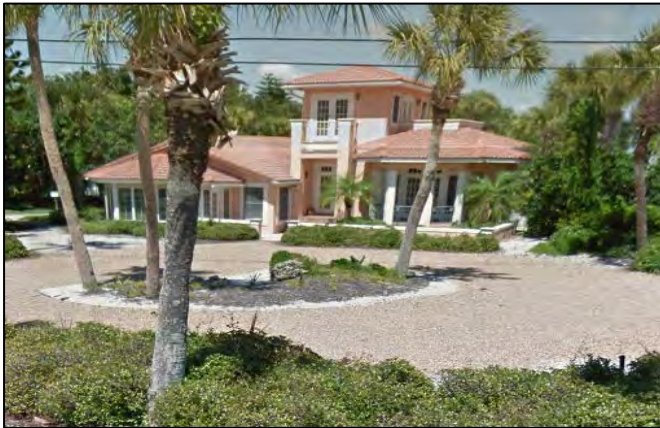
Figure 2: Slab on Grade Structure

This Repetitive Loss Area (RLA) is located on a portion of an island between Little Sarasota Bay to the east and the Gulf of Mexico to the west. This area is subject to tidal action, waves, and surge from the Little Sarasota Bay and coastal influences from the Gulf of Mexico. Most of the structures within this area were constructed on waterfront lots during various times in the past 50 years, many with concrete slab-on-grade foundations or elevated on foundation walls. All of the structures are within SFHA Zone AE-10, and are at a high risk of flooding and storm surge. Tables 1 and 4 provide a summary of the structures within this RLA.

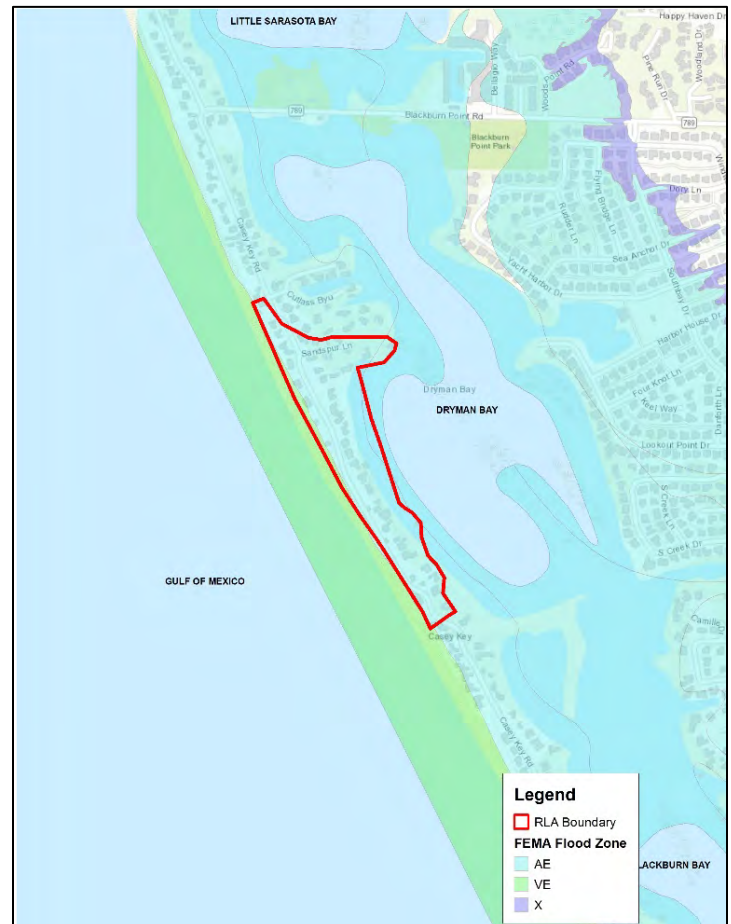
Figure 3: Spatial Distribution of Structures vs Flood Zone

Total	Repetitive Loss Data
60	Total Structures in Repetitive Loss Area
2	Total Repetitive Loss Structures in this Area
34	Properties w/Active Insurance Policies
1	Mitigated RL & SRL Properties
1	Unmitigated RL & SRL Properties
23	Insurance Claims (since 1978)
\$177.3	Total Insurance Claims (in thousands)
\$7.71	Average Insurance Claim (in thousands)

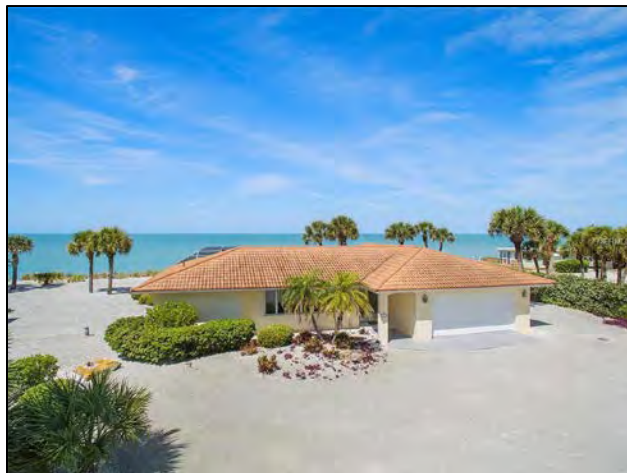
Figure 4: Average Concrete Block, Slab on Grade Structure

Composition	Foundation Type
61%	Slab on grade
11%	Elevated foundation walls with enclosure
12%	Elevated on posts/piles
12%	Stem wall with slab
4%	Undetermined due to vegetation/access
Composition	Frame Type
35%	Wood frame
65%	Concrete block/masonry
Composition	Number of Stories
42%	Single story
46%	Two story
12%	Three story or greater
Composition	Flood Zones
100%	Within SFHA Zone AE
6.7%	Within SFHA Zone VE

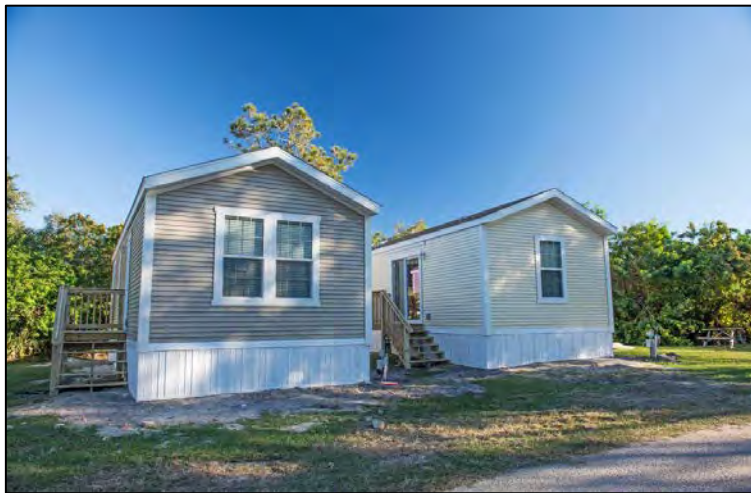
Figure 4: Slab on Grade Structures

Composition	Foundation Type
2%	Slab on grade
1%	Elevated slab on foundation walls
96%	Elevated on post/piles or walls
1%	Undetermined due to vegetation/access
Composition	Frame Type
2%	Wood frame
1%	Concrete block/masonry
97%	Manufactured/Mobile Home
Composition	Number of Stories
100%	Single story
Composition	Flood Zones
100%	Within SFHA Zone AE
85.5%	Within CFHA Zone AE

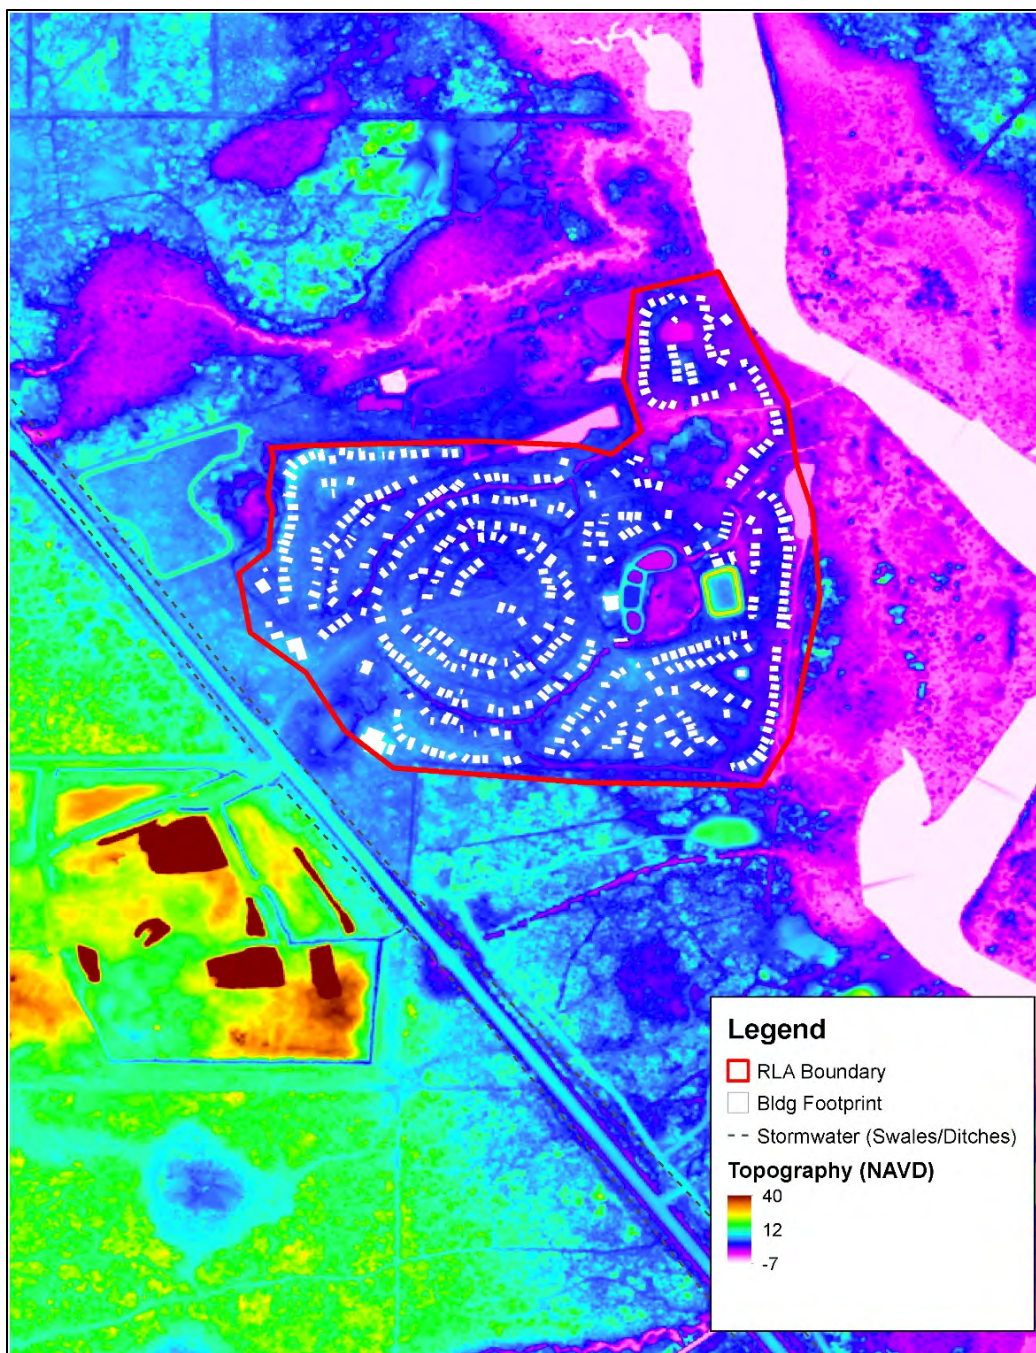
Overtopping of the Myakka River banks causes flooding during major storm events, particularly during periods of prolonged rainfall and repeated storms. The Myakka River often crests up to 72 hours after a storm. A high-water mark survey conducted June 23-26, 2003 indicated a high-water crest of 10.3 feet that resulted in flooding for all the one-story structures not well-elevated, along with well, pump and HVAC equipment. Figure 5 provides spatial context for the structures within the RLA in terms of topography, drainage infrastructure, and existing grades at the base of each structure.

Figure 5: Topography, Drainage, and Existing Grades at Base of Structures

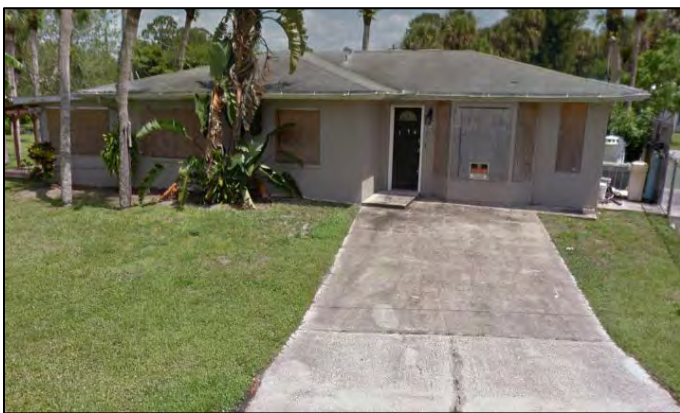
Figure 2: Slab on Grade Structure

This Repetitive Loss Area (RLA) is located west of the Myakka River, just south of US-41. It includes two peninsulas. Due to this location, the area is subject to flooding from overtopping of the banks of the river and possible stormwater system backup and capacity overflows, particularly during high rainfall events corresponding with high water levels in the Myakka River. All of the structures in this RLA are within SFHA Zone AE and some are within CFHA Zone AE. These structures were constructed in the 1950s with slab-on-grade foundations, and are below the Base Flood Elevation (BFE) of 7 feet NAVD. There are no public utilities, so each residence is required to maintain a well and pump equipment which, along with HVAC, is also susceptible to flood damage. Tables 1 and 4 provide a summary of the structures within this RLA.

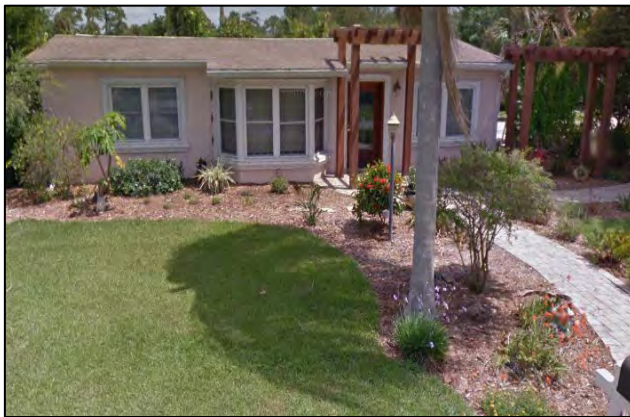
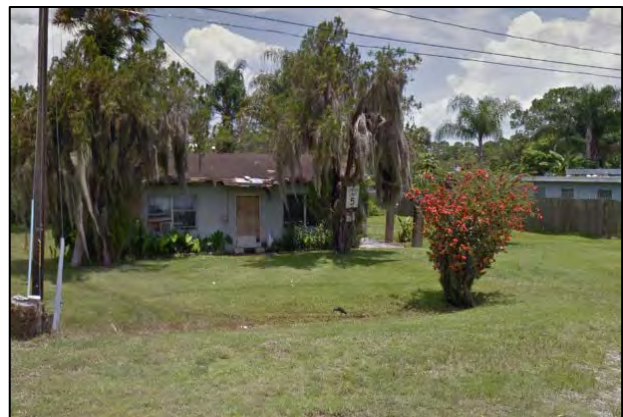
Figure 4: Wood Frame Structure & Slab on Grade Structure

Composition	Foundation Type
90%	Slab on grade
8%	Elevated foundation walls w/ enclosure
2%	Elevated on post/piles or walls
Composition	Frame Type
13%	Wood frame
87%	Concrete block/masonry
Composition	Number of Stories
82.5%	Single story
17.5%	Two story
Composition	Flood Zones
100%	Within SFHA Zone AE
9.3%	Within CFHA Zone AE

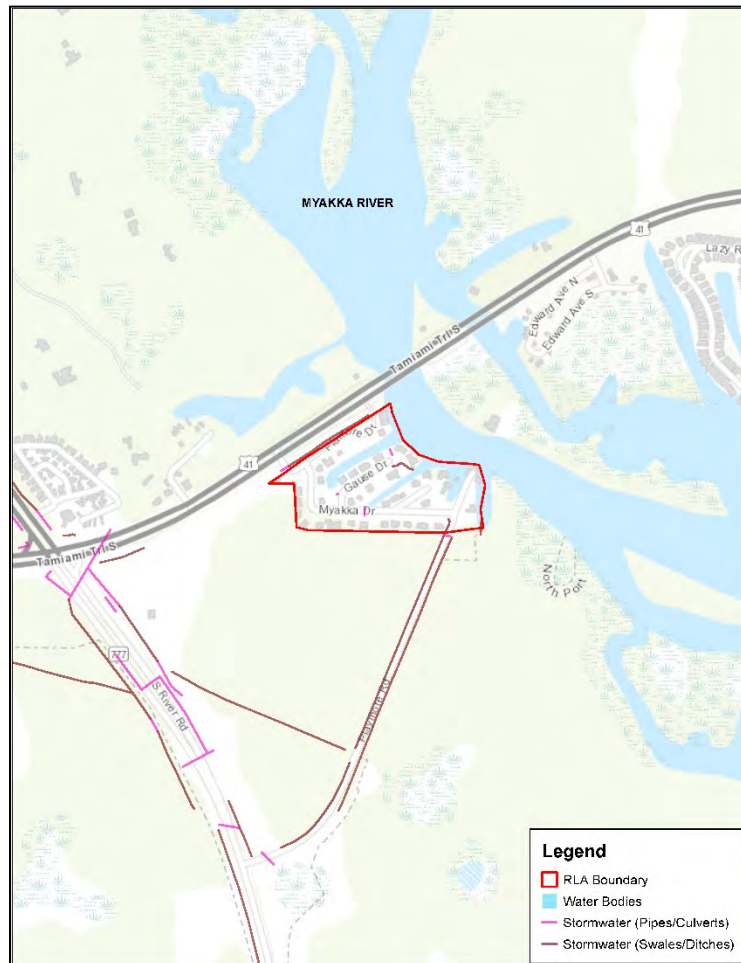
Figure 6: Distribution of Stormwater System Infrastructure

The stormwater utility infrastructure in this RLA includes five (5) outfall control structures that discharge to Myakka River with no swales and limited pipes. Based on observations from the field visits and the survey responses, water accumulates on the street and in the yards before potentially reaching the discharge points. Expansion of the stormwater infrastructure in this area would help provide mitigation to the properties that have low-level flooding.

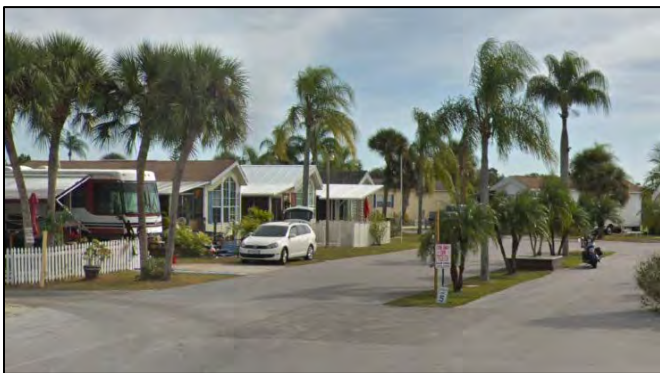
Figure 2: Manufactured/Mobile Home Structure

This Repetitive Loss Area (RLA) straddles the Myakka River and US-41. Due to this location, the area is subject to flooding from overtopping of the banks of the river, particularly during high rainfall events corresponding with high water levels in the Myakka River. All of the structures in this RLA are within SFHA Zone AE and most of the structures are manufactured/mobile homes that are susceptible to damage during flooding. These structures, constructed in 1979, are below the Base Flood Elevation (BFE) of 7 feet NAVD. There are no public utilities, so each residence is required to maintain a well and pump equipment which, along with HVAC, is also susceptible to flood damage. Tables 1 and 4 provide a summary of the structures within this RLA.

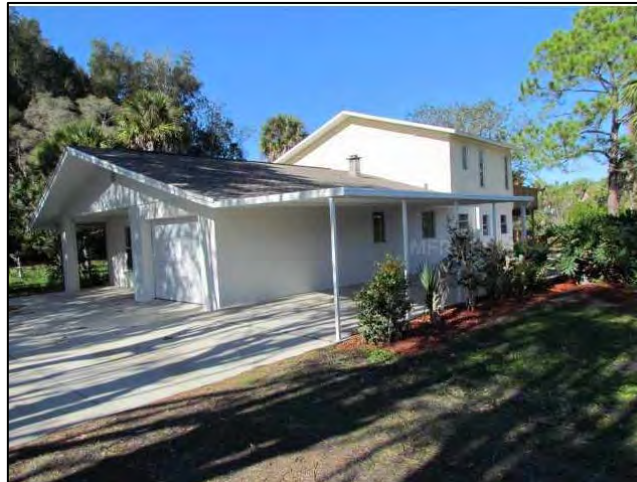
Figure 4: Elevated on Post/Piles or Walls Structures

Composition	Foundation Type
12%	Slab on grade
4%	Elevated foundation walls w/ enclosure
80%	Elevated on post/piles or walls
4%	Undetermined due to vegetation/access
Composition	Frame Type
12%	Wood frame
8%	Concrete block/masonry
80%	Manufactured/Mobile Home
Composition	Number of Stories
92%	Single story
8%	Two story
Composition	Flood Zones
100%	Within SFHA Zone AE
11.5%	Within CFHA Zone AE

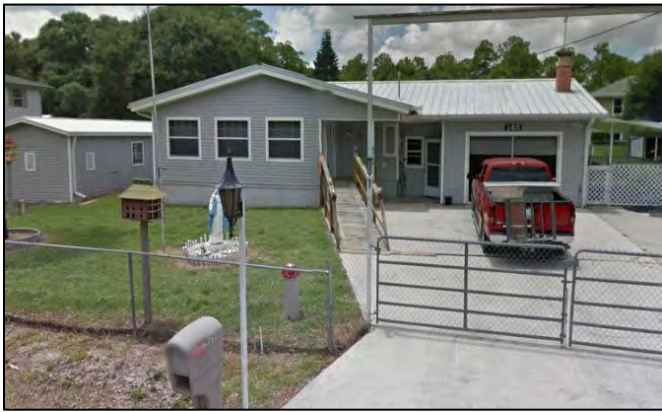
Figure 2: Elevated on Stem Wall Structure

This Repetitive Loss Area (RLA) is located west of the Myakka River, north of the I-75 river crossing. Due to this location, the area is subject to flooding from overtopping of the banks of the river during high rainfall events corresponding with high water levels in the Myakka River. Most of the structures in the RLA were constructed between 1970 and 1990, and are located within SFHA Zone A and CFHA Zone AE. More recent structures are elevated on fill, stem walls, or posts to meet or exceed the regulatory requirements of having their lowest floor 2 feet above the highest adjacent natural grade. The RLA also includes 62% wood frame structures, which are particularly susceptible to damage during flooding. There are no public utilities, so each residence is required to maintain a well and pump equipment which, along with HVAC, is also susceptible to flood damage. Tables 1 and 4 provide a summary of the structures within this RLA.

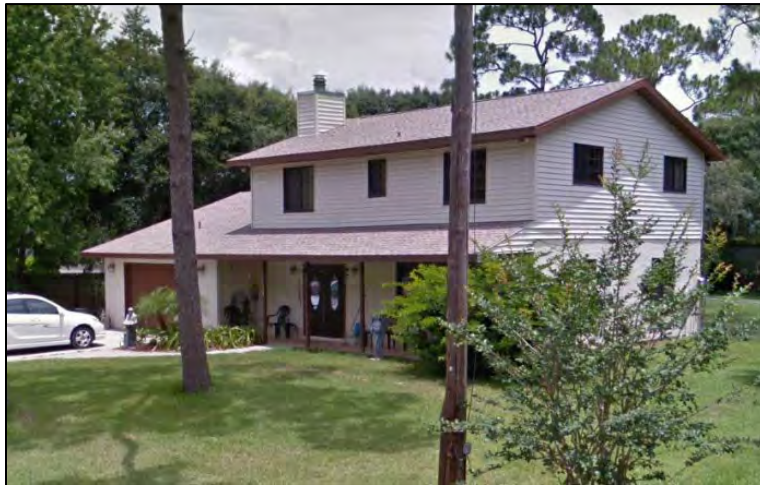
Figure 4: Slab on Grade Structure

Composition	Foundation Type
63%	Slab on grade
4%	Elevated slab on stem wall with fill
13%	Elevated on post/piles or walls
16%	Elevated on foundation walls w/ enclosure
4%	Undetermined due to vegetation/access
Composition	Frame Type
63%	Wood frame
37%	Concrete block/masonry
Composition	Number of Stories
50%	Single story
50%	Two story
Composition	Flood Zones
100%	Within SFHA Zone A
100%	Within CFHA Zone AE
