**SARASOTA COUNTY
FLOODPLAIN MANAGEMENT PLAN UPDATE**

Sarasota County | June 2021

Sarasota County Floodplain Management Plan Committee
1001 Sarasota Center Blvd.
Sarasota, Florida 34240
June 2021

Jones Edmunds & Associates, Inc.
730 NE Waldo Road
Gainesville, Florida 32641
Certificate of Engineering Authorization #1841

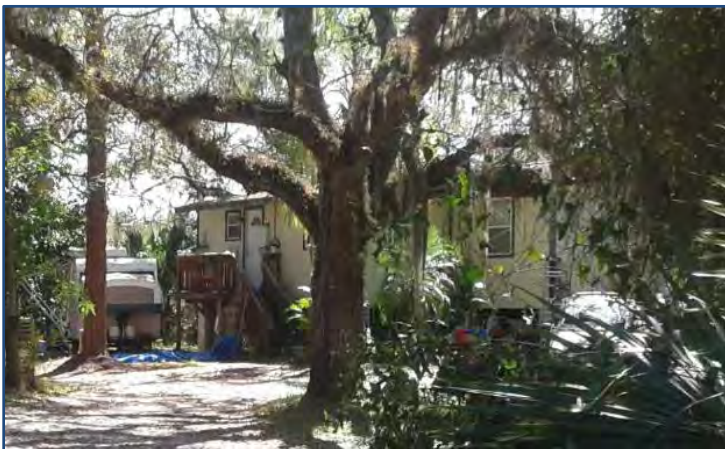
Figure 2: Wood Frame Structure

This Repetitive Loss Area (RLA) straddles the Myakka River just north of the I-75 river crossing. It includes an island, and the east and west banks of the river oxbow, and is at the confluence of the Blackburn Canal, a major tributary to the Myakka River. Due to this location, the area is subject to flooding from overtopping of the banks of the river and possible stormwater system backup and capacity overflows, particularly during high rainfall events corresponding with high water levels in the Myakka River. The median year built for the structures in the RLA is 1980, so while typically post-FIRM, there are several dating between 1930 and 1970. More recent structures are elevated on fill, stem walls, or posts to meet or exceed the Base Flood Elevation (BFE) of 7 feet NAVD. The RLA also includes 84% wood frame structures, which are particularly susceptible to damage during flooding. There are no public utilities, so each residence is required to maintain a well and pump equipment which, along with HVAC, is also susceptible to flood damage. This RLA includes a high number of Repetitive Loss Properties (RLPs). This is due to extremely low-elevation terrain (average 3.3 feet NAVD), combined with the river overtopping its banks during periods of extreme rainfall. Tables 1 and 4 provide a summary of the structures within this RLA.

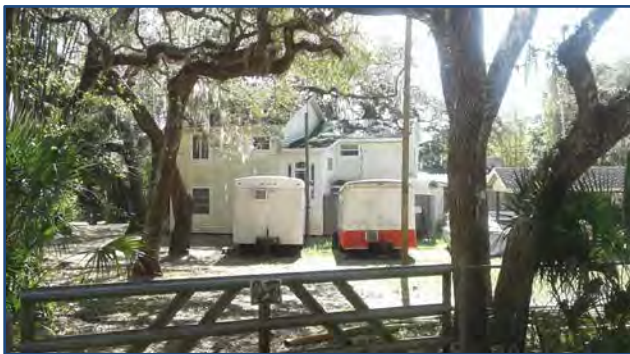
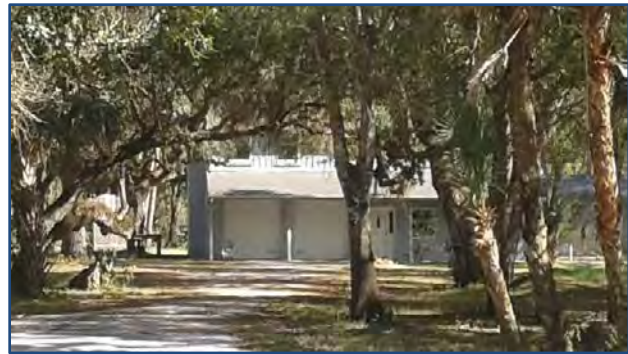
Figure 4: Wood Frame Structure and Slab on Grade Structure

Composition	Foundation Type
30%	Slab on grade
12%	Elevated slab on stem wall with fill
56%	Elevated on post/piles or walls
2%	Unable to determine
Composition	Frame Type
84%	Wood frame
16%	Concrete block/masonry
Composition	Number of Stories
54%	Single story
40%	Two story
6%	Three story or greater
Composition	Flood Zones
82%	Within SFHA Zone AE
18%	Within SFHA Zone A
100%	Within CFHA Zone AE

Overtopping of the Myakka River banks causes flooding during major storm events, particularly during periods of prolonged rainfall and repeated storms. The Myakka River often crests up to 72 hours after a storm. The lots in this area are relatively low in elevation, and the structures are not significantly elevated above existing lot grade. While there were some normal system maintenance issues observed during the field work, these areas appear to be routinely maintained by County staff based on review of the maintenance callouts. Most of the structures are estimated to be elevated at or above the BFE (7 feet NAVD). A high-water mark survey conducted June 23-26, 2003 indicated a high-water crest of 10.3 feet that resulted in flooding for all the one-story structures not well-elevated, along with well, pump and HVAC equipment.

A number of the elevated two-story structures were observed during the site visits to include some form of enclosure. These lower levels are prone to flooding such as was experienced in 2003. Figure 5 provides spatial context for the structures within the RLA in terms of topography, drainage infrastructure, and existing grades at the base of each structure.

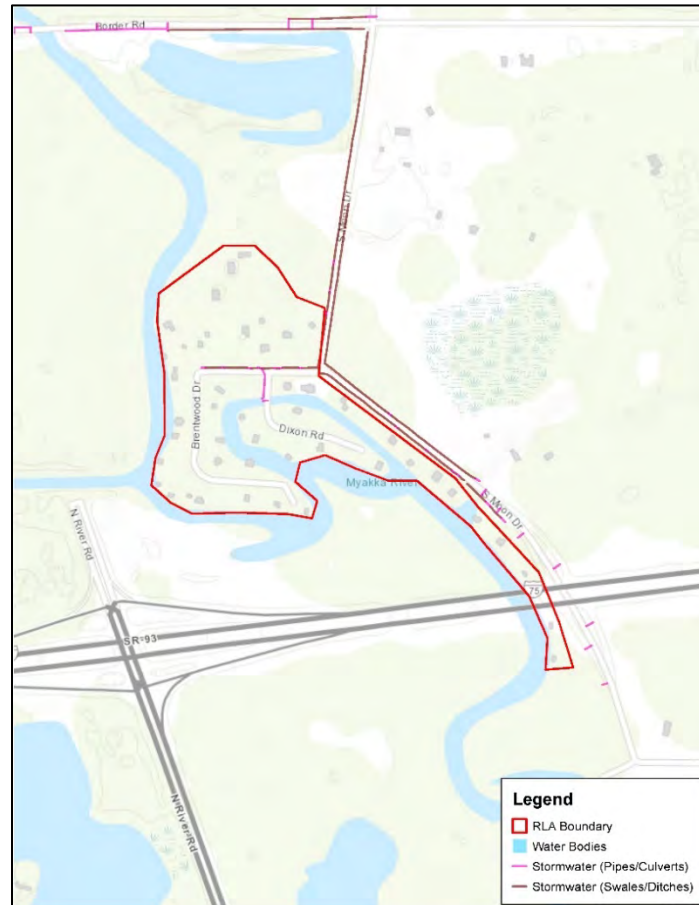
Figure 6: Distribution of Stormwater System Infrastructure

The stormwater utility infrastructure is limited to S. Moon Dr. running north/south, with one (1) outfall to the river side. There is one (1) outfall off Dixon Rd. near the large box culvert under the entrance to the island, and one (1) outfall from the stormwater system on S. Moon Dr. to the ditch running east-west which connects to the river. Based on observations from the field visits, the waterfront lots typically have positive drainage toward the river. However, there is extensive back up of the stormwater system when the river overtops its banks, which in this area is approximately 3 feet. Records indicate the County does maintain the right of way swales, but the main east-west ditch and island portion of Dixon Rd. is private property.

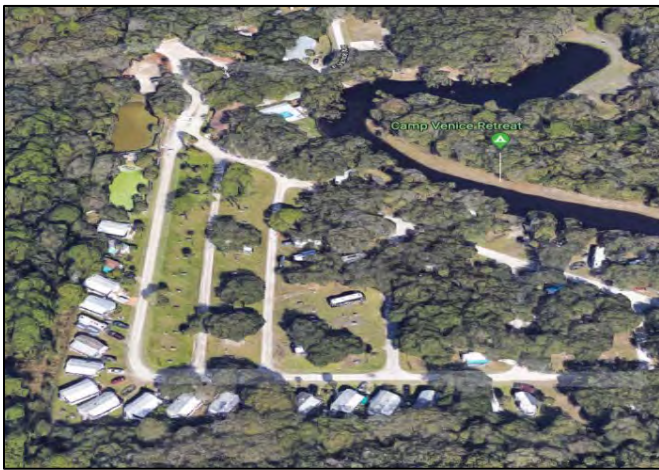
Figure 2: Overhead View of Structures (Google)

This Repetitive Loss Area (RLA) is located west of the Myakka River with meandering confluences to the north and east of the RLA. All the structures in this RLA are located within SFHA Zone AE and CFHA Zone AE. Due to this location, the area is subject to flooding from overtopping of the banks of the river, particularly during high rainfall events corresponding with high water levels in the Myakka River. Most of the structures in this RLA are manufactured/mobile homes constructed in 1972 that are susceptible to damage during flooding. Tables 1 and 4 provide a summary of the structures within this RLA.

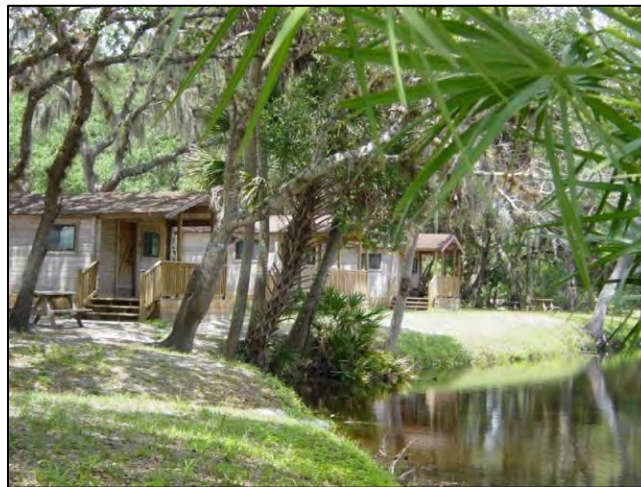
Figure 4: Average Elevated on post/piles Structures

Composition	Foundation Type
21%	Slab on grade
79%	Elevated on post/piles
Composition	Frame Type
17%	Wood frame
13%	Concrete block/masonry
70%	Manufactured/mobile home
Composition	Number of Stories
92%	Single story
8%	Two story
Composition	Flood Zones
100%	Within SFHA Zone AE
100%	Within CFHA Zone AE

Overtopping of the Myakka River banks causes flooding during major storm events, particularly during periods of prolonged rainfall and repeated storms. The Myakka River often crests up to 72 hours after a storm. The lots in this area are relatively low in elevation, and the structures are not significantly elevated above existing lot grade. Figure 5 provides spatial context for the structures within the RLA in terms of topography, drainage infrastructure, and existing grades at the base of each structure.

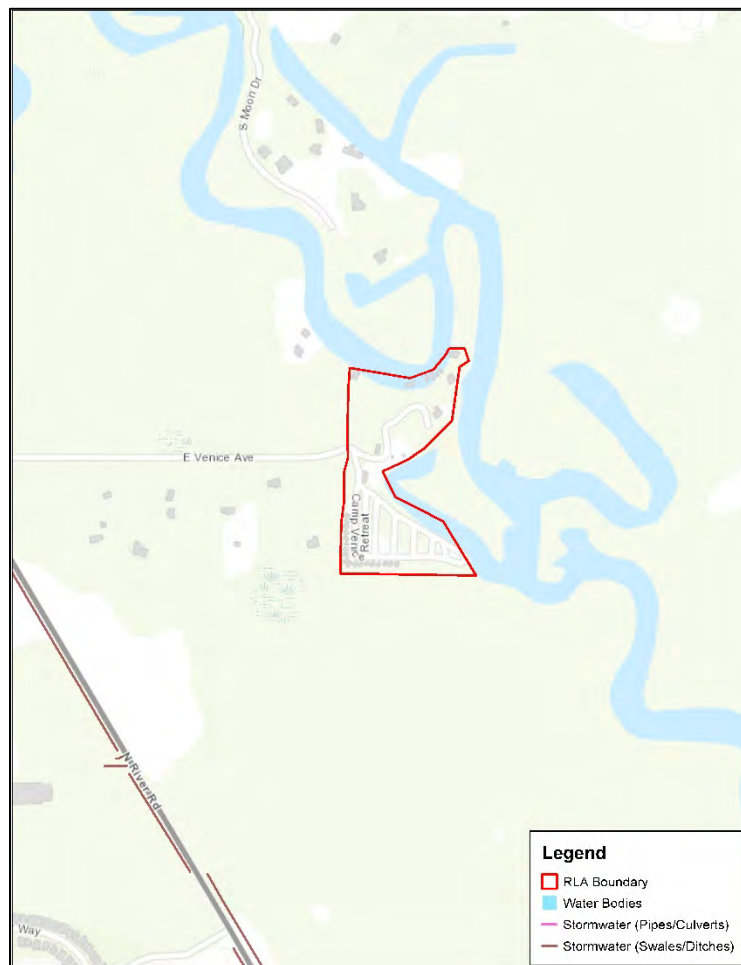
Figure 6: Distribution of Stormwater System Infrastructure

There was no stormwater utility infrastructure identified within this RLA; however due to the close proximity to the Myakka River and risk of flooding due to extreme rain events and high tides, it is unlikely that construction of stormwater infrastructure would provide adequate mitigation for flooding from major storm events.

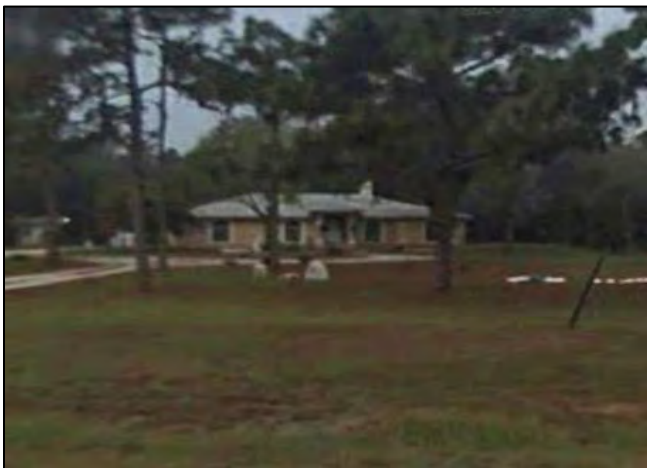
Figure 2: Slab on Grade, Concrete Block Structure

This Repetitive Loss Area (RLA) straddles Howard Creek. Due to this location, the area is subject to flooding from overtopping of the banks of the creek and the high tides of the Myakka River, particularly during high rainfall events corresponding with high water levels in the Myakka River. The RLA is located within SFHA Zone A and CFHA Zone D (undetermined). The median construction year for the structures is 1980, and most structures are elevated 2 feet above the highest adjacent grade. There are no public utilities, so each residence is required to maintain a well and pump equipment which, along with HVAC, is also susceptible to flood damage. Tables 1 and 4 provide a summary of the structures within this RLA.

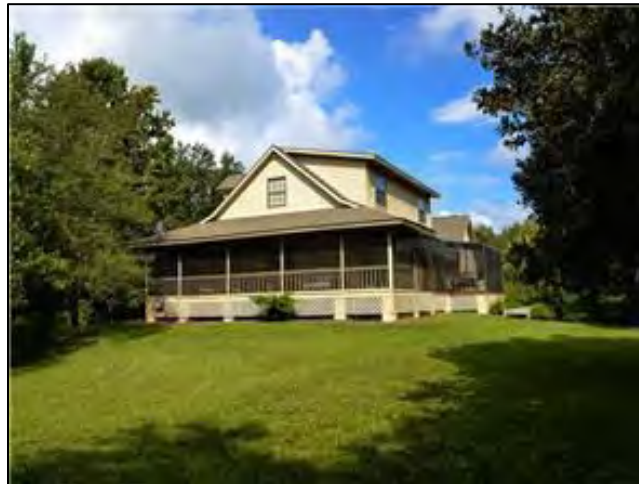
Figure 4: Average Wood Frame Structure

Composition	Foundation Type
50%	Slab on grade
50%	Undetermined due to vegetation/access
Composition	Frame Type
56%	Wood frame
38%	Concrete block/masonry
6%	Steel
Composition	Number of Stories
62%	Single story
38%	Two story
Composition	Flood Zones
100%	Within SFHA Zone A
100%	Within CFHA Zone D (undetermined)

Overtopping of the Howard Creek and Myakka River banks causes flooding during major storm events, particularly during periods of prolonged rainfall and repeated storms. The Myakka River often crests up to 72 hours after a storm. All structures within this area are estimated to be elevated at or above 2 feet above the highest adjacent grade. Figure 5 provides spatial context for the structures within the RLA in terms of topography, drainage infrastructure, and existing grades at the base of each structure.

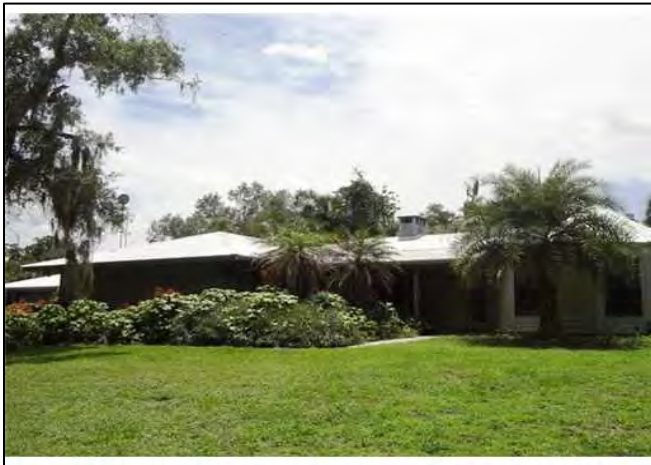
Figure 2: Slab on Grade, Concrete Block Structure

This Repetitive Loss Area (RLA) is located east of the Myakka River. Due to this location, the area is subject to flooding from overtopping of the banks of the river, particularly during heavy rainfall events corresponding with high water levels in the Myakka River. The structures in this RLA are located within SFHA Zone A, and were constructed in the 1970s, with most assumed to be elevated at least 2 feet above the highest adjacent grade. Only 9% of the structures were confirmed to be elevated on stemwall foundations. Of the remaining structures, half were confirmed to be slab-on-grade, while heavy vegetation prevented an assessment of the foundation conditions for the others. However, it is reasonable to assume that most obscured by vegetation are not elevated on stemwall foundations, as typical landscaping would not block visibility for this type of construction. Therefore, these can be assumed to be slab-on-grade. There are no public utilities, so each residence is required to maintain a well and pump equipment which, along with HVAC, is also susceptible to flood damage. Tables 1 and 4 provide a summary of the structures within this RLA.

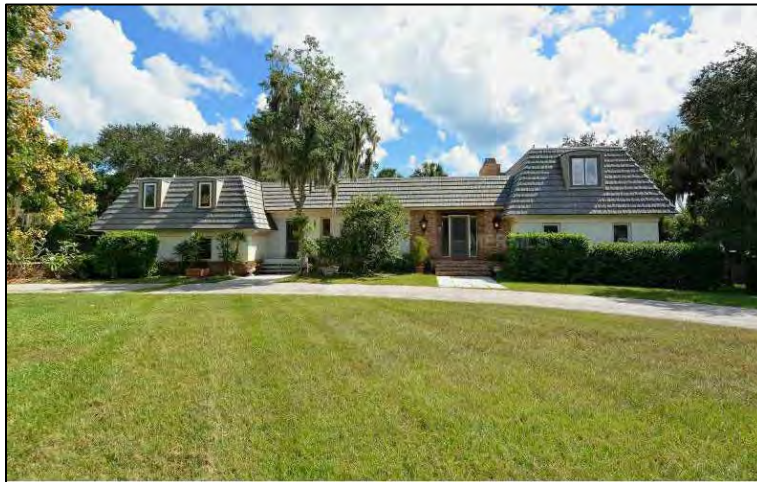
Figure 4: Average Masonry Structure

Composition	Foundation Type
45.5%	Slab on grade
9.1%	Elevated on stemwall
45.4%	Undetermined due to heavy vegetation
Composition	Frame Type
17%	Wood frame
83%	Concrete block/masonry
Composition	Number of Stories
67%	Single story
33%	Two story
Composition	Flood Zones
90%	Within SFHA Zone A
36.4%	Within Zone X

Overtopping of the Myakka River banks causes flooding during major storm events, particularly during periods of prolonged rainfall and repeated storms. The Myakka River often crests up to 72 hours after a storm. All structures within this area are estimated to be elevated at least 2 feet above the highest adjacent grade. Figure 5 provides spatial context for the structures within the RLA in terms of topography, drainage infrastructure, and existing grades at the base of each structure.

Appropriate mitigation alternatives for the structures within the area were evaluated. The exposure to flooding from overtopping of the banks of the Myakka River, indicates the most appropriate mitigation alternatives include repairing stormwater structures or increasing conveyance capacity of hydraulic structures on the river, rebuilding or elevating buildings and/or flood prone components, or acquisition.

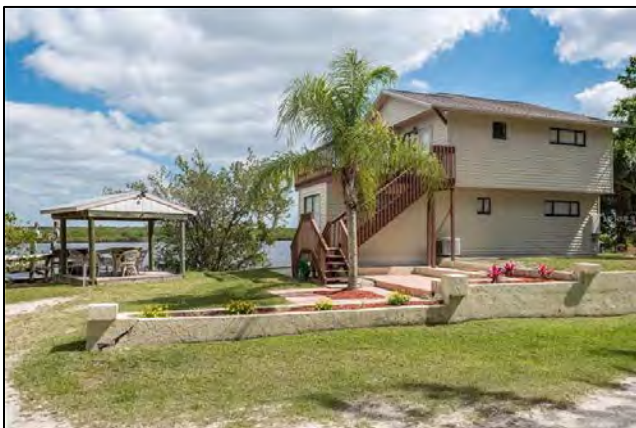
Figure 2: Average Wood Frame Structure

This Repetitive Loss Area (RLA) is located west of the Myakka River. Due to this location, the area is subject to flooding from overtopping of the banks of the river and possible stormwater system backup and capacity overflows, particularly during high rainfall events corresponding with high water levels in the Myakka River, or high tides combined with strong westerly winds. Construction dates for the structures located within SFHA Zone AE range from 1920 to 1985 with Finished Floor Elevations (FFE) less than the Base Flood Elevation (BFE) of 7 feet NAVD. The RLA also includes 73% wood frame structures which are particularly susceptible to damage during flooding. There are no public utilities, so each residence is required to maintain a well and pump equipment which, along with HVAC, is also susceptible to flood damage. Tables 1 and 4 provide a summary of the structures within this RLA.

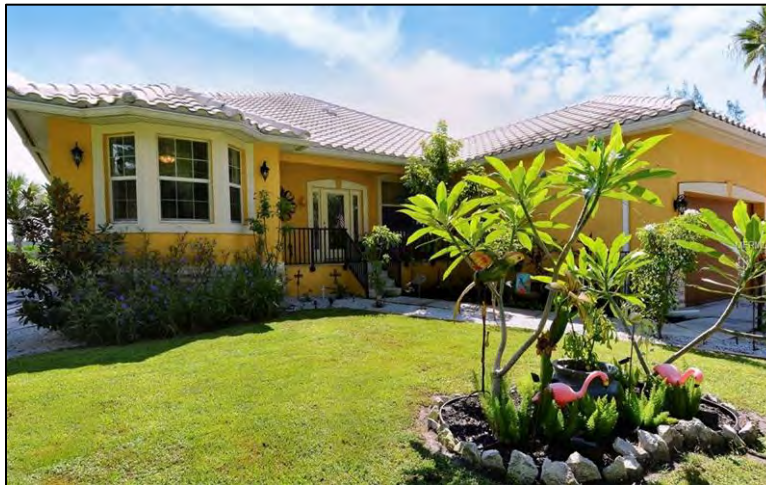
Figure 4: Average Elevated on Post/Piles or Walls

Composition	Foundation Type
45%	Slab on grade
9%	Elevated slab on stem wall with fill
9%	Elevated on post/piles or walls
37%	Unable to determine
Composition	Frame Type
73%	Wood frame
27%	Concrete block/masonry
Composition	Number of Stories
64%	Single story
27%	Two story
9%	Three story or greater
Composition	Flood Zones
100%	Within SFHA Zone AE

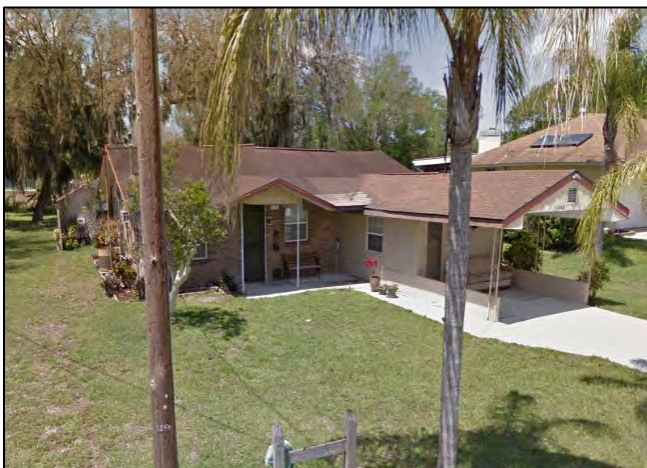
Figure 2: Concrete Block Structure

This Repetitive Loss Area (RLA) is located along the eastern shoreline of Phillippi Creek in a residential neighborhood. Due to the area's low elevation, structures are subject to flooding from overtopping of the banks of the creek, as well as possible stormwater system backup, particularly during high rainfall events corresponding with high water levels in Phillippi Creek. This location on the creek is north of Roberts Bay and has tidal, backwater, and storm surge contributing to flooding conditions. The structures in this RLA are within SFHA Zone AE and CFHA Zone AE and median year built for the structures is 1952, with several dating back to the 1920s. These are primarily slab-on-grade foundations. More recently constructed structures have been elevated on fill, stem walls, or posts to meet the Base Flood Elevation (BFE) of 11 feet NAVD. Tables 1 and 4 provide a summary of the structures within this RLA.

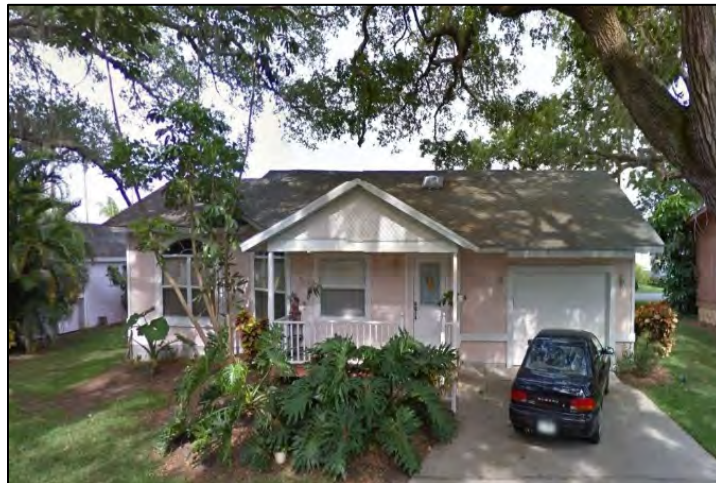
Figure 4: Elevated slab on Post/Piles or Walls

Composition	Foundation Type
19%	Slab on grade
38%	Elevated foundation walls w/ enclosure
13%	Elevated slab on stem wall with fill
13%	Elevated on post/piles or walls
17%	Undetermined due to vegetation/access
Composition	Frame Type
38%	Wood frame
50%	Concrete block/masonry
6%	Steel
6%	Mobile Home
Composition	Number of Stories
81%	Single story
19%	Two story
Composition	Flood Zones
100%	Within SFHA Zone AE
100%	Within CFHA Zone AE

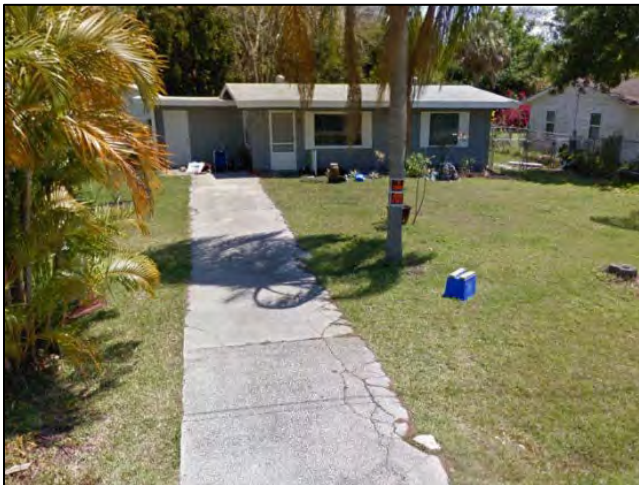
Figure 2: Slab on Grade Structures

This Repetitive Loss Area (RLA) is located along the western shoreline of Phillippi Creek north of Bahia Vista. Due to the area's low elevation, structures are subject to flooding from overtopping of the banks of the river, as well as possible stormwater system backup, particularly during high rainfall events corresponding with high water levels in Phillippi Creek. This location on the creek is north of Roberts Bay and has tidal, backwater, and storm surge contributing to flooding conditions. The structures in this RLA are located within SFHA Zone AE and CFHA Zone AE. Most of the structures were constructed during the 1950s as slab-on-grade foundations, with an average of 2.6 feet NAVD, which is below the Base Flood Elevation (BFE) of 11 feet NAVD. Tables 1 and 4 provide a summary of the structures within this RLA.

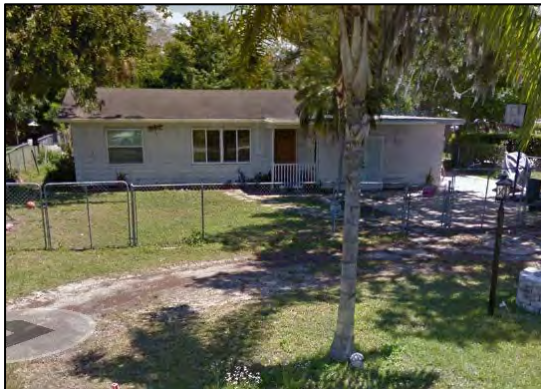
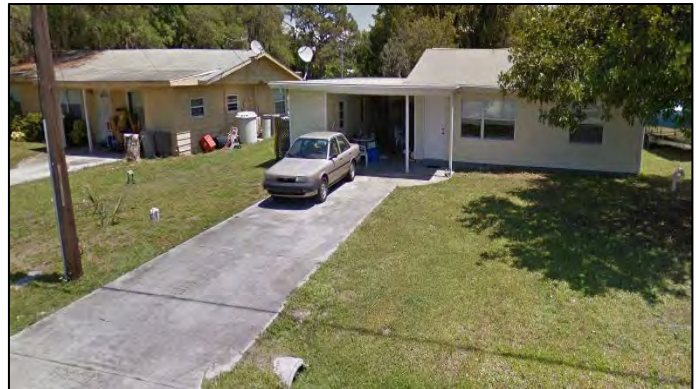
Figure 4: Slab on Grade Structures

Composition	Foundation Type
100%	Slab on grade
Composition	Frame Type
69%	Wood frame
31%	Concrete block/masonry
Composition	Number of Stories
92%	Single story
8%	Two story
Composition	Flood Zones
98%	Within SFHA Zone AE
4.1%	Within SFHA Zone X
12.5%	Within CFHA Zone AE

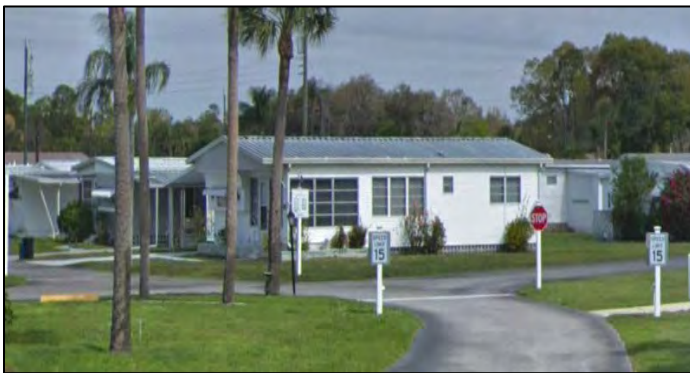
Figure 2: Mobile Home Structures

This Repetitive Loss Area (RLA) straddles Phillippi Creek in a residential neighborhood. The structures are subject to flooding from overtopping of the banks of the river, particularly during high rainfall events corresponding with high water levels in Phillippi Creek. This location on the creek is north of Roberts Bay and has tidal, backwater, and storm surge contributing to flooding conditions. The structures in this area are within Zone Shaded X, SFHA Zone AE and CFHA Zone AE. Most of the structures were constructed in 1959 and are mobile homes, which are more prone to flood damage. Tables 1 and 4 provide a summary of the structures within this RLA.

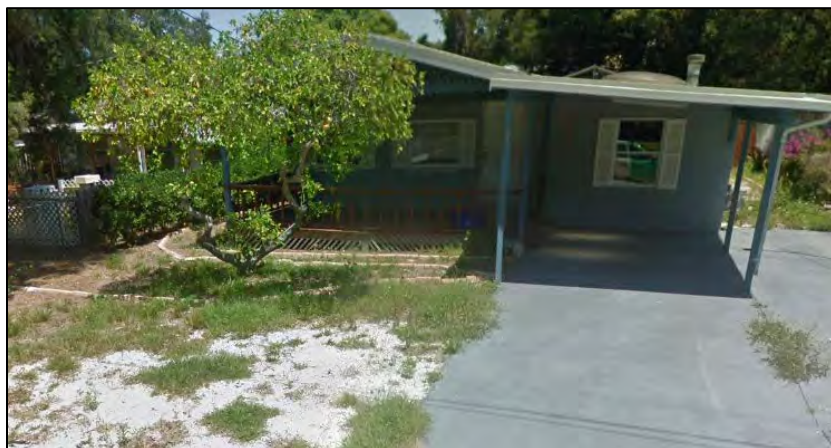
Figure 4: Slab on Grade Structure

Composition	Foundation Type
3%	Slab on grade
2%	Elevated slab on stem wall with fill
82%	Elevated on post/piles or walls
2%	Elevated on foundation walls
11%	Undetermined due to vegetation/access
Composition	Frame Type
18%	Wood frame
4%	Concrete block/masonry
78%	Manufactured/Mobile Home
Composition	Number of Stories
98%	Single story
2%	Two story
Composition	Flood Zones
88.88%	Within SFHA Zone AE
39.7%	Within Zone Shaded X
14.3%	Within Zone X
100%	Within CFHA Zone AE

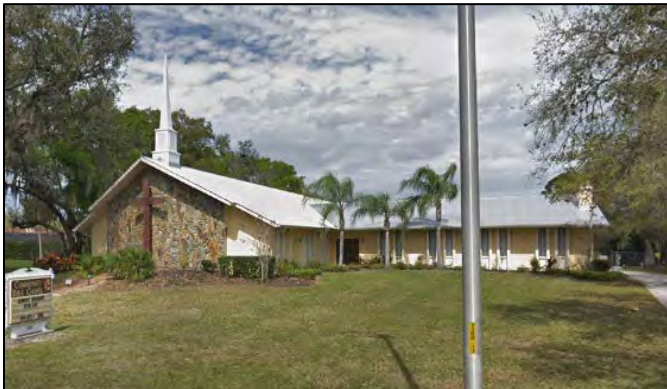
Figure 2: Slab on Grade Structure

This Repetitive Loss Area (RLA) is located along the southern shoreline of Phillippi Creek in a residential neighborhood. Due to the area's low elevation, structures are subject to flooding from overtopping of the banks of the river, particularly during high rainfall events corresponding with high water levels in Phillippi Creek. This area of Phillippi Creek is not tidally influenced by Roberts Bay but will still experience flood conditions under high rainfall events. The structures in this RLA are located within Floodway, Zone Shaded X, SFHA Zone AE and CFHA Zone AE. The median year built for the structures is 1989 with the structures primarily being slab-on-grade. More recently constructed structures have been elevated on fill to meet the Base Flood Elevation (BFE) of 15 feet NAVD. Tables 1 and 4 provide a summary of the structures within this RLA.

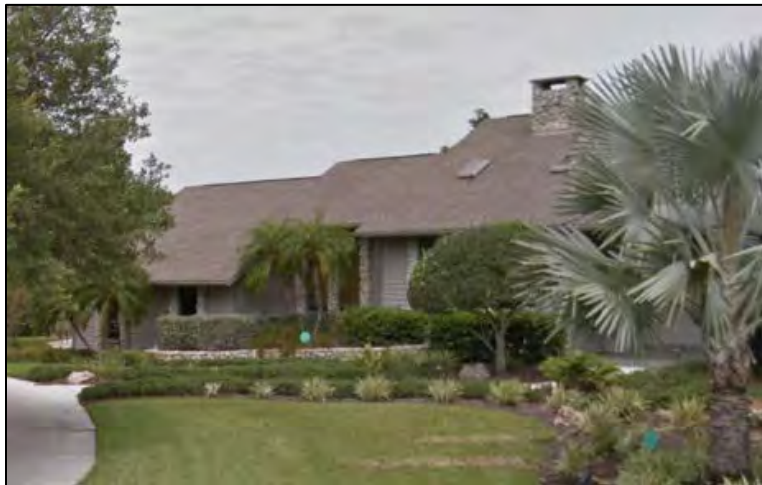
Figure 4: Slab on Grade Structure

Composition	Foundation Type
86%	Slab on grade
14%	Undetermined due to vegetation/access
Composition	Frame Type
14%	Wood frame
86%	Concrete block/masonry
Composition	Number of Stories
57%	Single story
29%	Two story
14%	Three story or greater
Composition	Flood Zones
100%	Within SFHA Zone AE
62.5%	Within Zone X
100%	Within CFHA Zone AE

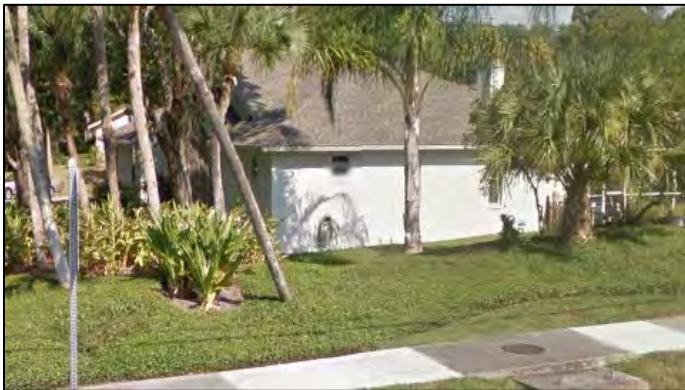
Figure 2: Slab on Grade Structure

This Repetitive Loss Area (RLA) is located along the north-eastern shoreline of Phillippi Creek at the McIntosh Rd. bridge crossing with two residential subdivisions. This area has relatively higher elevations with a flood zone combination of SFHA Zone AE, X and CFHA Zone AE. The waterfront properties located on the creek are subject to flooding from overtopping of the banks of the creek, particularly during high rainfall events corresponding with high water levels in Phillippi Creek. This area of Phillippi Creek is not tidally influenced by Roberts Bay but will still experience flood conditions under high rainfall events. The median year built for the structures is 1986, with primarily elevated structures. Tables 1 and 4 provide a summary of the structures within this RLA.

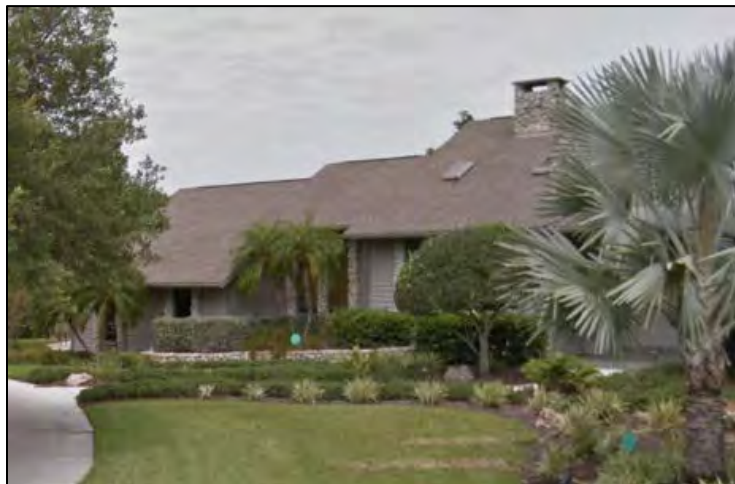
Figure 4: Raised Slab on Grade Structure

Composition	Foundation Type
10%	Slab on grade
87%	Elevated slab on stem wall with fill
3%	Undetermined due to vegetation/access
Composition	Frame Type
97%	Wood frame
3%	Concrete block/masonry
Composition	Number of Stories
67%	Single story
30%	Two story
3%	Three story or greater
Composition	Flood Zones
100%	Within SFHA Zone AE
32.3%	Within Zone Shaded X
38.7%	Within Zone X
100%	Within CFHA Zone AE

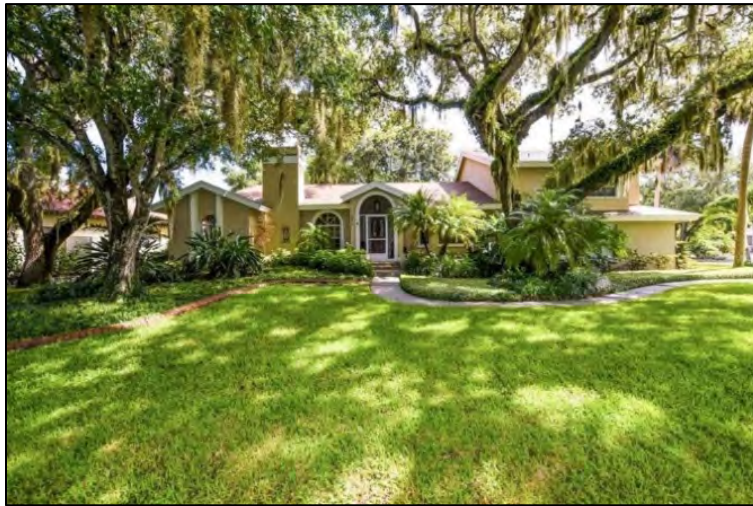
Figure 2: Concrete Block Masonry Structure

This Repetitive Loss Area (RLA) is located along the south western shoreline of Phillippi Creek south of the McIntosh St bridge crossing and primarily consists of both single and multi-family residential subdivisions. The structures are subject to flooding from overtopping of the banks of the river, as well as possible stormwater system backup, particularly during high rainfall events. This area has relatively higher elevations with a flood zone combination of Floodway, SFHA Zone AE, X and CFHA Zone AE. The waterfront properties located on the creek are subject to flooding from overtopping of the banks of the creek, particularly during high rainfall events corresponding with high water levels in Phillippi Creek. This area of Phillippi Creek is not tidally influenced by Roberts Bay but will still experience flood conditions under high rainfall events. Most of the structures in this RLA were constructed in the 1980s, with primarily elevated structures. Tables 1 and 4 provide a summary of the structures within this RLA.

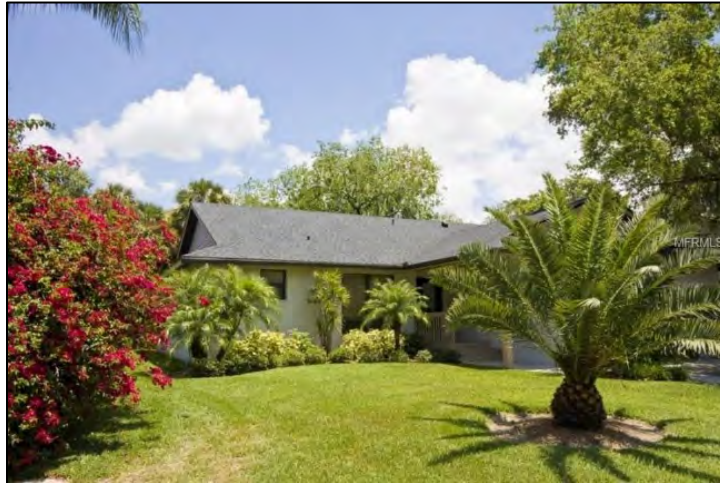
Figure 4: Slab on Grade Structure

Composition	Foundation Type
16%	Slab on grade
83%	Elevated slab on stem wall with fill
1%	Elevated on post/piles or walls
Composition	Frame Type
65%	Wood frame
32%	Concrete block/masonry
3%	Manufactured/Mobile home
Composition	Number of Stories
71%	Single story
29%	Two story
Composition	Flood Zones
100%	Within SFHA Zone AE
12.8%	Within Zone Shaded X
2.6%	Within Zone X
100%	Within CFHA Zone AE

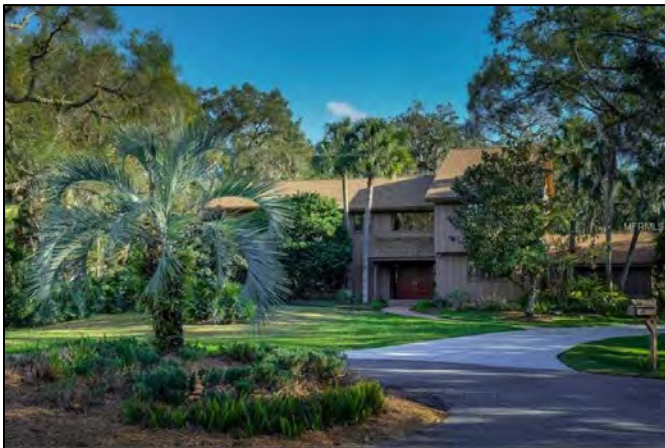
Figure 2: Wood Frame Structure

This Repetitive Loss Area (RLA) is located along the northern shoreline of Phillippi Creek south of Bahia Vista St. This area has relatively higher elevations with a combination of SFHA Zone AE, X and CFHA Zone AE. The waterfront properties located on the creek are subject to flooding from overtopping of the banks of the creek, particularly during high rainfall events corresponding with high water levels in Phillippi Creek. This area of Phillippi Creek is not tidally influenced by Roberts Bay but will still experience flood conditions under high rainfall events. Most of the structures in this RLA were constructed during the 1980s, with primarily elevated structures. Tables 1 and 4 provide a summary of the structures within this RLA.

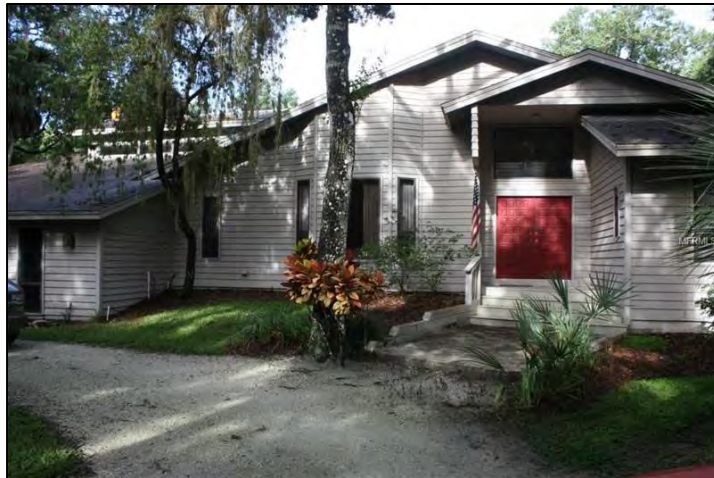
Figure 4: Elevated slab on stem wall with fill Raised Slab on Grade Structure

Composition	Foundation Type
0%	Slab on grade
100%	Elevated slab on stem wall with fill
Composition	Frame Type
100%	Wood frame
Composition	Number of Stories
0%	Single story
75%	Two story
25%	Three story or greater
Composition	Flood Zones
100%	Within SFHA Zone AE
25%	Within SFHA Zone X
100%	Within CFHA Zone AE

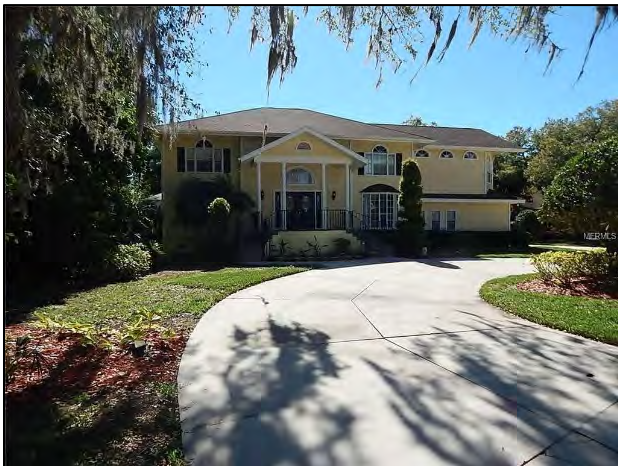
Figure 2: Wood Frame Structure

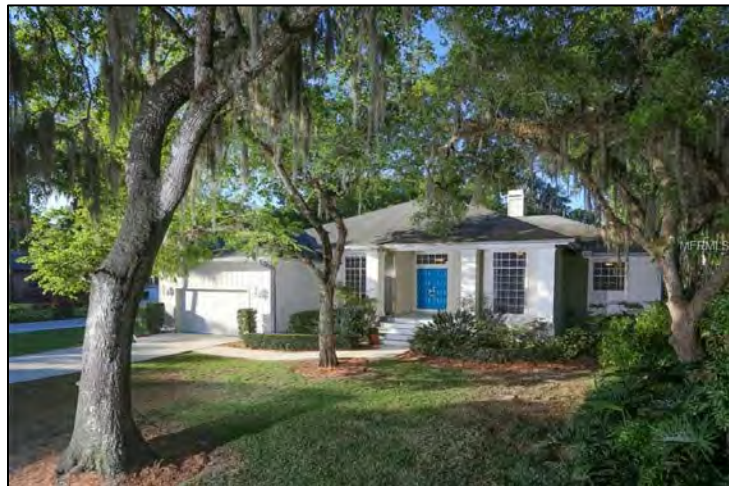
Figure 4: Slab on Grade Structure

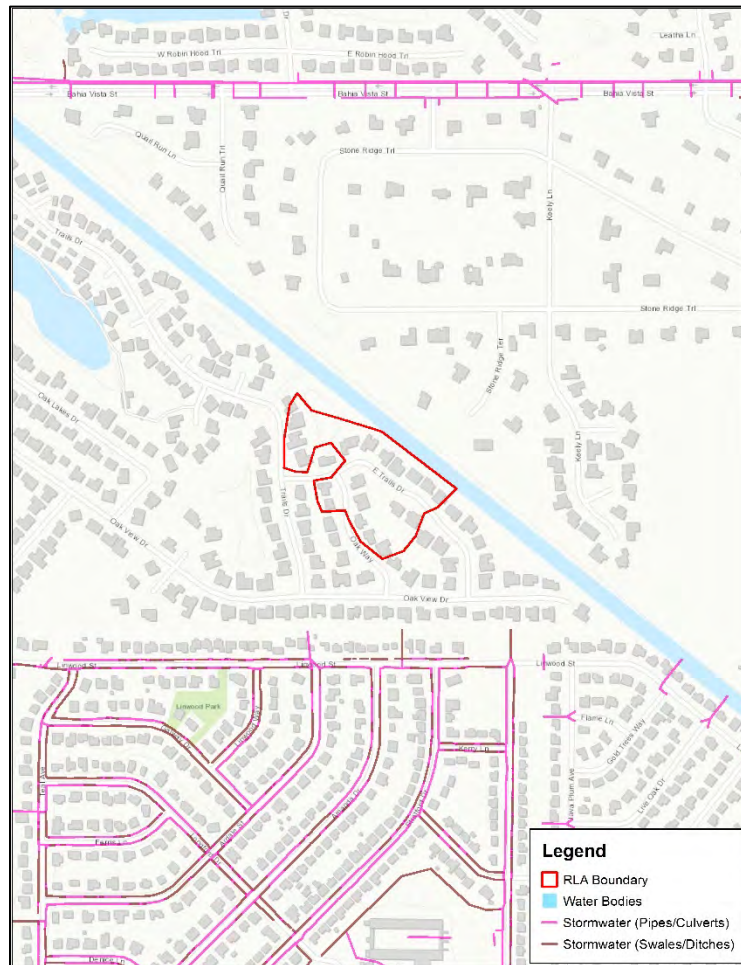
There was no County maintained stormwater utility infrastructure identified within this RLA. However, during the field visit it was noted that “The Lakes” private subdivision does have a collection of retention ponds to contain the stormwater system within the subdivision. It is unlikely that expansion of the stormwater system in this area will mitigate the flooding concerns for this RLA.

Figure 6: Distribution of Stormwater System Infrastructure

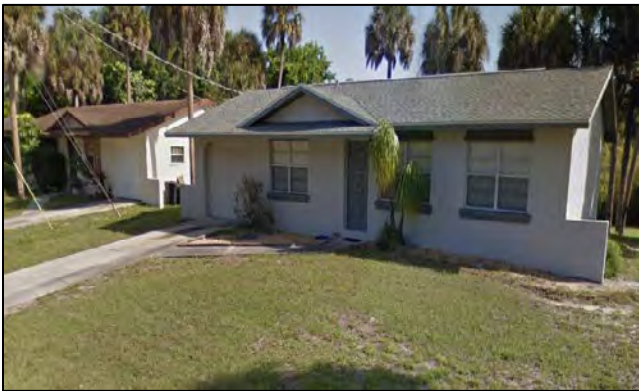
Figure 2: Concrete Masonry Structure

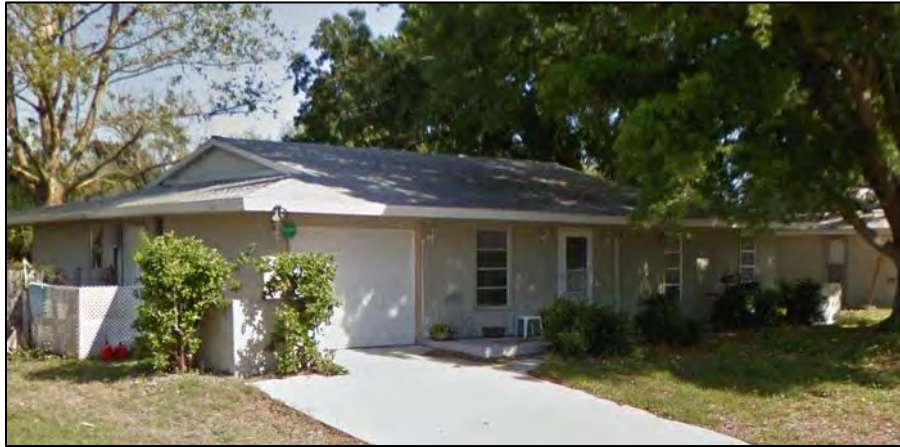
Figure 4: Slab on Grade Structure

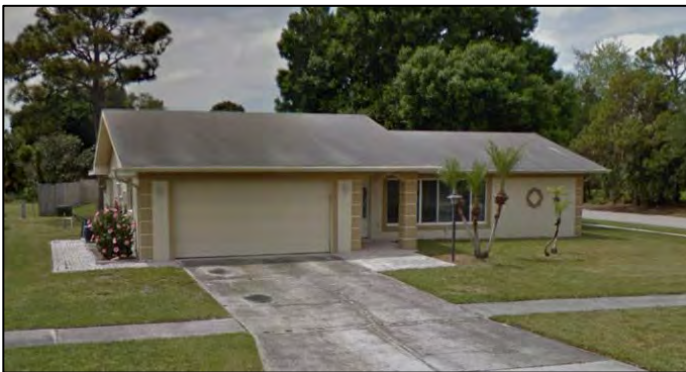
Figure 2: Slab on Grade Structure

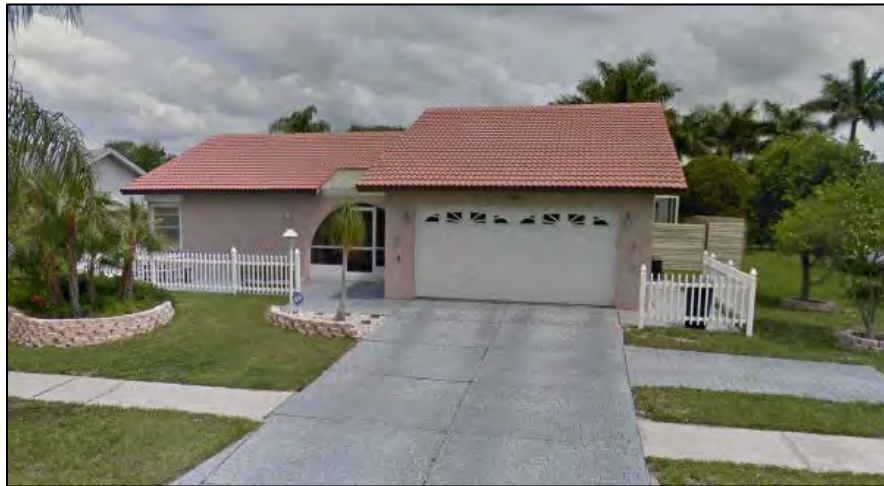
Figure 4: Slab on Grade Structure

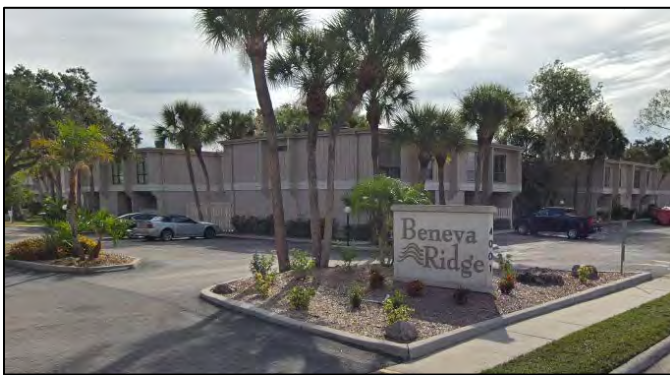
Figure 2: Slab on Grade Condominium Structures

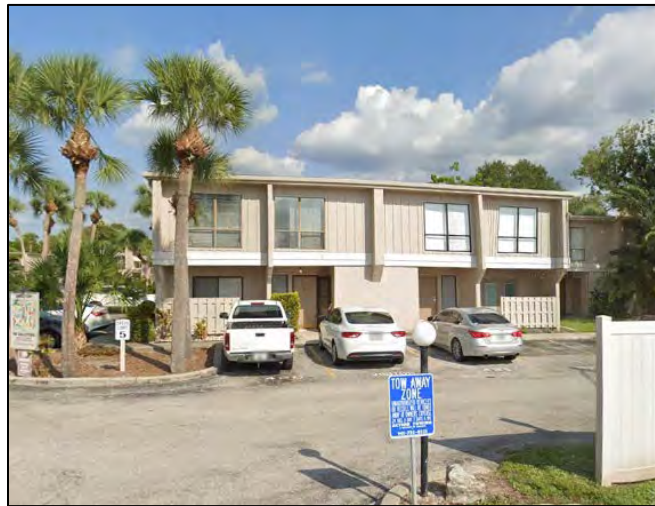
Figure 4: Slab on Grade Condominium Structures (from Google maps)

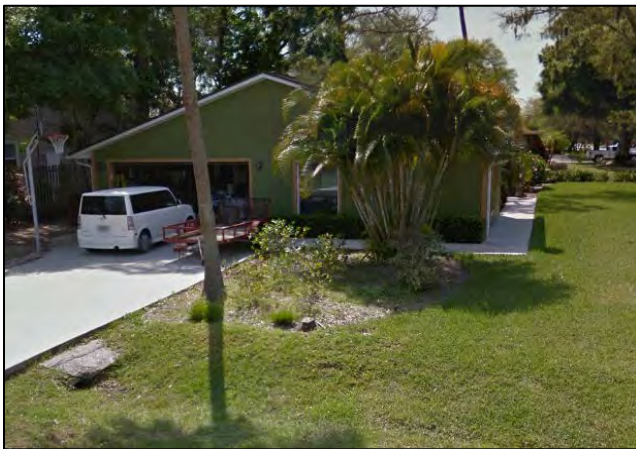
Figure 2: Wood Frame-Slab on Grade Structure

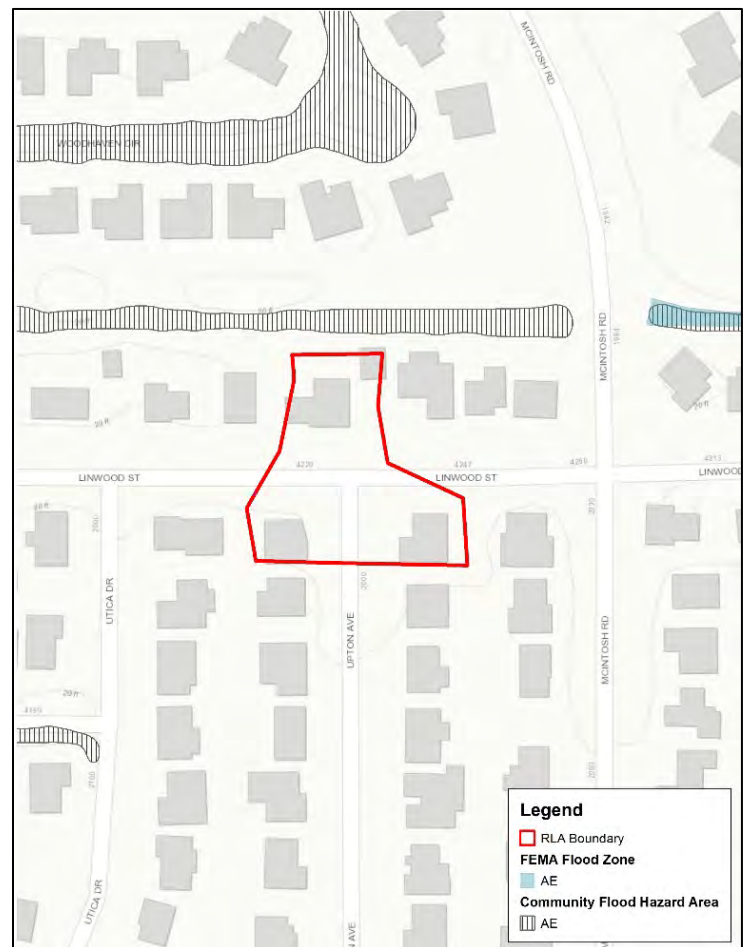
Figure 3: Spatial Distribution of Structures vs Flood Zone

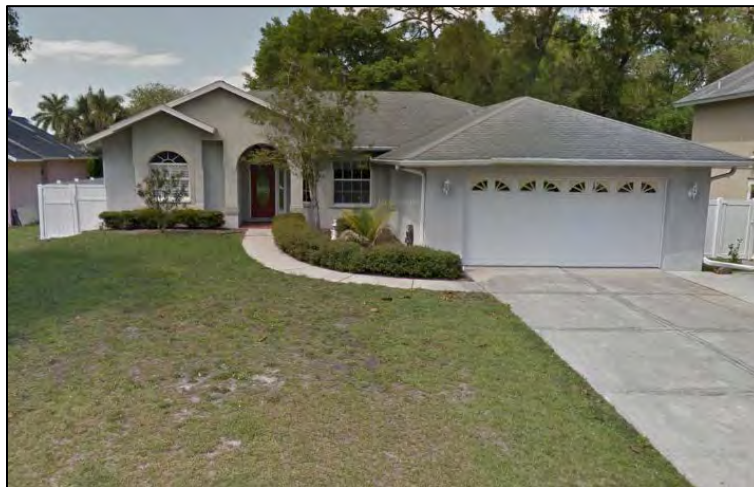
Figure 4: Slab on Grade Structure

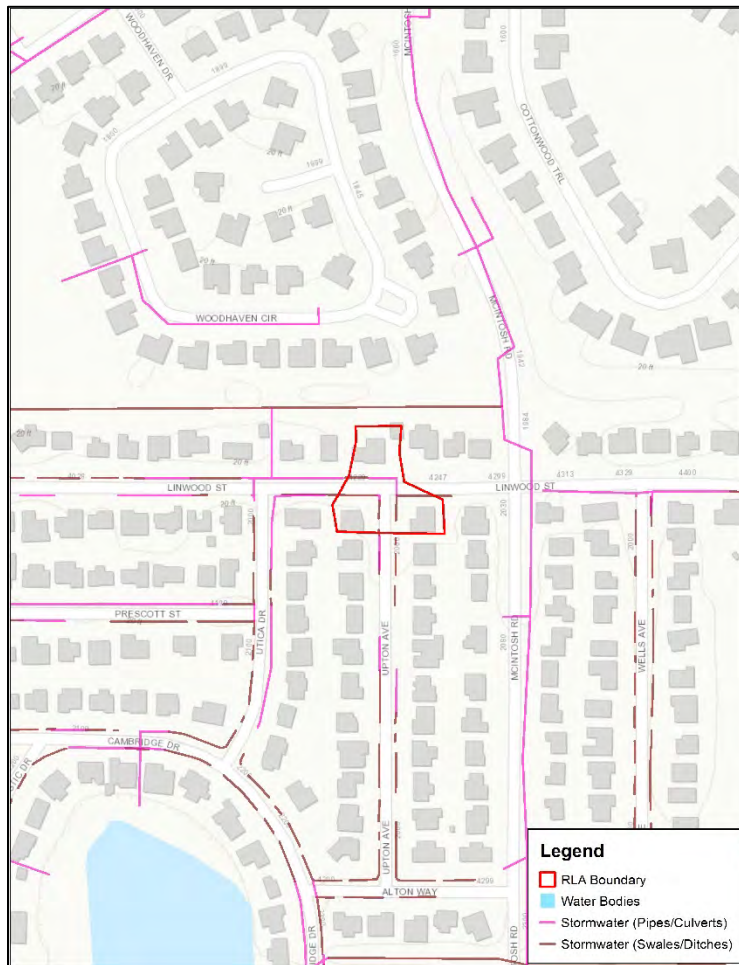
The stormwater system in this RLA includes a combination of swales and pipes collecting on both sides of Linwood St and Upton Ave that discharge into a drainage canal as part of the County's maintained stormwater infrastructure. It is unlikely that expansion of the stormwater infrastructure in this area will provide mitigation from stormwater backup and flooding.

Figure 6: Distribution of Stormwater System Infrastructure

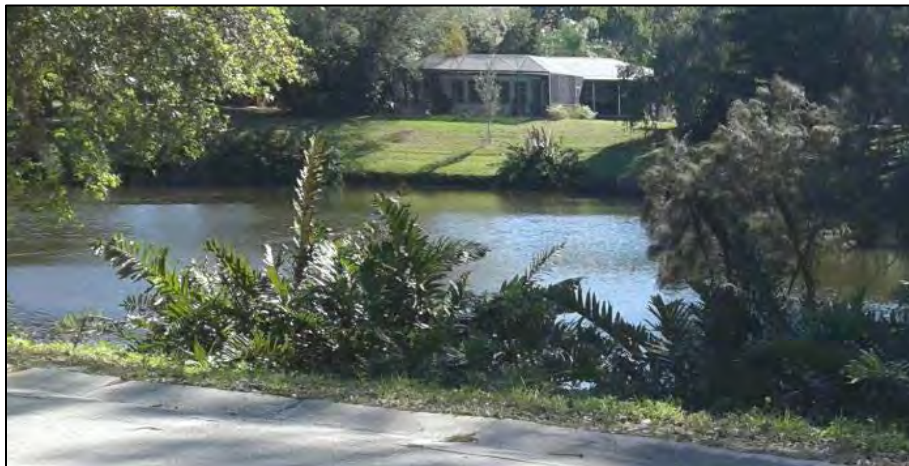
Figure 2: Example of Location of Phillippi Creek to Structures

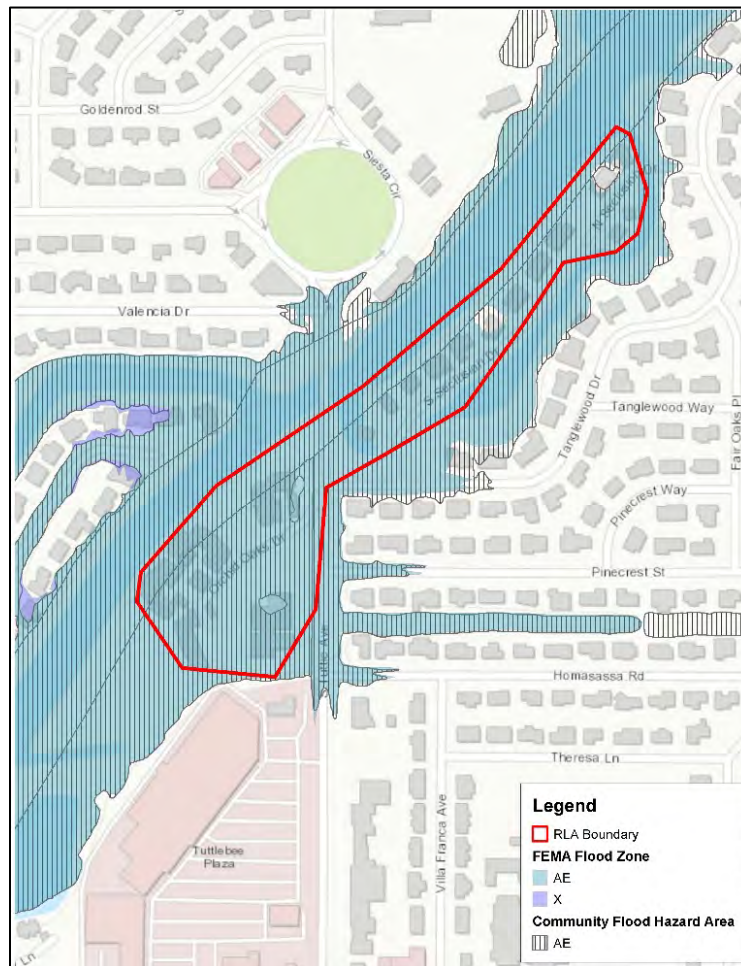
Figure 3: Spatial Distribution of Structures vs Flood Zone

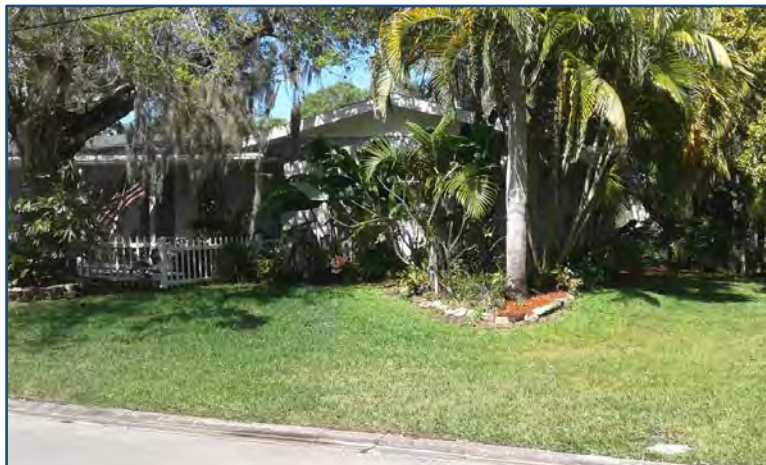
Figure 4: Slab on Grade Structure
