**SARASOTA COUNTY
FLOODPLAIN MANAGEMENT PLAN UPDATE**

Sarasota County | June 2021

Sarasota County Floodplain Management Plan Committee
1001 Sarasota Center Blvd.
Sarasota, Florida 34240
June 2021

Jones Edmunds & Associates, Inc.
730 NE Waldo Road
Gainesville, Florida 32641
Certificate of Engineering Authorization #1841

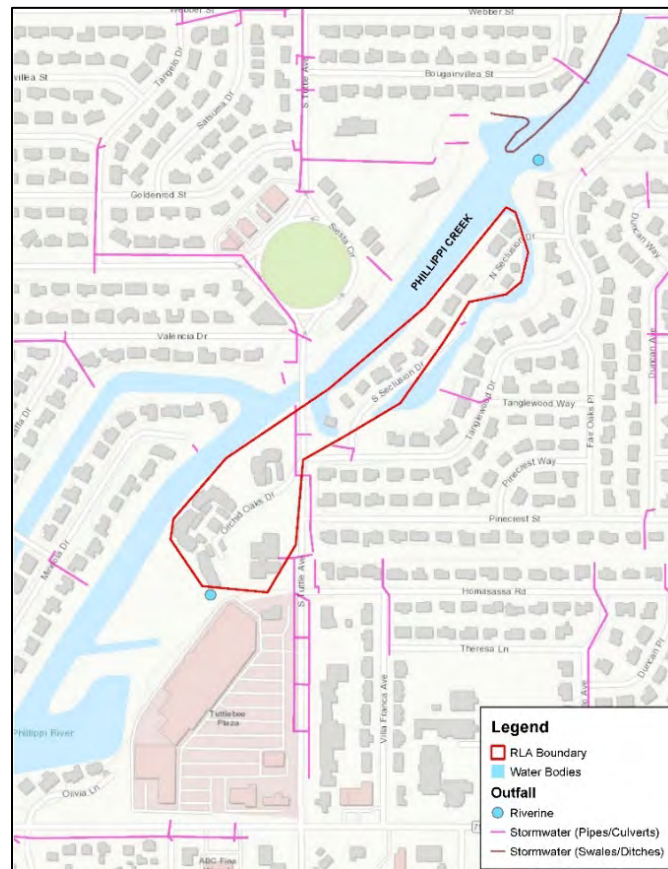
The stormwater system serving the area is limited to one (1) outfall to Lake Seclusion from S. Seclusion Dr. Stormwater runoff sheet flows along streets and low-lying parcels into Phillippi Creek or Lake Seclusion. There are two (2) major outfalls to Phillippi Creek in the immediate vicinity that contribute to flooding conditions (east-west running Bermuda Brook and Bermuda Brook North Canal). Based on site visits and resident surveys, the lots that do not have positive drainage away from the building should be regraded to sheet flow towards the street or to the floodways based on site topography; doing so may be beneficial to direct low-level flood waters away from structures. Low elevations of lots averaging less than 5.5 feet NAVD, means stormwater backup and inundation can occur when the creek is at or near top of bank. Review of maintenance records indicate that the stormwater infrastructure on S. Seclusion Dr. is maintained by County, however, that which is west of Tuttle Ave. (Orchid Oaks Dr.) is on private property without easements and is maintained by those owners.

Figure 6: Distribution of Stormwater System Infrastructure

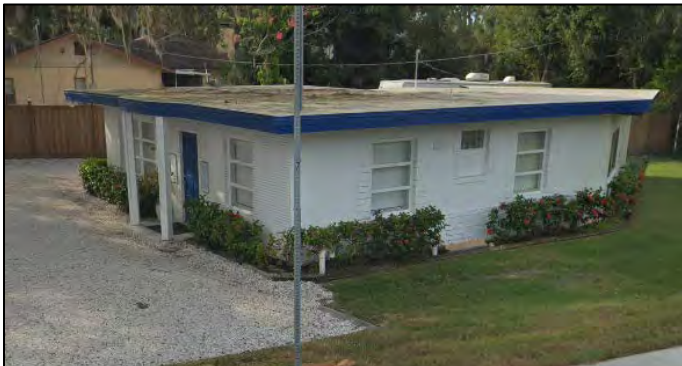
Figure 2: Slab on Grade Structure

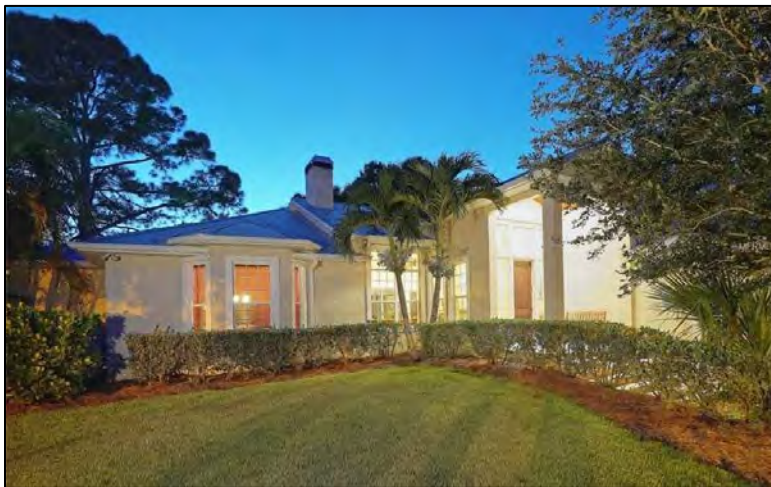
Figure 4: Concrete Block/Masonry

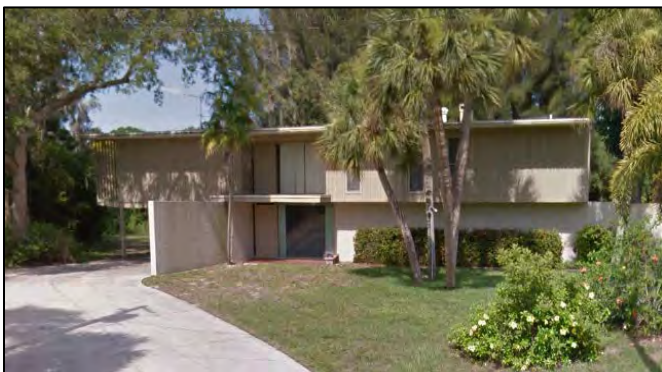
Figure 2: Slab on Grade Two-Story Structure

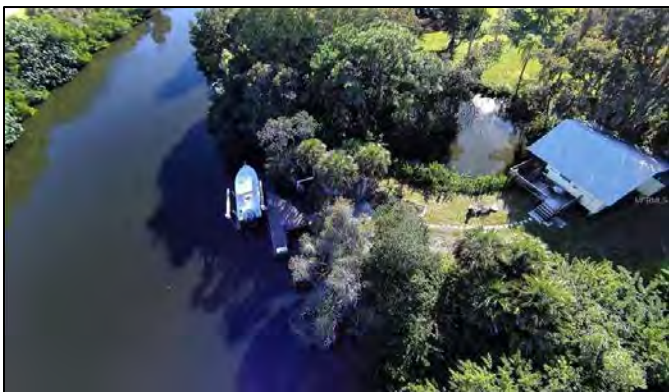
Figure 2: Structure Elevated on Posts/Piles or Walls

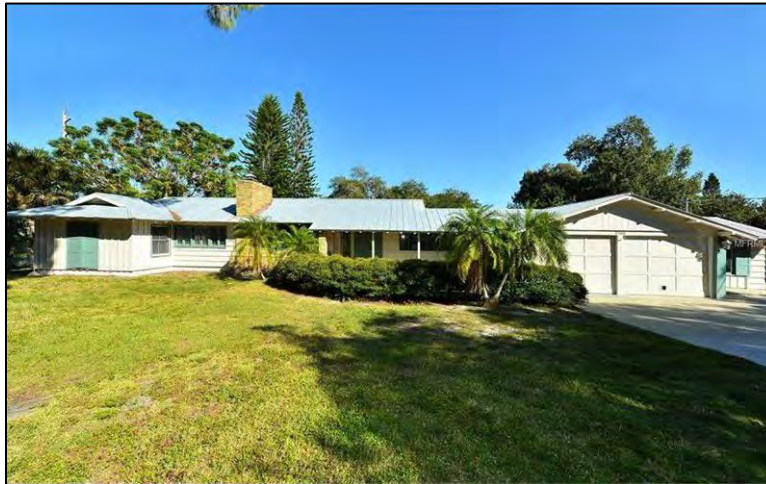
Figure 4: Wood Frame Structure

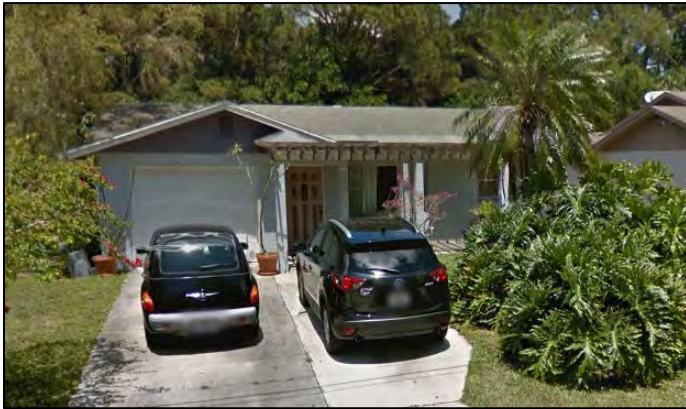
Figure 2: Slab on Grade Structure

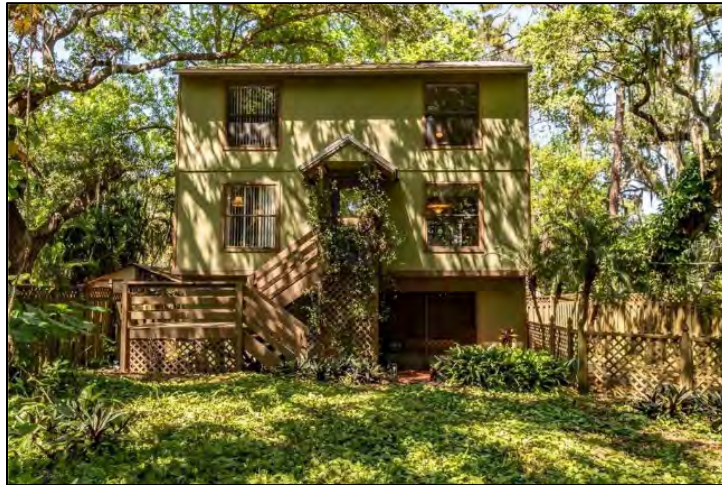
Figure 4: Elevated on Posts/Piles with Walls

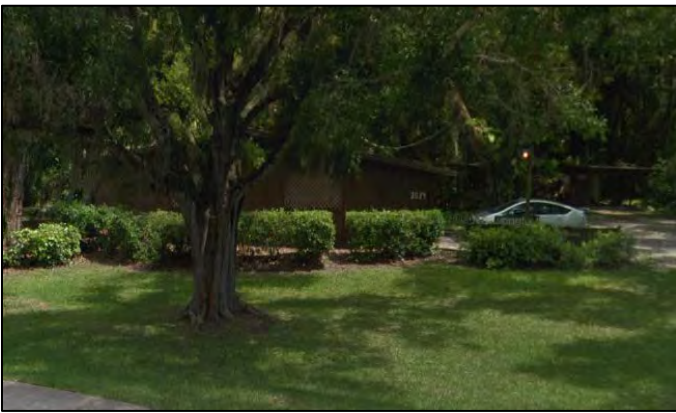
Figure 2: Slab on Grade, Wood Frame Structures

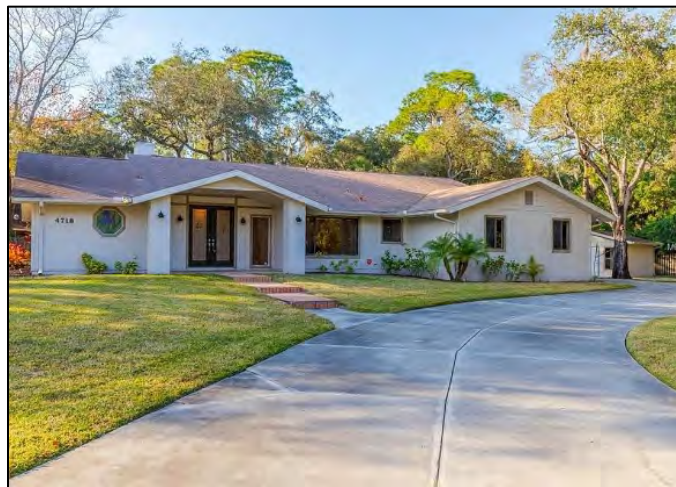
Figure 4: Elevated Slab on Grade

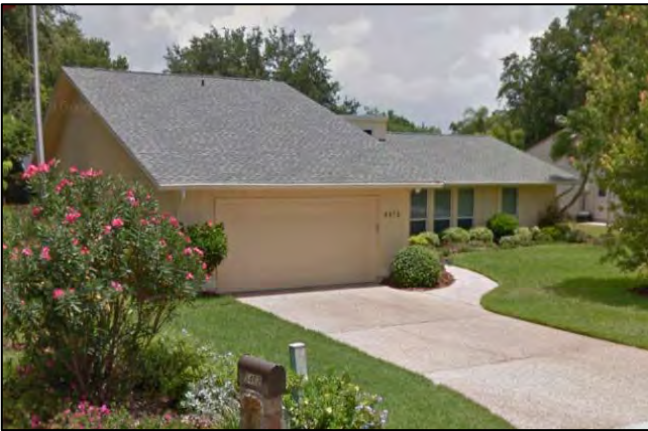
Figure 2: Slab on Grade Structure

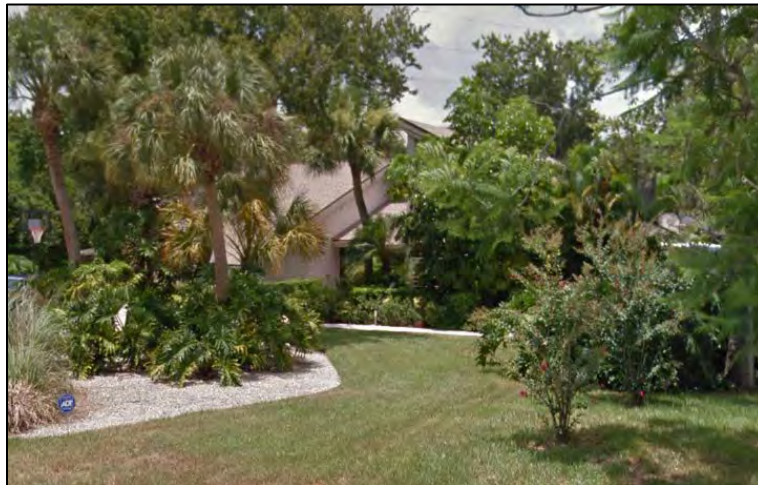
Figure 4: Slab on Grade Structure

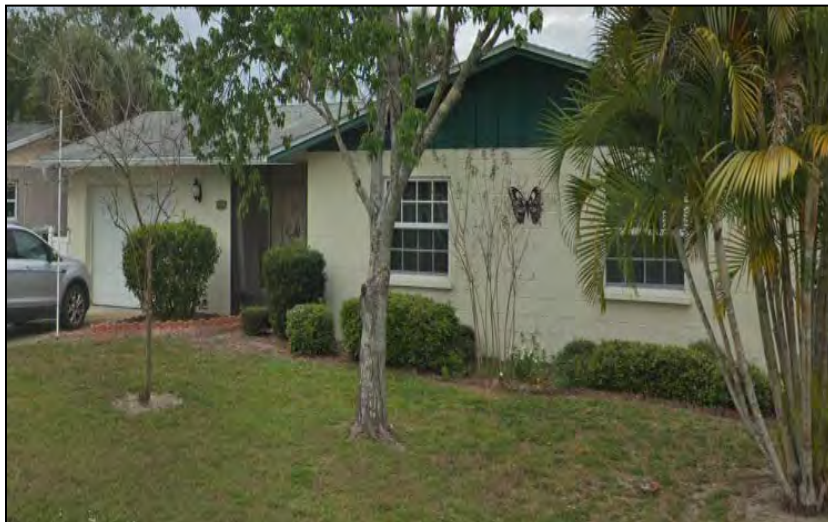
Figure 3: Slab on Grade Structure

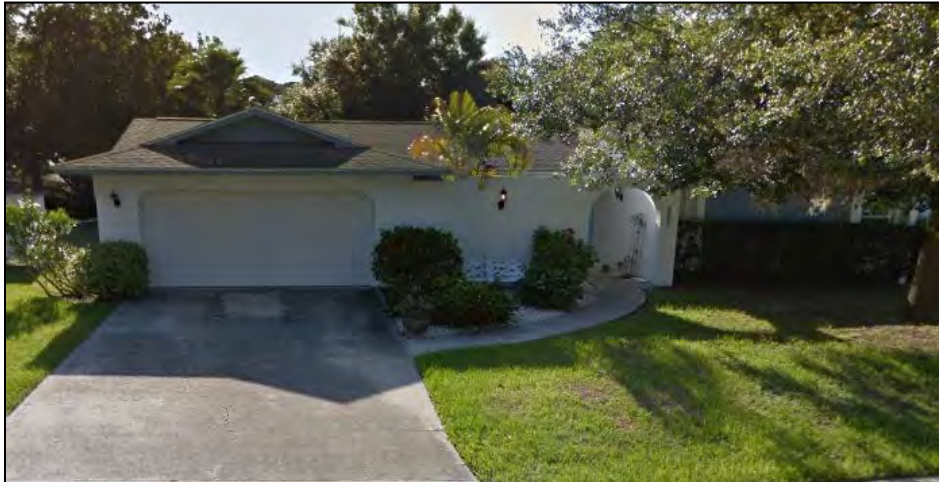
Figure 4: Slab on Grade Structure

Composition	Foundation Type
100%	Slab on grade
Composition	Frame Type
5%	Wood frame
95%	Concrete block/masonry
Composition	Number of Stories
99%	Single story
1%	Two story
Composition	Flood Zones
85%	Within SFHA Zone AE
15%	Within Zone X (shaded)
43%	Within CFHA Zone AE

Overtopping of the Phillippi Creek banks cause flooding during major storm events particularly during period of prolonged rainfall and repeated storms. Major outfalls to Phillippi Creek are likely to contribute to flooding conditions. Review of the spatial relationship between historical flood damage claims, the stormwater system and drainage patterns indicate that properties are typically in proximity to the creek banks, where the lots are relatively lower in elevation and older structures are not significantly elevated above existing grade. Figure 5 provides spatial context for the structures within the RLA in terms of topography, drainage infrastructure, and existing grades at the base of each structure.

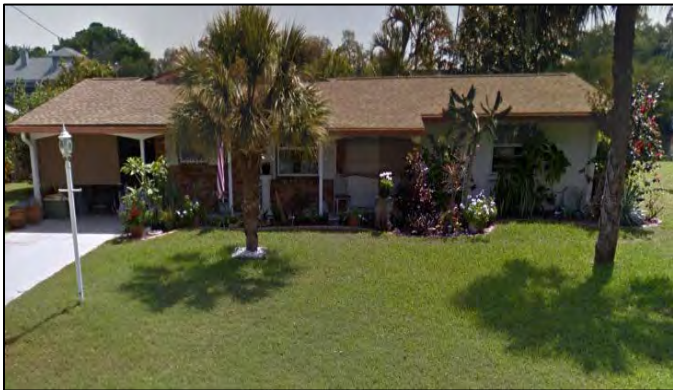
Figure 2: Slab on Grade Structure on Phillippi Creek Bank

This Repetitive Loss Area (RLA) is located on a peninsula within Phillippi Creek and includes single-family residences. Due to the area's low elevation within SFHA Zone AE and CFHA Zone AE, structures are subject to flooding from overtopping of the riverbanks, particularly during high rainfall events corresponding with high water levels in Phillippi Creek. This tidal location on the creek is only 1.25 miles north of Roberts Bay and has tidal, backwater, and storm surge contributing to flooding conditions. The median year built for the structures in the RLA is 1973, typically pre-FIRM with non-elevated slab-on-grade structures accounting for 35% of the total. Post-FIRM constructed structures have been elevated on fill, stem walls, or posts to meet the Base Flood Elevation (BFE) of 10 feet NAVD. Tables 1 and 4 provide a summary of the structures within this RLA.

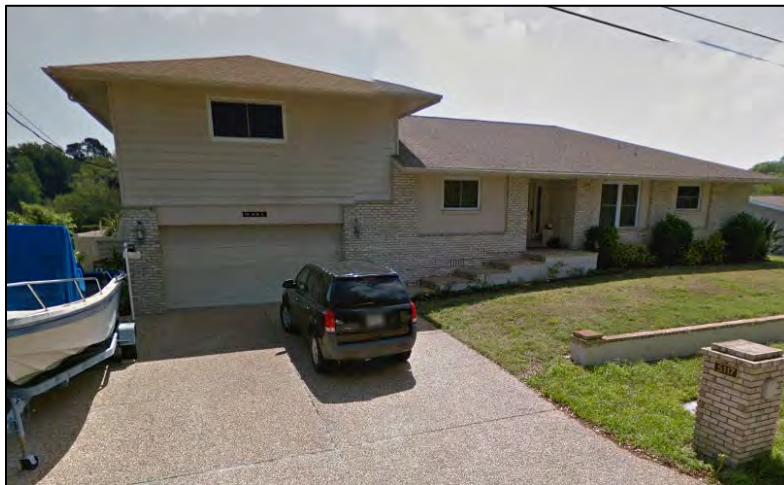
Figure 4: Slab on Grade Structure

Composition	Foundation Type
35%	Slab on grade
6%	Elevated slab on stem wall with fill
41%	Elevated on foundation walls
18%	Elevated on post/piles
Composition	Frame Type
71%	Wood frame
29%	Concrete block/masonry
Composition	Number of Stories
29%	Single story
71%	Two story
Composition	Flood Zones
100%	Within SFHA Zone AE
94.1%	Within CFHA Zone AE

Overtopping of the Phillippi Creek banks cause flooding during major storm events particularly during period of prolonged rainfall and repeated storms, along with high tides and backwater from Roberts Bay. Review of the spatial relationship between historical flood damage claims, the stormwater system and drainage patterns indicate that properties are in proximity to the creek banks, where the lots are relatively lower in elevation and older structures are not significantly elevated above existing grade. This RLA is characterized by low-lying areas. Figure 5 provides spatial context for the structures within the RLA in terms of topography, drainage infrastructure, and existing grades at the base of each structure.

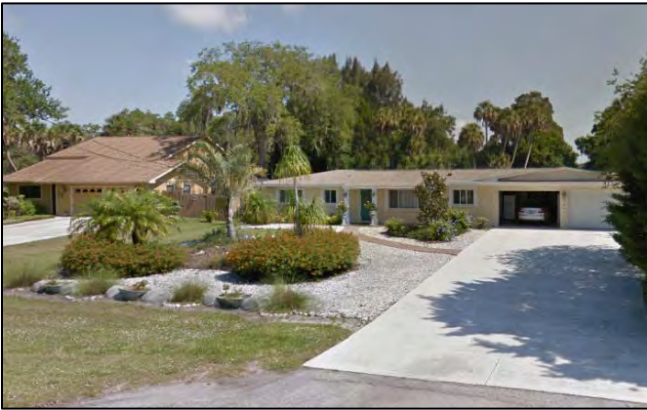
Figure 2: Slab on Grade Structures

This Repetitive Loss Area (RLA) is located along the southern shoreline of Mirror Lake, in a single-family residential neighborhood. Structures in this area are subject to flooding from overtopping of the banks of the lake as well as stormwater system backup for the system discharging into Mirror Lake. The structures in this RLA are located within Zone X, SFHA Zone A, and CFHA Zone AE. The median year built for the structures is 1972, so while typically post-FIRM with non-elevated slab-on-grade structures accounting for 80% of the total. Tables 1 and 4 provide a summary of the structures within this RLA.

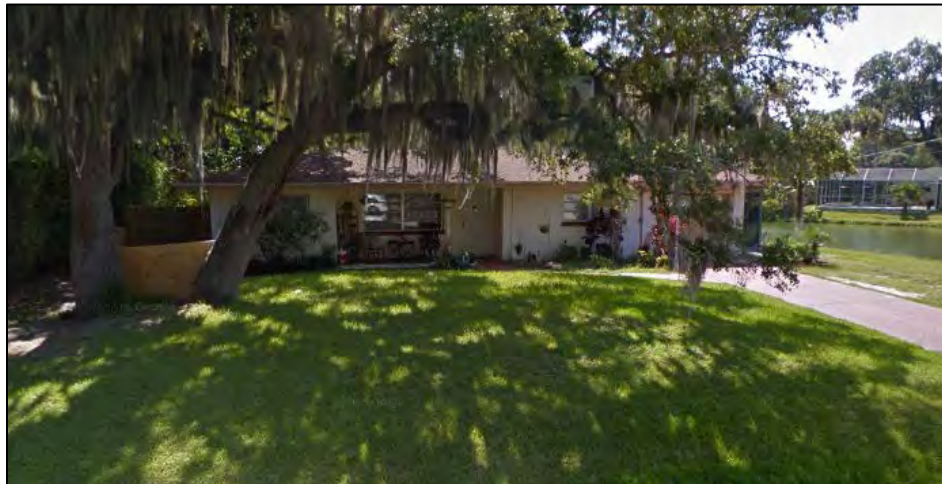
Figure 4: Slab on Grade Structure

Composition	Foundation Type
80%	Slab on grade
10%	Elevated slab on stem wall with fill
10%	Elevated on post/piles or walls
Composition	Frame Type
30%	Wood frame
70%	Concrete block/masonry
Composition	Number of Stories
70%	Single story
30%	Two story
Composition	Flood Zones
20%	Within SFHA Zone A
80%	Within Zone X
70%	Within CFHA Zone AE

Overtopping of the Mirror Lake banks causes flooding during major storm events, particularly during period of prolonged rainfall and repeated storms. Review of the spatial relationship between historical flood damage claims, the stormwater system and drainage patterns indicate that properties are typically in proximity to the lake banks, where the lots are relatively lower in elevation and older structures are not significantly elevated above existing grade. The RLA is within Zone X, SFHA Zone A, and CFHA Zone AE. Figure 5 provides spatial context for the structures within the RLA in terms of topography, drainage infrastructure, and existing grades at the base of each structure.

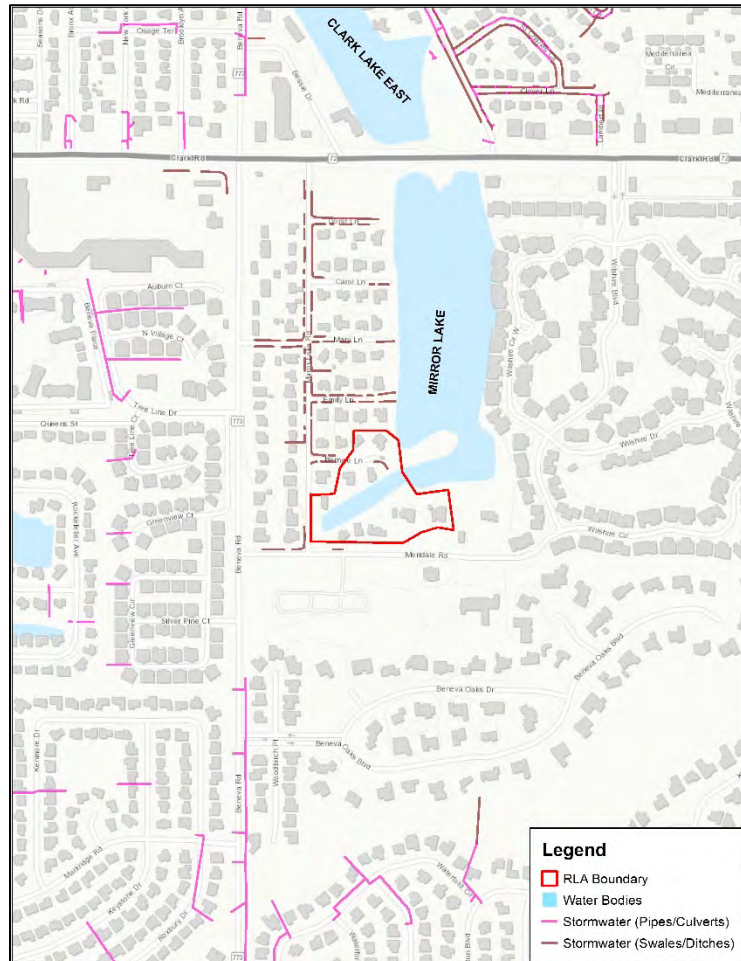
Figure 6: Distribution of Stormwater System Infrastructure

The stormwater utility system serving this RLA includes a collection of swales and storm pipes that discharge into Mirror Lake. Based on site visits and resident surveys, the lots that do not have positive drainage away from the building should be regraded to sheet flow towards the street or to the floodways based on site topography; doing so may be beneficial to direct low-level flood waters away from the structure. Low elevations of lots means stormwater backup and inundation can occur when the lake is at or near top of bank. Review of maintenance records indicate that the stormwater infrastructure is maintained by County.

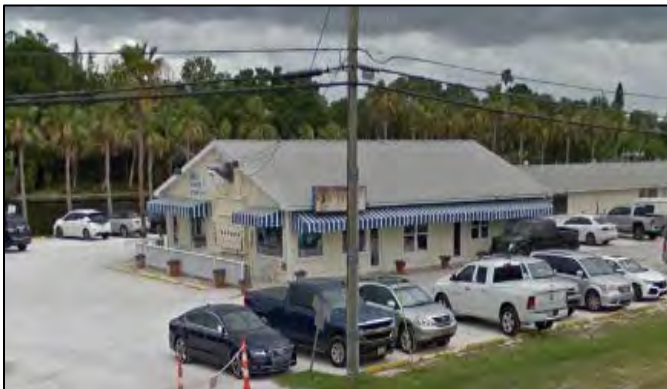
Figure 2: Commercial Slab on Grade Structures

This Repetitive Loss Area (RLA) is located on an island within Phillippi Creek, with a major highway on the western boundary line. Phillippi Creek forms an island that includes commercial structures. Due to the area's low elevation within SFHA Zone AE and CFHA Zone AE and major highway system, structures are subject to flooding from overtopping of the riverbanks as well as possible stormwater system backup, particularly during high rainfall events corresponding with high water levels in Phillippi Creek. This tidal location on the creek is only 0.75 miles north of Roberts Bay and has tidal, backwater, and storm surge contributing to flooding conditions. The median year built for the structures is 1950, typically pre- FIRM with non-elevated slab-on-grade construction, with average First Floor Elevation (FFE) at 8.2 feet below the Base Flood Elevation (BFE) of 10 feet NAVD. Tables 1 and 4 provide a summary of the structures within this RLA.

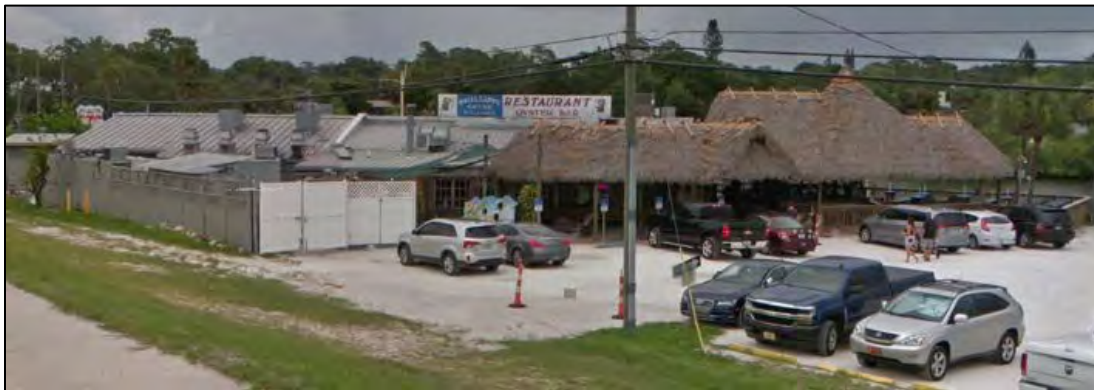
Figure 4: Low Elevation, Slab on Grade Structure

Composition	Foundation Type
100%	Slab on grade
Composition	Frame Type
100%	Wood frame
Composition	Number of Stories
100%	Single story
Composition	Flood Zones
100%	Within SFHA Zone AE
100%	Within CFHA Zone AE

Overtopping of the Phillippi Creek banks cause flooding during major storm events particularly during period of prolonged rainfall and repeated storms, exacerbated by high tides and backwater from Roberts Bay. This RLA is located on an island and a major roadway that runs through it. Review of the spatial relationship between historical flood damage claims, the stormwater system and drainage patterns indicate that properties are typically in proximity to the creek banks, where the lots are relatively lower in elevation, and older structures are not elevated above existing grade. Figure 5 provides spatial context for the structures within the RLA in terms of topography, drainage infrastructure, and existing grades at the base of each structure.

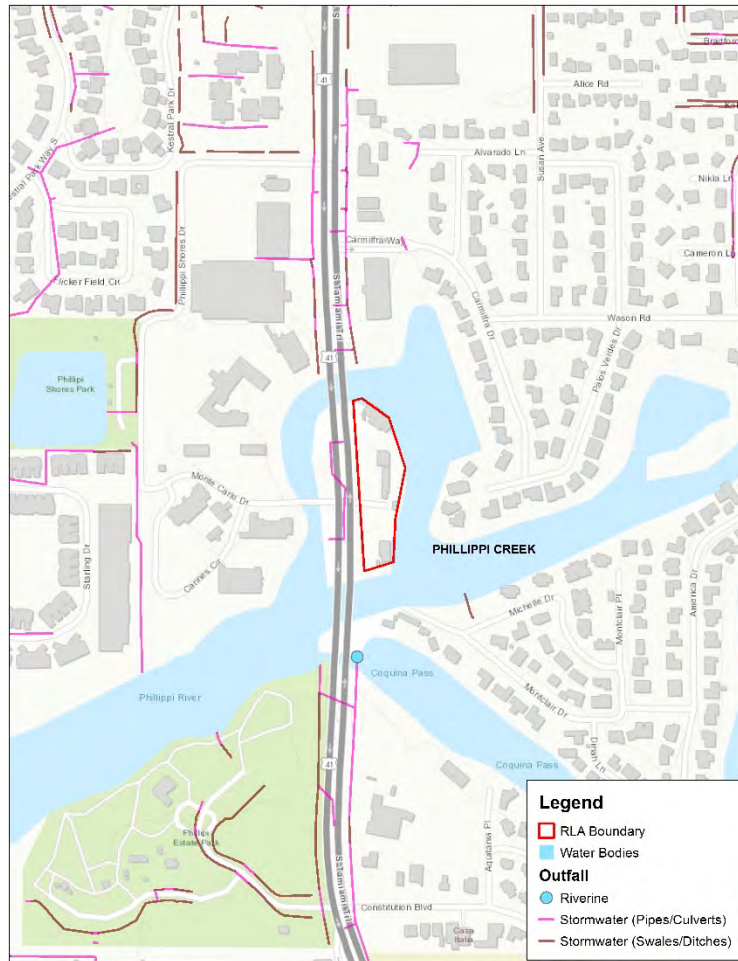
Figure 6: Distribution of Stormwater System Infrastructure

The stormwater system in this RLA includes storm pipes and an outfall structure draining US 41 off the island. Low elevations of lots averaging less than 1.8 feet NAVD, means stormwater backup and inundation can occur when the Creek is at or near top of bank. Review of maintenance records indicate that the stormwater infrastructure system on Tamiami Trl is maintained by County. It is unlikely that expansion of the stormwater infrastructure in this area will provide mitigation for this RLA.

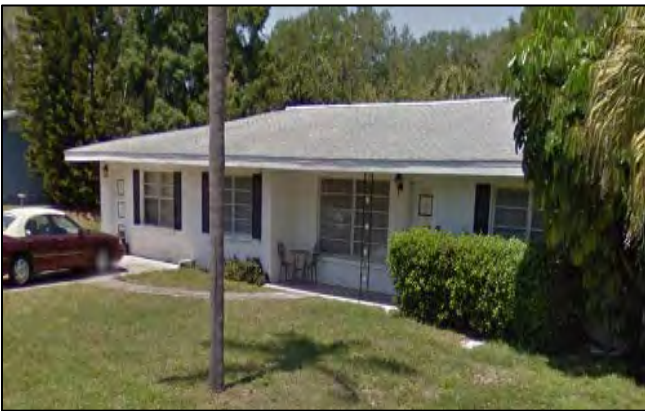
Figure 2: Slab on Grade Structure

This Repetitive Loss Area (RLA) is located east of Phillippi Creek with two (2) major drainage canals to the west and south that discharge to Phillippi Creek. The structures in this RLA are within Zone X and CFHA Zone AE and consist of single-family, non-elevated slab-on-grade structures constructed in the 1950s and 1960s, so typically pre-FIRM structures. Due to the area's location to the drainage canal, structures are subject to flooding from overtopping of the riverbanks as well as possible stormwater system backup, particularly during high rainfall events corresponding with high water levels in Phillippi Creek. This portion of Phillippi Creek is not tidally influenced, which could contribute to flooding conditions. Tables 1 and 4 provide a summary of the structures within this RLA.

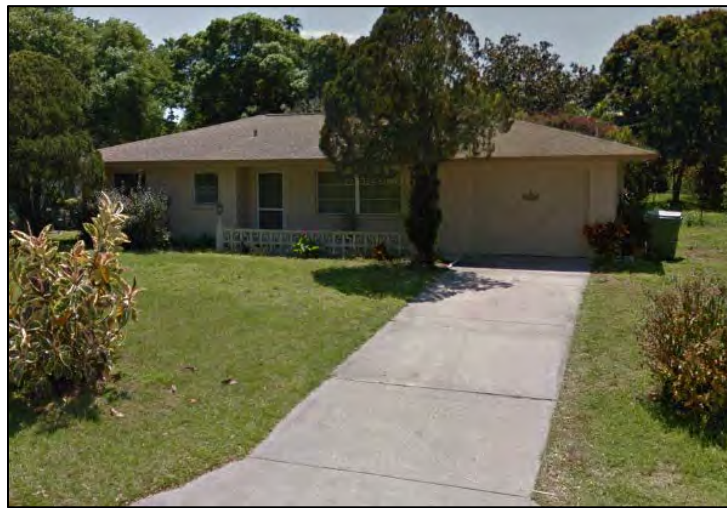
Figure 4: Slab on Grade Structure

Composition	Foundation Type
100%	Slab on grade
Composition	Frame Type
11%	Wood frame
89%	Concrete block/masonry
Composition	Number of Stories
100%	Single story
Composition	Flood Zones
100%	Within Zone X
100%	Within CFHA Zone AE

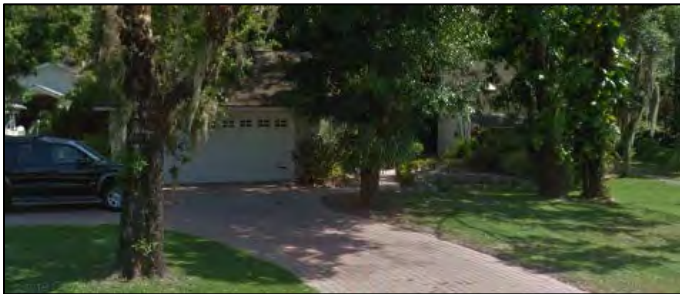
Figure 2: Slab on Grade Structure on Phillippi Creek Bank

This Repetitive Loss Area (RLA) is located along the northern shoreline of Phillippi Creek and includes single-family residential structures. Due to the area's elevation within Zone X and CFHA Zone AE, structures are subject to flooding from overtopping of the banks of the creek as well as possible stormwater system backup, particularly during high rainfall events corresponding with high water levels in Phillippi Creek, as noted in the resident survey. The median year built for the structures is 1980, typically post-FIRM with non-elevated slab-on-grade structures accounting for 33% of the total. Tables 1 and 4 provide a summary of the structures within this RLA.

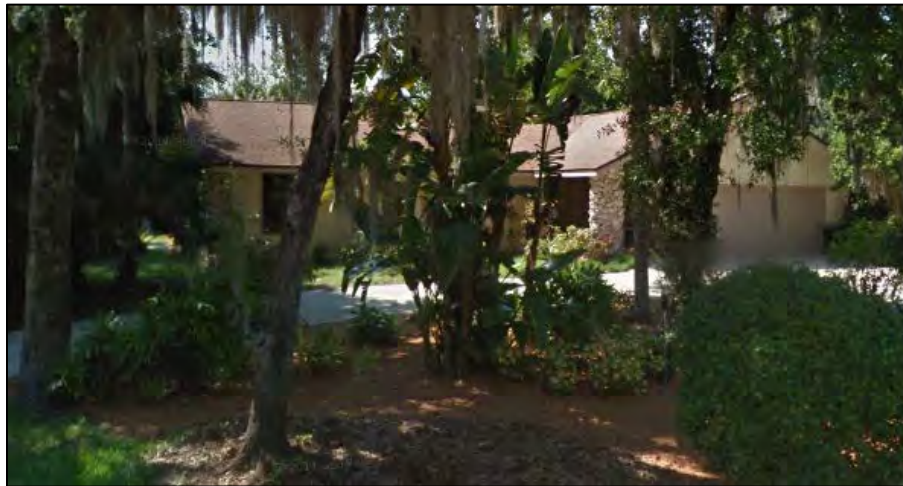
Figure 4: Raised Slab on Grade Structure

Composition	Foundation Type
33%	Slab on grade
33%	Elevated slab on stem wall with fill
17%	Elevated on post/piles or walls
17%	Undetermined due to vegetation/access
Composition	Frame Type
100%	Wood frame
Composition	Number of Stories
50%	Single story
50%	Two story
Composition	Flood Zones
100%	Within Zone X
100%	Within CFHA Zone AE

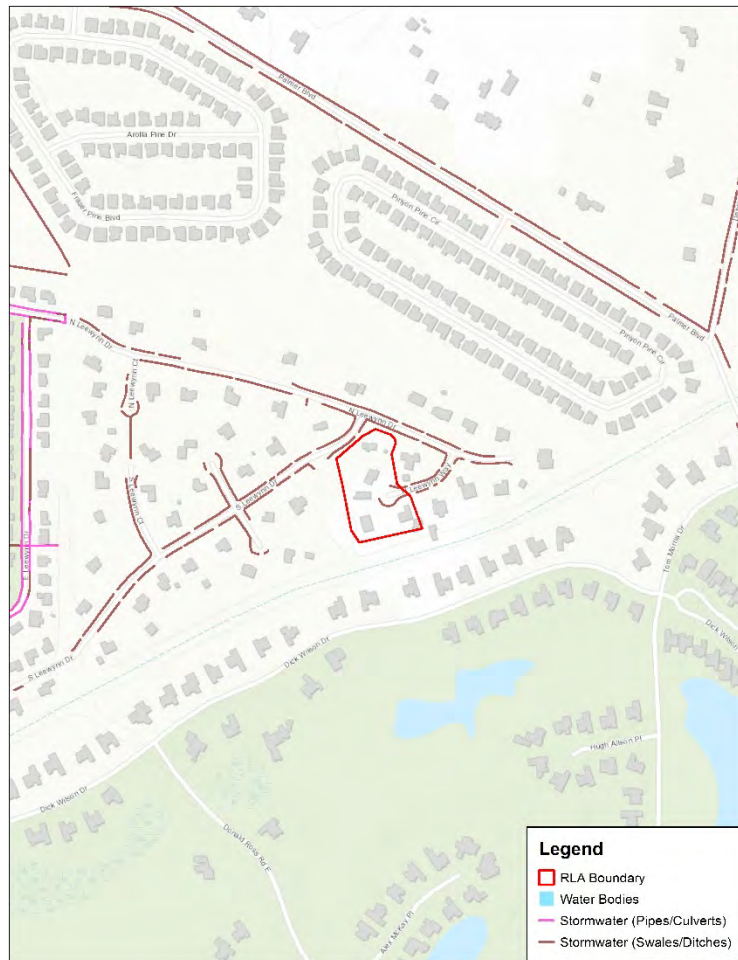
Figure 6: Distribution of Stormwater System Infrastructure

The stormwater system serving this RLA includes a combination of swales and storm pipes discharging to a wet retention pond and Phillippi Creek. Based on site visits and resident surveys, the lots that do not have positive drainage away from the building, should be re-graded to sheet flow towards the street or to the floodways based on site topography; doing so may be beneficial to direct low-level flood waters away from structures.

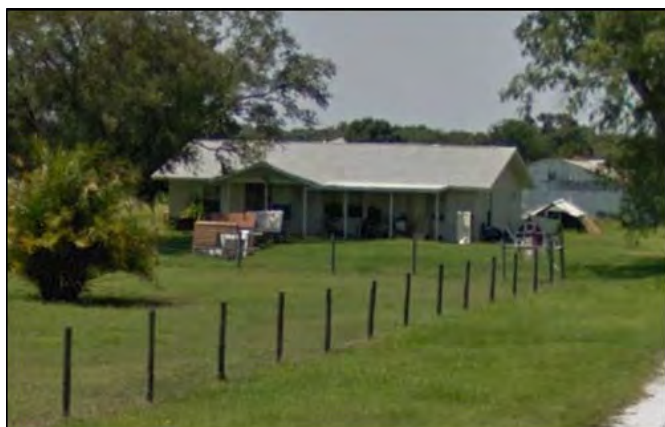
Figure 2: Slab on Grade, Low Level Structures

This Repetitive Loss Area (RLA) is located south of Phillippi Creek and consists of primarily commercial buildings. Due to the area's low elevation, structures are subject to flooding from stormwater system backup, particularly during high rainfall events corresponding with high water levels in Phillippi Creek. The structures in this RLA are within Zone X and CFHA Zone AE making them at moderate risk of flooding. The median year built for the structures is 1950, so while some are post-FIRM, the non-elevated slab on grade structures are at risk of flooding accounting for 29% of total. Tables 1 and 4 provide a summary of the structures within this RLA.

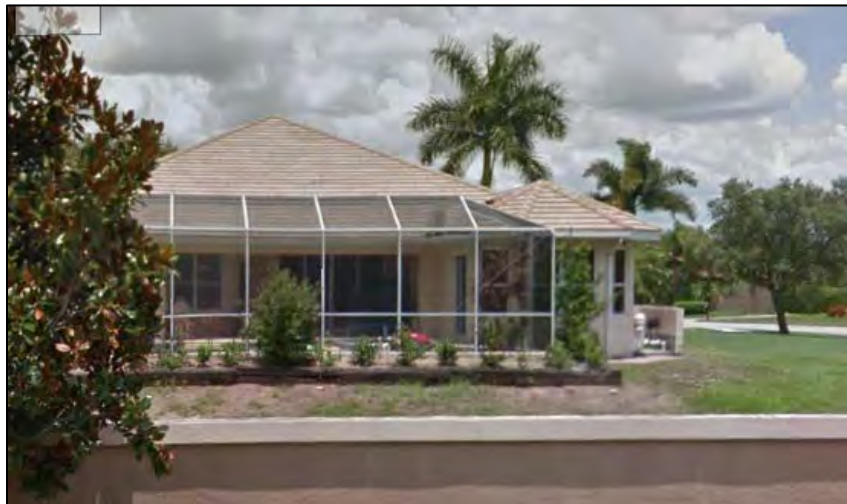
Figure 4: Example of Slab on Grade

Composition	Foundation Type
29%	Slab on grade
71%	Undetermined due to vegetation/access
Composition	Frame Type
71%	Wood frame
29%	Steel
Composition	Number of Stories
71%	Single story
29%	Two story
Composition	Flood Zones
100%	Within Zone X
71.5%	Within CFHA Zone AE

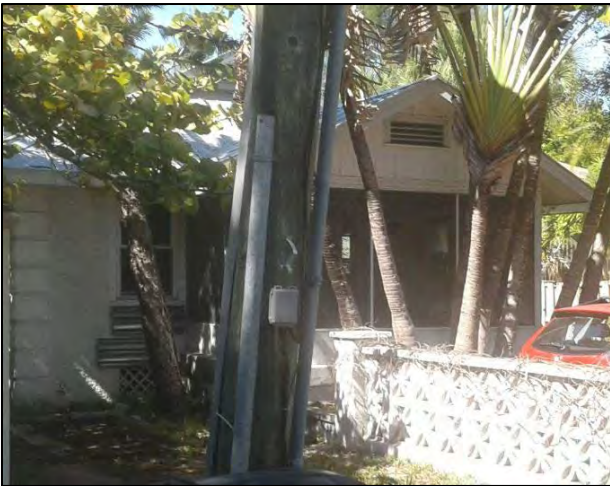
Figure 2: Slab on Grade Structure

This Repetitive Loss Area (RLA) is a peninsula on the bay side of the Siesta Key barrier island. It is subject to flooding from the storm surge, waves, and tidal action from the Roberts Bay Sarasota, Big Pass, and the Gulf of Mexico as well as stormwater system backup from outfalls to the bay during storm events with high rainfall, exacerbated by high tides and/or storm surge. All structures in this RLA are within SFHA Zone AE and includes a mix of newer, large single-family homes, older cottages, and mid-century homes. Approximately one third of the structures are elevated, with the rest non- or minimally elevated slab on grade construction. The combination of extremely low-elevation terrain, high proportion of older, non-elevated structures, and its peninsular landform on a barrier island near Big Pass and the entrance to Sarasota Bay from the Gulf, with both coastal and bay influences, make this area particularly susceptible to flooding. Tables 1 and 4 provide a summary of the structures within this RLA.

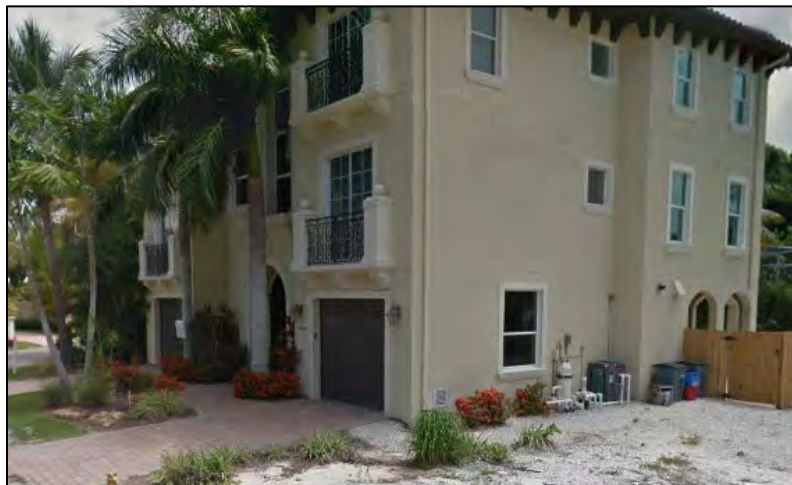
Figure 4: Example of Elevated on Post Structure

Composition	Foundation Type
54%	Slab on grade
17%	Elevated slab on stem wall with fill
29%	Elevated on post/piles or walls
Composition	Frame Type
29%	Wood frame
71%	Concrete block/masonry
Composition	Number of Stories
32%	Single story
54%	Two story
14%	Three story or greater
Composition	Flood Zones
100%	Within SFHA Zone AE

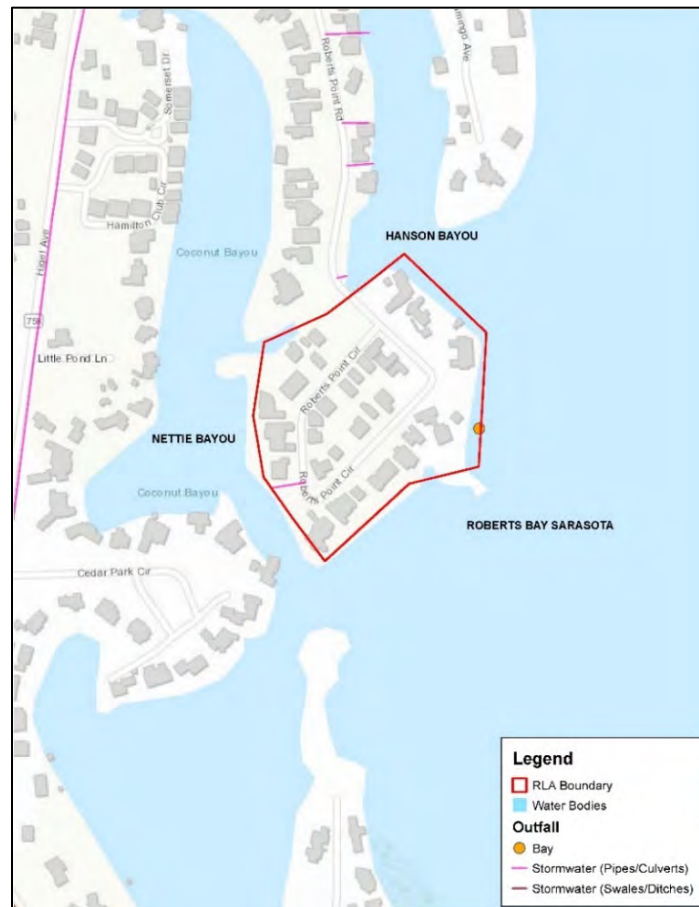
Figure 6: Distribution of Stormwater System Infrastructure

The stormwater system includes two (2) Bay outfalls where it collects runoff from adjacent properties then travels via piping to one (1) Bay outfall at the canal system. Streets in this area are extremely low in elevation, and direct runoff from adjacent lots to North and South to the respective drop structures and outfalls. The "center" of the circle is lower in elevation and tends to pool runoff from the street side of the waterfront lots around Roberts Point Cir. Review of stormwater complaints and resident comments indicate that the inlets in this area must be regularly maintained to avoid low level flooding during high rainfall events. While there were some normal system maintenance issues observed during the field work, these areas appear to be routinely maintained by County staff based on review of the maintenance callouts. Low elevations of many of the structures relative to the BFE (6.2 feet NAVD average FFE versus 10 feet NAVD BFE), indicates stormwater system improvements in this area are not expected to provide flood mitigation.

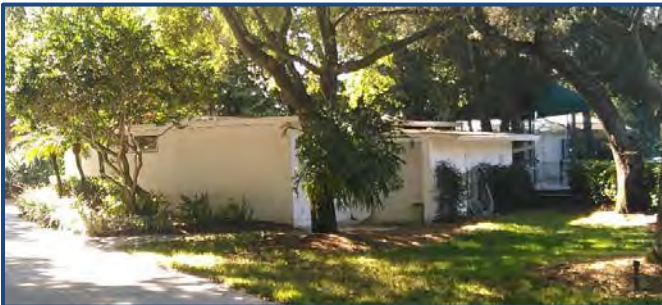
Figure 2: Slab on Grade Structures

This Repetitive Loss Area (RLA) is located on the Siesta Key barrier island along the east side of Higel Avenue, with direct water frontage to Coconut Bayou (Bay). Big Sarasota Pass and the Gulf beach are just to the west across Higel Avenue. This area is subject to flooding from the storm surge, waves, and tidal action from Roberts Bay, Big Sarasota Pass, and the Gulf of Mexico as well as stormwater system backup from outfalls to the bay during storm events with high rainfall, unusually high tides and/or storm surge. All structures in this RLA are within SFHA Zone AE and are mostly single-family residences dating back to late 1940's and early 1950's which are not elevated. The area is particularly low lying relative to surrounding uplands. The combination of extremely low-elevation terrain, and existence of older, non-elevated structures, and its location between the Gulf/Big Sarasota Pass and the Bay, with both coastal and bay influences, make this area particularly susceptible to flooding. Tables 1 and 4 provide a summary of the structures within this RLA.

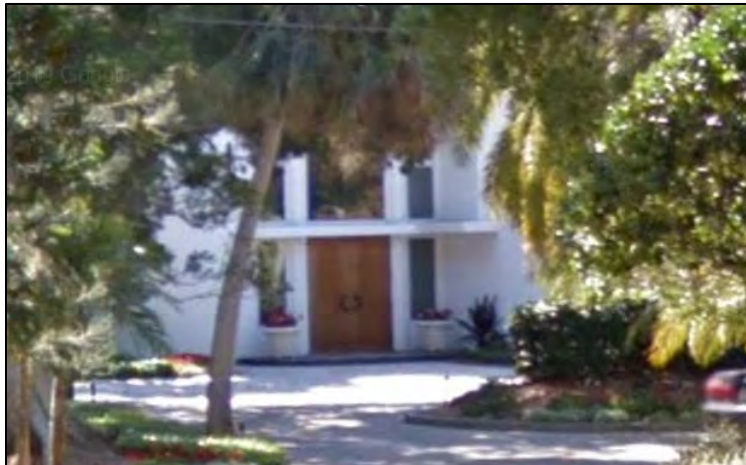
Figure 4: Slab on Grade Structures (Google Maps)

Composition	Foundation Type
89%	Slab on grade
0%	Elevated slab on stem wall with fill
11%	Elevated on post/piles or walls
Composition	Frame Type
33%	Wood frame
67%	Concrete block/masonry
Composition	Number of Stories
56%	Single story
33%	Two story
11%	Three story or greater
Composition	Flood Zones
100%	Within SFHA Zone AE

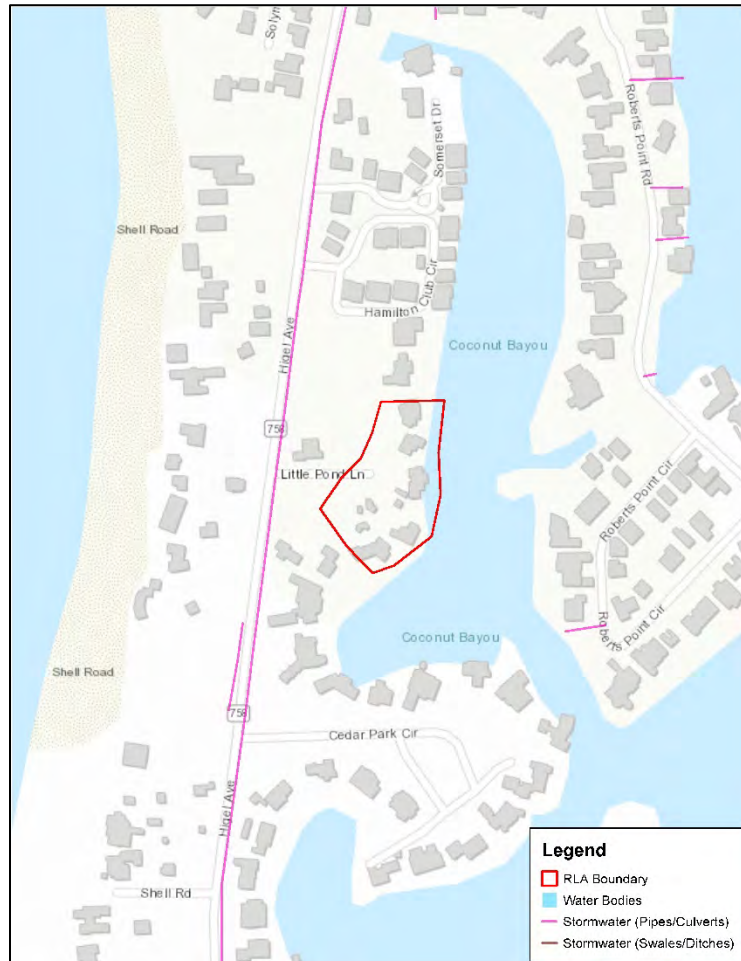
Figure 6: Distribution of Stormwater System Infrastructure

There is no stormwater infrastructure system within this RLA, which has extremely low elevation terrain adjacent to the Bay shoreline. As such, stormwater sheet flows from slightly higher uplands (west) down the street and across low-lying lots (average elevation 2.4 feet) to the Bay. This low elevation area is particularly susceptible to stormwater backup from surrounding areas during high tides coinciding with high rainfall events. Because of the low elevations of many of the structures in the surrounding area relative to the BFE (3.3 feet NAVD average FFE versus 10 feet BFE), stormwater system improvements in the surrounding area are not expected to provide flood mitigation.

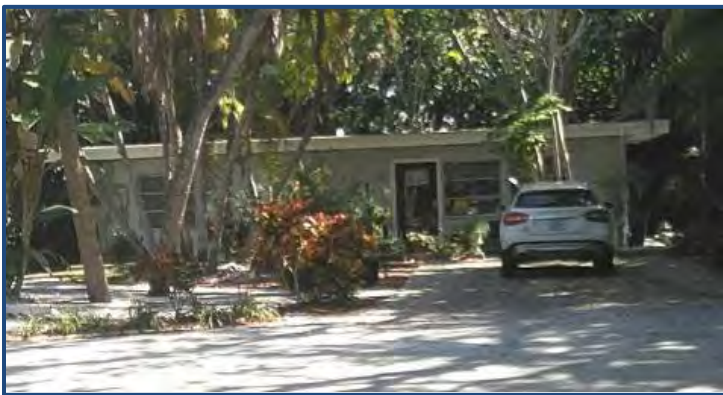
Figure 2: Slab on Grade Structures

Composition	Foundation Type
96%	Slab on grade
4%	Elevated on post/piles or walls
Composition	Frame Type
13%	Wood frame
87%	Concrete block/masonry
Composition	Number of Stories
21%	Single story
75%	Two story
4%	Three story or greater
Composition	Flood Zones
100%	Within SFHA Zone AE

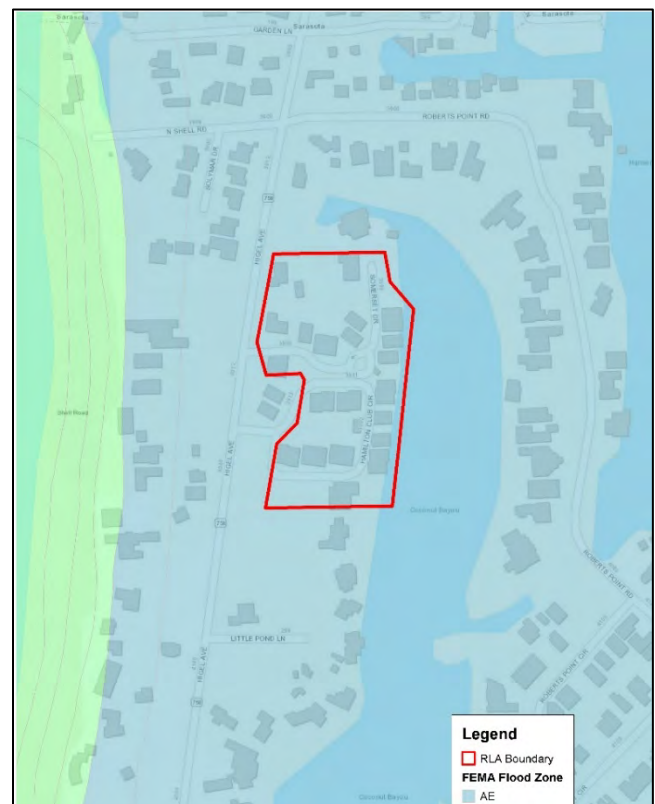
Figure 3: Spatial Distribution of Structures vs Flood Zone

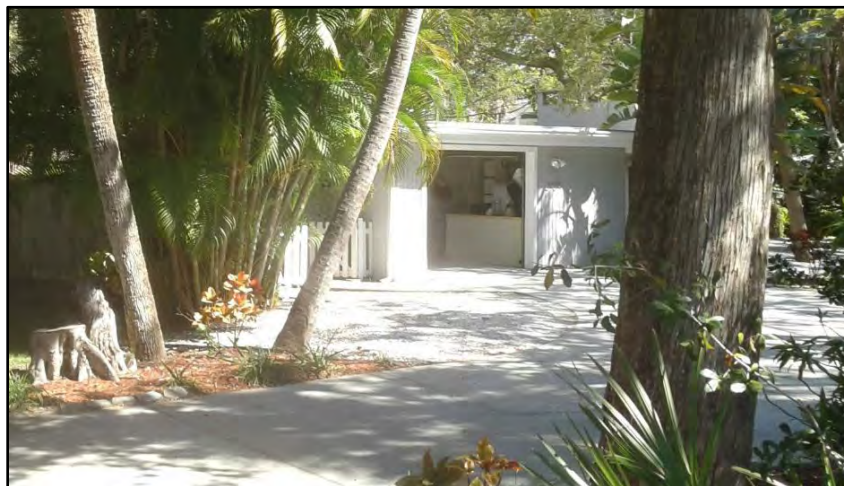
Figure 4: Slab on Grade Accessory Structures

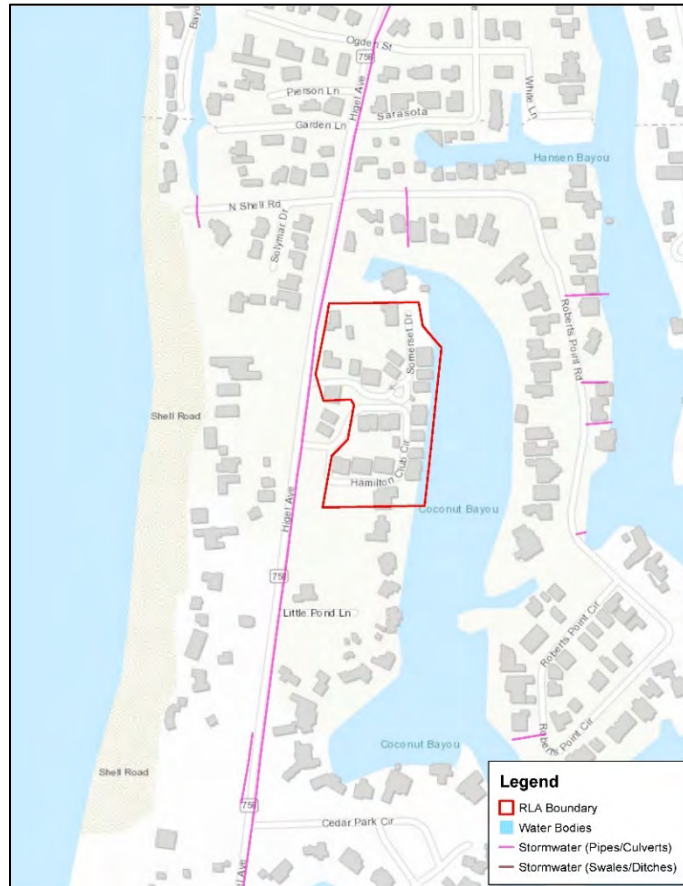
The stormwater system includes three (3) small stormwater ponds and a collection system within the gated community that is privately maintained by the HOA. Along Higel Avenue there is also a system of inlets and piping that convey stormwater to the Bay outfall at Siesta Dr and Hansen Bayou bridge. Review of the topography and drainage patterns in this area reveal that there is a prominent west-east running drainage swale between the older single-family structures to the north, and the gated community to the south. This is an extremely low elevation area which appears to have a Bay outfall and would be a source of tidal and storm surge inundation during high rainfall storm events. It continues across Higel Avenue to the west and is likely a conveyance for runoff and flood inundation from the beach side properties as well. Because of the low elevations of slab on grade structures in this area relative to the BFE, stormwater system improvements in this area are not expected to provide flood mitigation for the single-story structures.

Figure 6: Distribution of Stormwater System Infrastructure

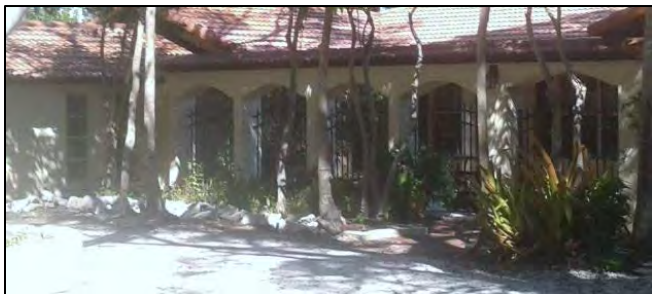
Figure 2: Masonry, Slab on Grade Structures

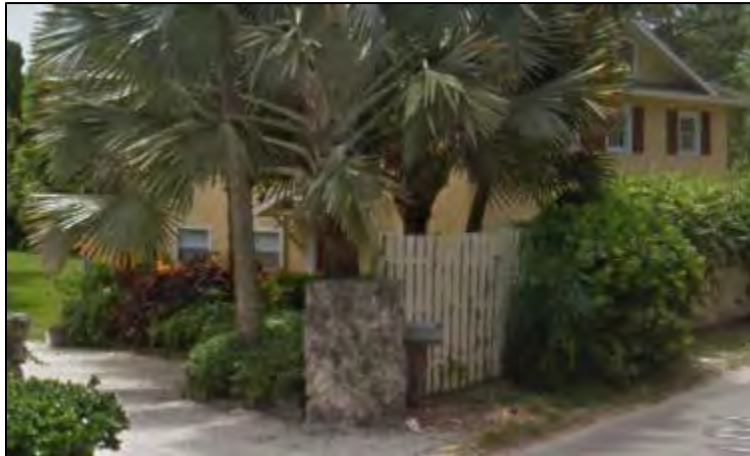
Figure 4: Slab on Grade Structures (Google Map)

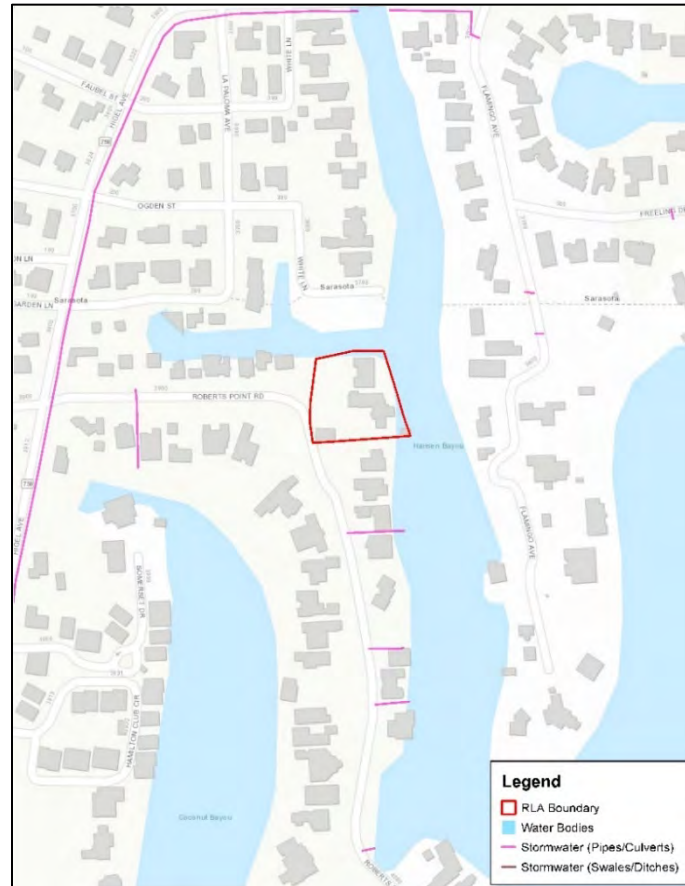
The stormwater infrastructure system in the vicinity includes two (2) Bay outfalls to the South that collect runoff from the street and adjacent properties then route it to the Bay outfalls. Streets in this area are extremely low in elevation and convey runoff from adjacent lots to the lower elevation areas south along Roberts Point Rd to the respective drop structures and outfalls. Review of stormwater complaints and resident comments indicate that the inlets in this area must be regularly maintained to avoid low level flooding during high rainfall storm events with high tides. It appears that the stormwater system can experience back up all the way to the RLA properties, which are relatively low in elevation when compared to adjacent properties. Because of the low elevations of many of the structures relative to the BFE (3.1 feet NAVD average FFE versus 10 feet NAVD BFE), stormwater system improvements in this area are not expected to provide flood mitigation.

Figure 6: Distribution of Stormwater System Infrastructure

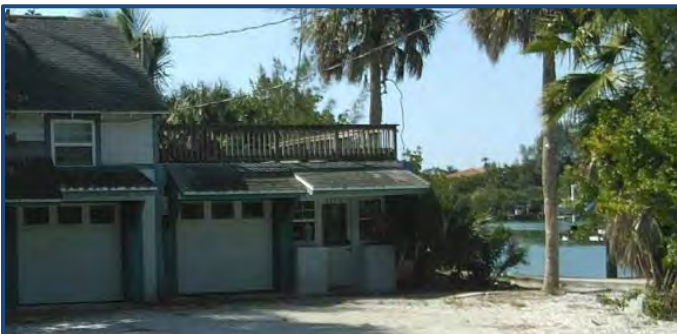
Figure 2: Slab on Grade Structure Adjacent to Waterway
