**SARASOTA COUNTY
FLOODPLAIN MANAGEMENT PLAN UPDATE**

Sarasota County | June 2021

Sarasota County Floodplain Management Plan Committee
1001 Sarasota Center Blvd.
Sarasota, Florida 34240
June 2021

Jones Edmunds & Associates, Inc.
730 NE Waldo Road
Gainesville, Florida 32641
Certificate of Engineering Authorization #1841

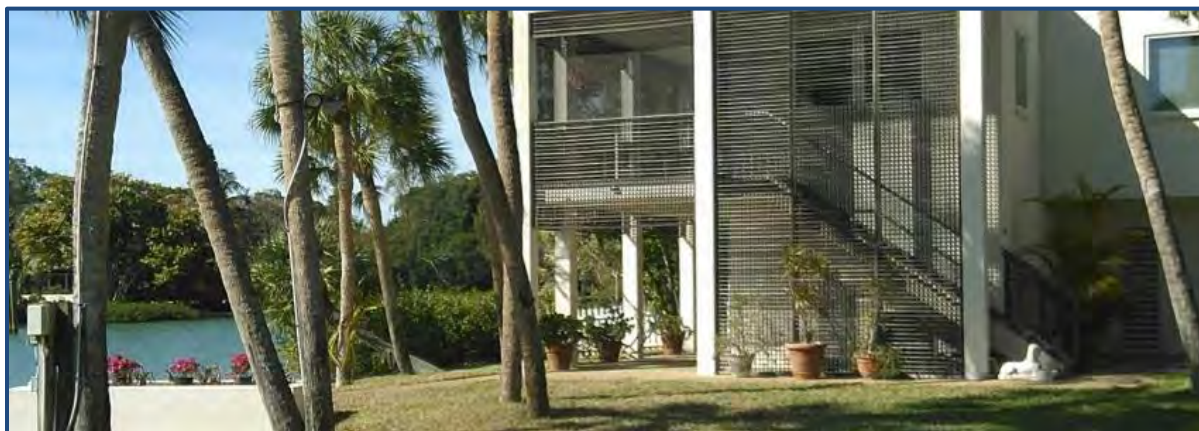
Figure 4: Structure Adjacent to Waterway

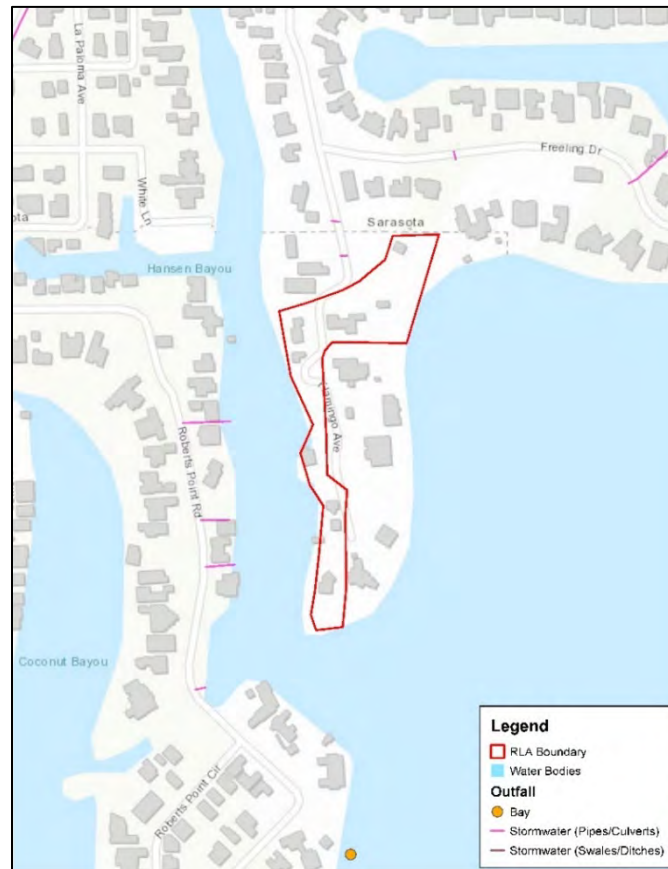
The stormwater system includes two (2) Bay outfalls with catch basin structures and a short pipe run to each of the outfalls. These collect accumulated runoff from Flamingo Ave and adjacent properties. Streets in this area are extremely low in elevation, with generally higher elevation built-up lots on the east shore side of the narrow peninsula contributing to runoff accumulating on Flamingo Ave and the lower elevation lots on the west shoreline. Review of stormwater complaints and resident comments indicate the inlets in this area must be regularly maintained to avoid low level flooding during high rainfall events. Low elevations of many of the structures relative to the BFE (6.5 feet NAVD average FFE versus 10 feet NAVD BFE) indicate stormwater system improvements in this area are not expected to provide flood mitigation.

Figure 6: Distribution of Stormwater System Infrastructure

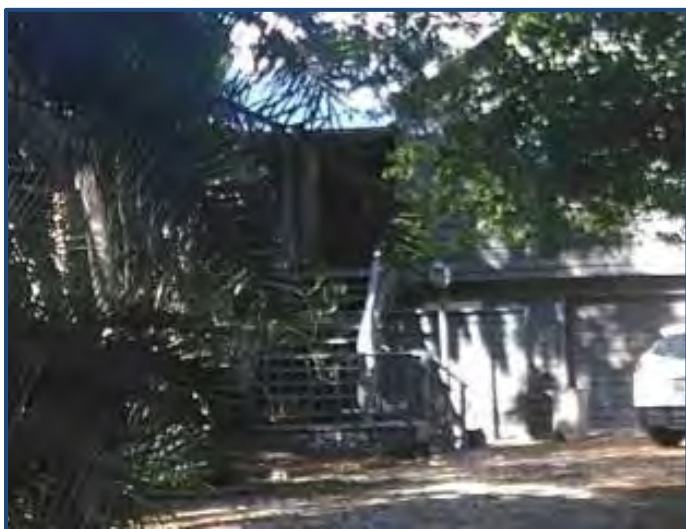
Figure 2: Elevated Structures

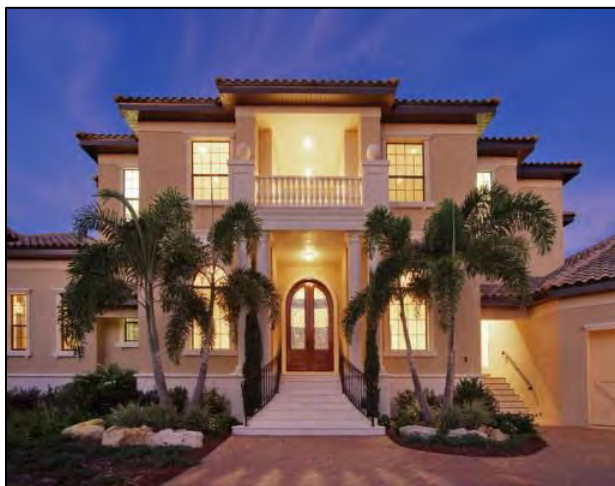
Figure 4: Elevated Structures (Realtor.com)

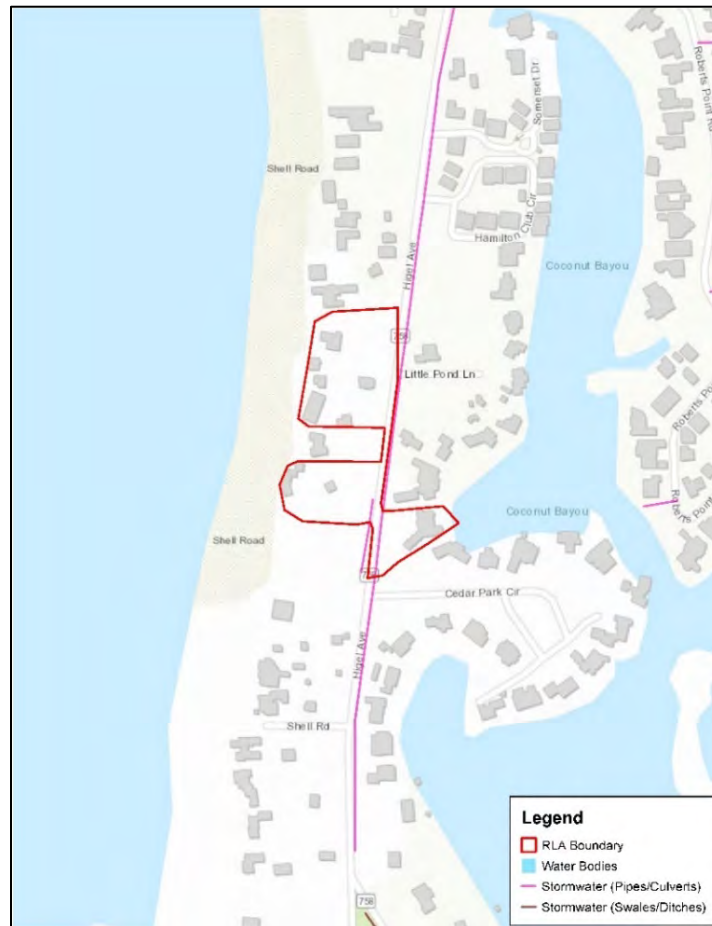
Along Higel Avenue is a system of inlets and piping that conveys stormwater to the Bay outfall at Siesta Dr and Hansen Bayou bridge. Runoff from the properties east of Higel appears to drain to the low-lying areas and discharge into Coconut Bayou (Bay). Review of work order history along Higel Ave indicates complaints in this area are typically referred to FDOT for resolution. Review of the topography indicates a possible gap in the frontal dune in this area, which is likely to contribute to inundation of the beachfront properties from wave action, storm surge, and unusually high tides during major storm events. FEMA guidelines suggest that beach re-nourishment activities focusing on natural dune replenishment may reduce the risk of flooding and could be a mitigation alternative. However, the low elevations of many structures relative to the BFE (6.5 feet NAVD average FFE versus 11 feet NAVD BFE), combined with the location on the beach within SFHA Zone VE, indicates stormwater system improvements and dune restoration in this area are not expected to provide flood mitigation.

Figure 6: Distribution of Stormwater System Infrastructure

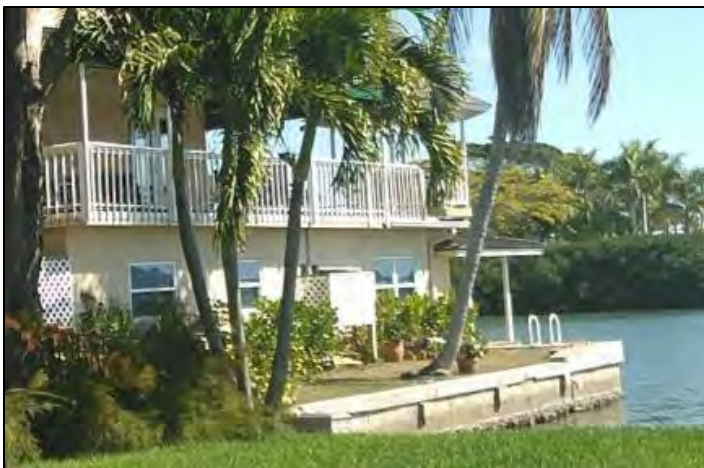
Figure 2: Slab on Grade Structure Adjacent to Waterway

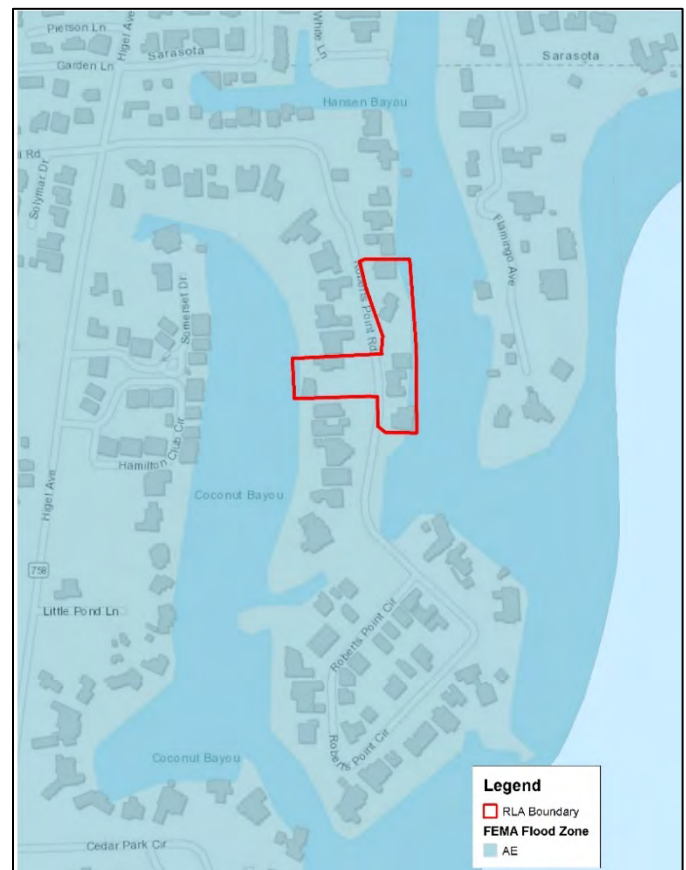
Figure 3: Spatial Distribution of Structures vs Flood Zone

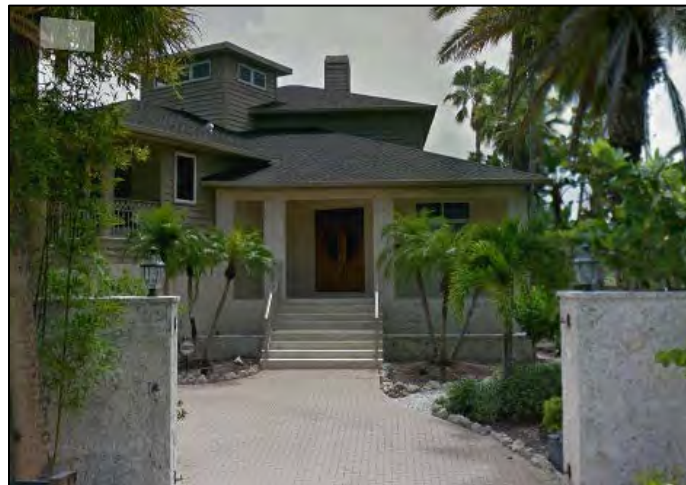
Figure 4: Elevated Structure (Google Maps)

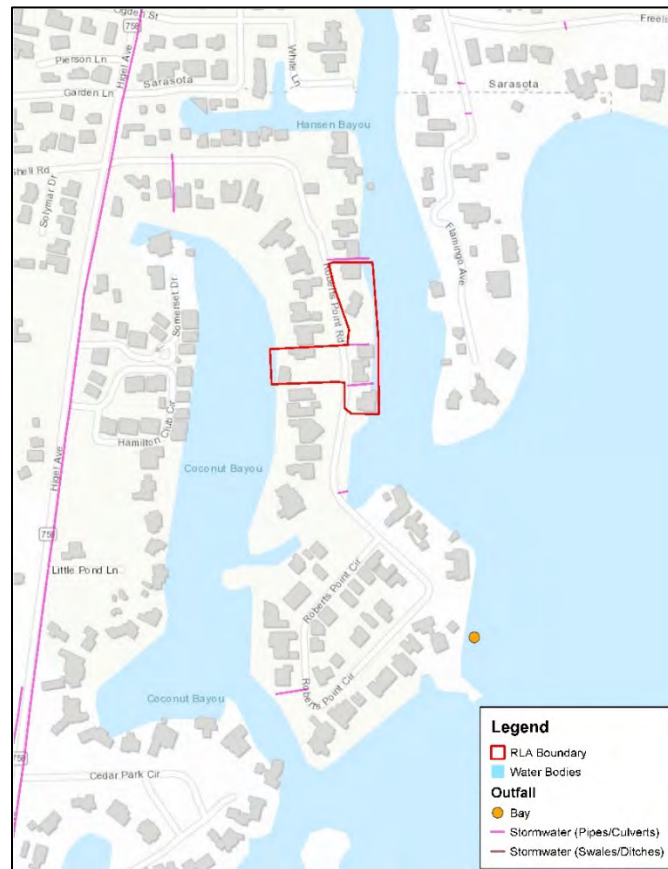
The stormwater system includes three (3) Bay outfalls with inlets on Roberts Point Road that collects runoff conveyed via piping between lots to the immediately adjacent Hansen Bayou (bayside bayou). This RLA is a particularly low-lying area along the narrow peninsula leading to Roberts Point and all streets are extremely low in elevation. Review of stormwater complaints and resident comments indicate the inlets in this area must be regularly maintained to avoid low-level flooding during high rainfall events. Lots along Roberts Point Rd have been built up over the years, with runoff accumulating in this low area, and during high tides, along with intense rainfall events, stormwater system backup can occur. While there were some normal system maintenance issues observed during the field work, these areas appear to be routinely maintained by County staff based on review of the maintenance callouts. Low elevations of some slab on grade structures relative to the BFE (2.5 feet NAVD average lot elevation versus 10 feet NAVD BFE) indicate stormwater system improvements in this area are not expected to provide flood mitigation.

Figure 6: Distribution of Stormwater System Infrastructure

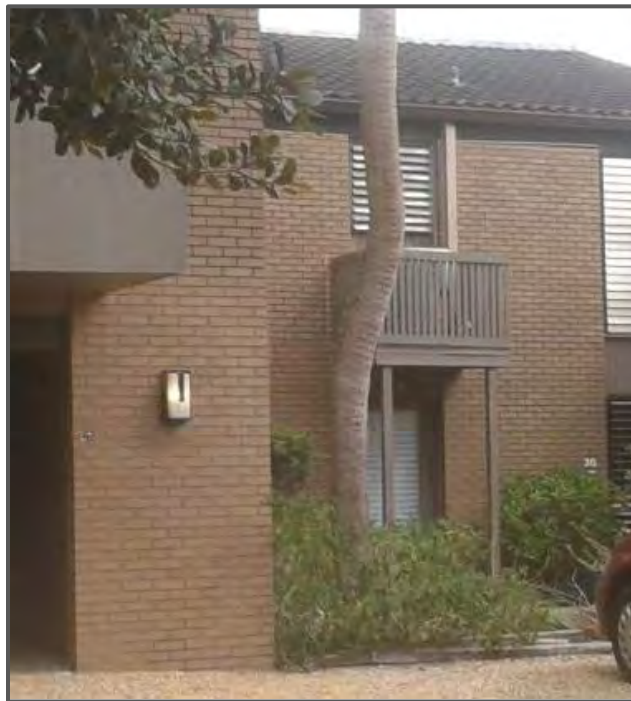
Figure 2: Slab on Grade Multi-Family Structure

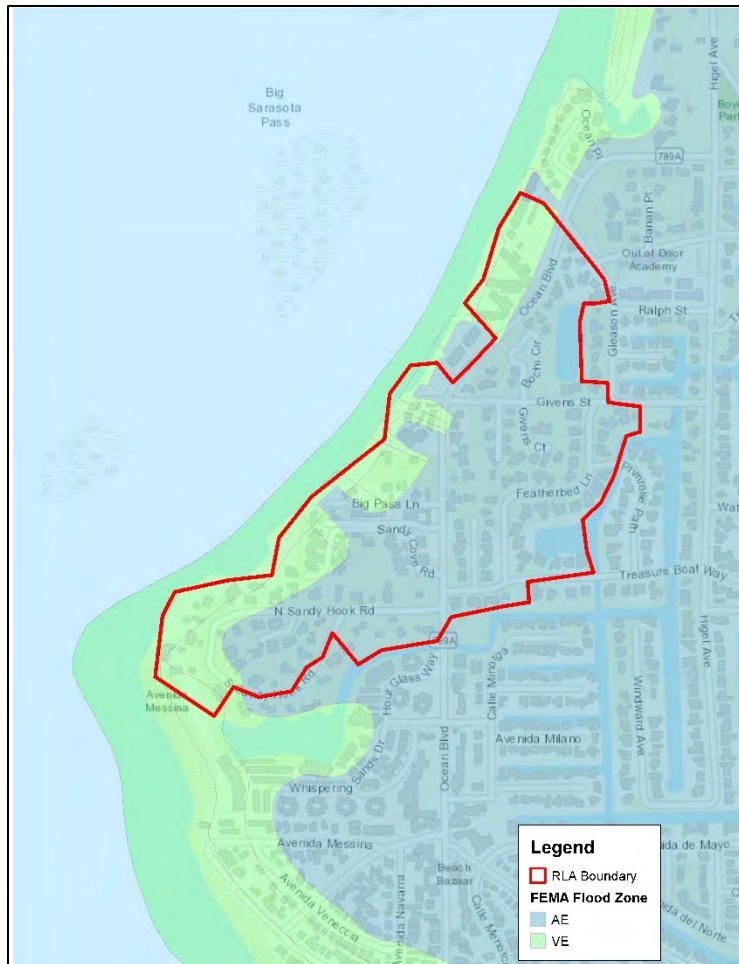
Figure 3: Spatial Distribution of Structures vs Flood Zone

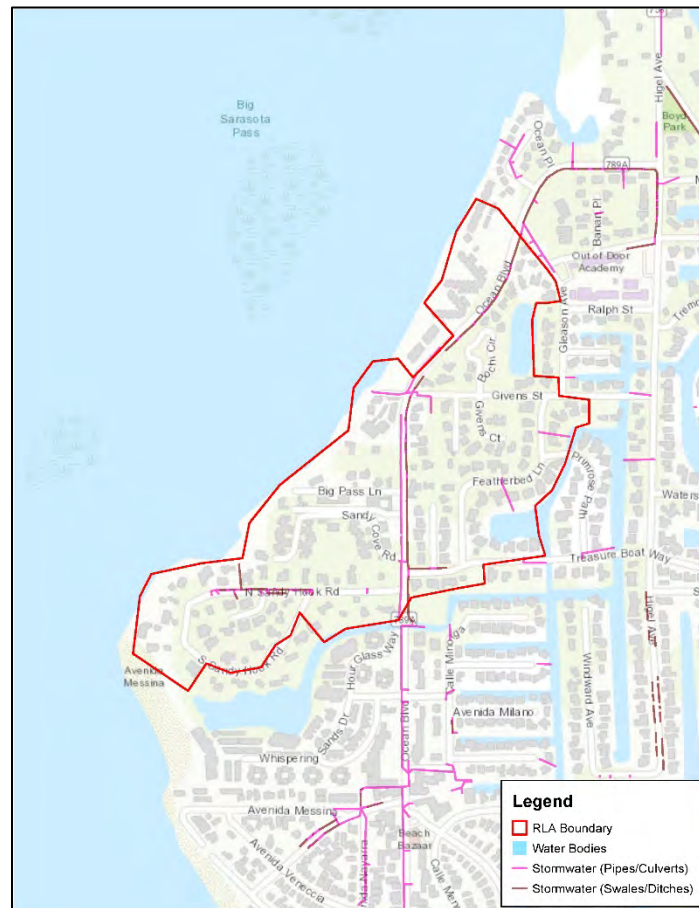
The stormwater utility infrastructure is concentrated primarily along Ocean Boulevard running north/south, with outfalls to both the Gulf and the canal system on the Bay side. Recent sidewalk improvements on portions of Ocean Blvd. also appear to have included street drains and other stormwater improvements. Stormwater conveyances on the side streets are limited, with numerous lots being below street grade. There are six (6) outfalls to the bay-side canal system and four (4) outfalls to the Gulf of Mexico, which includes the two (2) Gulf outfalls just outside the RLA that provide drainage to the north portion of the area. There are also eight (8) stormwater ponds, many of which are County-maintained ponds, while others appear to be part of the stormwater management system for private developments. Only two (2) of these private ponds show connections to the County's stormwater system. Maintenance of the private stormwater systems is the responsibility of the owners (typically HOAs).

Figure 6: Distribution of Stormwater System Infrastructure

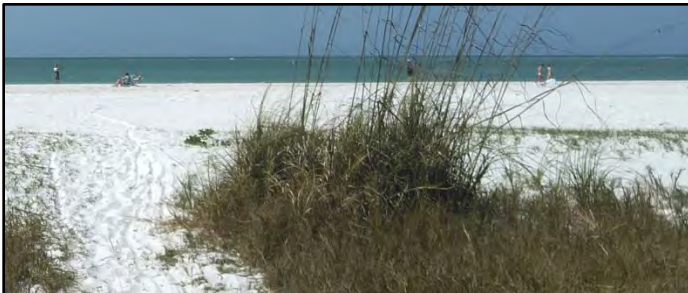
Figure 2: Adjacent to Open Beach & Coastal Dunes

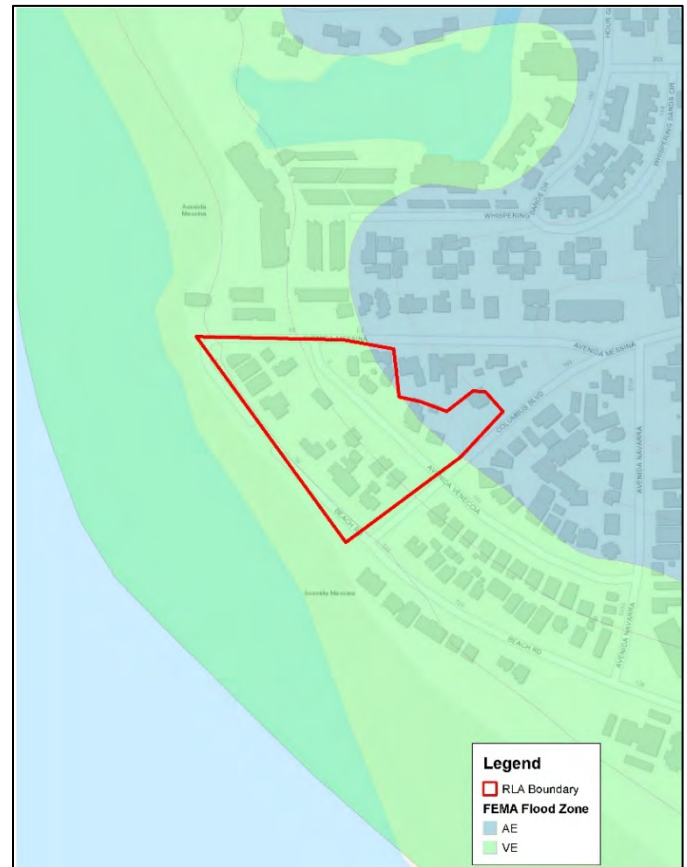
Figure 3: Spatial Distribution of Structures vs Flood Zone

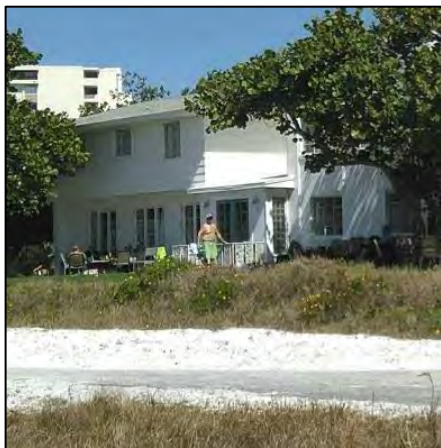
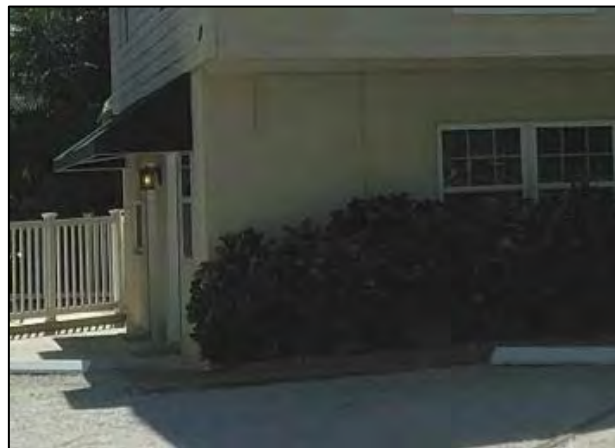
Figure 4: Structure Located Adjacent to Coastal and Slab on Grade Structures Beaches

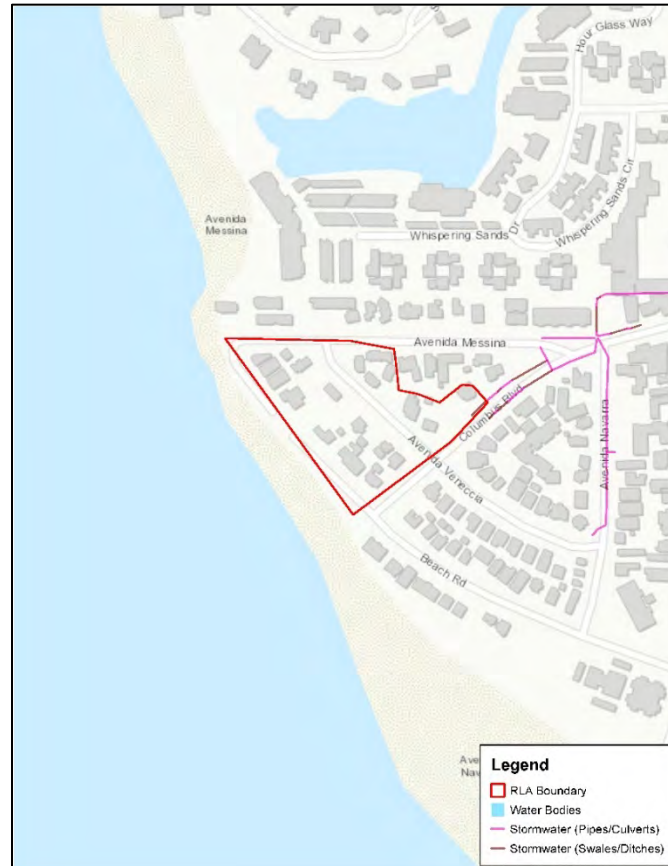
The stormwater system includes conveyance swales and piping but is limited to the east end of the area along Columbus Blvd., where it collects runoff from adjacent properties and then conducts it via piping to one (1) Bay outfall at the canal system. Streets in this area are extremely low in elevation, for the most part sloping to the east along Avenida Messina and Columbus Blvd. The intersection of Beach Rd and Columbus Blvd is a low spot acting like an outfall, likely discharging directly to the Gulf. Review of stormwater complaints indicate that this is a frequent location where sand accumulates and must be regularly maintained. This location is essentially a gap in what little frontal dune remains and is a source of inundation and stormwater backup during periods of unusually high tides, storm surge, and wave action. Because of the low elevations of structures relative to the BFE (5.9 feet NAVD average FFE versus 13 feet NAVD BFE), stormwater system improvements in this area are not expected to provide mitigation.

Figure 6: Distribution of Stormwater System Infrastructure

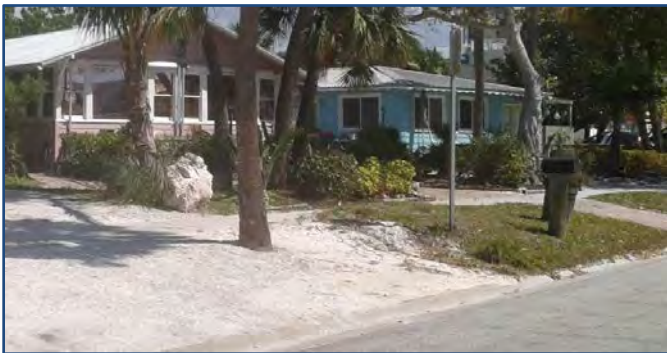
Figure 2: Minimally Elevated Structure Adjacent to Coastal Beaches

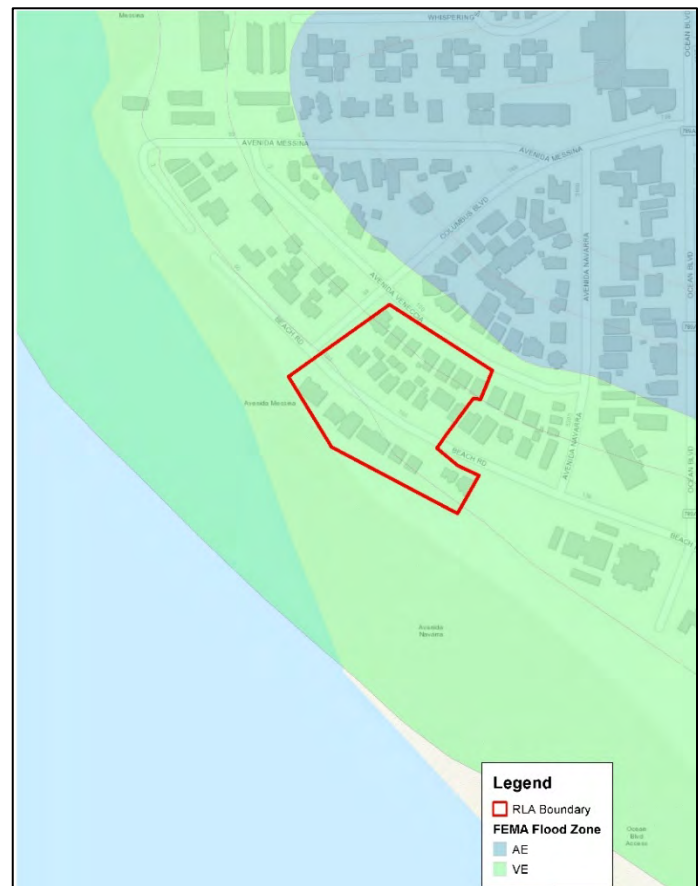
Figure 3: Spatial Distribution of Structures vs Flood Zone

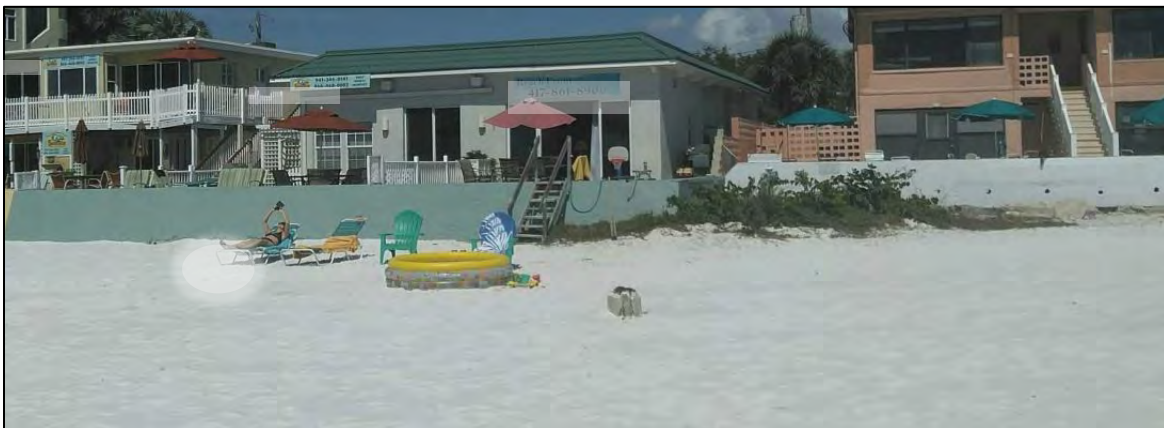
Figure 4: Minimally Elevated Structure Adjacent to Coastal Beaches

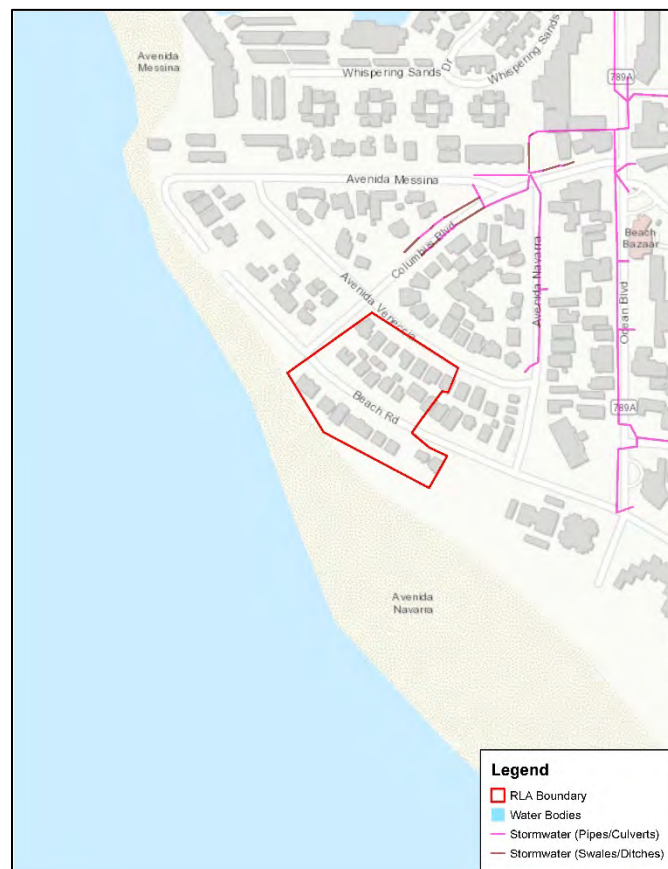
Figure 6: Distribution of Stormwater System Infrastructure

The stormwater system appears to be essentially sheet flow from lots to Beach Rd; then the street conveys the stormwater to the Beach Rd./Columbus Blvd. intersection, where it outfalls directly to the Gulf. It appears that the lots on the south side of Avenida Venecia also may drain to this street, in which case the runoff will get into the Avenida Messina and Columbus Blvd. stormwater conveyance swales, where it collects runoff from adjacent properties then travels via piping to one (1) Bay outfall at the canal system. Streets in this area are extremely low in elevation, for the most part sloping to the east along Avenida Messina and Columbus Blvd. The intersection of Beach Rd. and Columbus Blvd. is a low spot on Beach Rd., which appears to discharge directly to the Gulf. Review of stormwater complaints and maintenance requests indicate this is a frequent location where sand accumulates and must be regularly maintained. This location is essentially a gap in what little frontal dune remains and is a source of inundation and stormwater backup during periods of unusually high tides, storm surge, and wave action. FEMA guidelines suggests that beach re-nourishment activities focusing on natural dune replenishment may reduce the risk of flooding and could be a mitigation alternative. However, because of the low elevations of structures relative to the BFE (6.0 feet NAVD average FFE versus 14 feet NAVD BFE), stormwater system improvements and dune restoration in this area are not expected to provide mitigation.

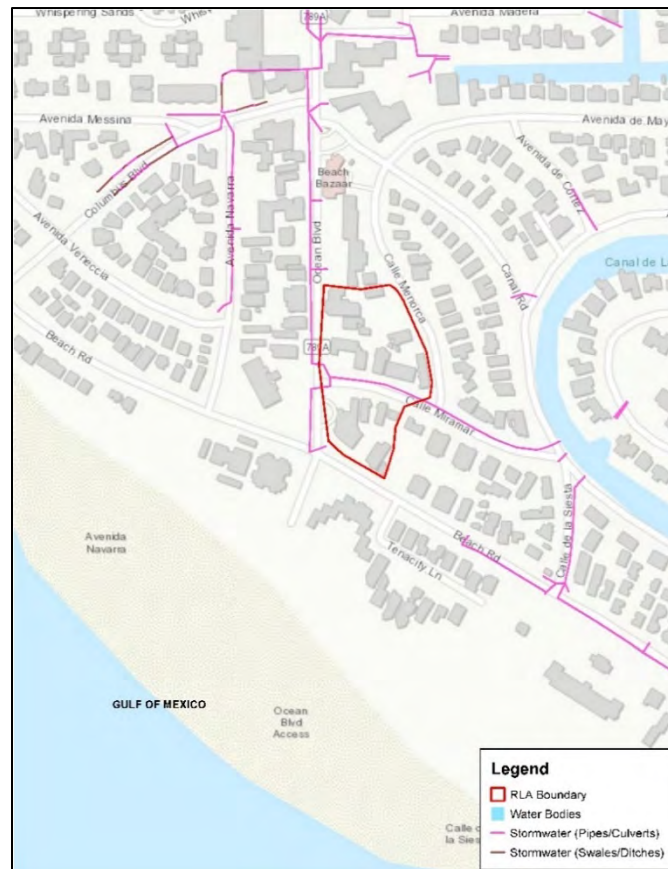
Figure 6: Distribution of Stormwater System Infrastructure

The stormwater infrastructure system along Calle Miramar conveys runoff to the east, to the nearby Bay outfalls into the Palm Island canal system. Inlets and piping system on Ocean Blvd. convey stormwater north to more distant canal outfalls. The streets are lower elevation than the surrounding property grades, particularly at the Calle Miramar/Calle Menorca intersection, which become the conveyance for flood waters. There are five (5) outfalls to the bay-side canal system, and the nearest one to Palm Island canal system is in a significantly lower elevation at the intersection of Canal Rd. and Calle Miramar. Regrading of the lots away from the structures may provide some mitigation but likely not much because of the low elevations of structures relative to the BFE (6 feet NAVD average FFE versus 14 feet NAVD BFE).

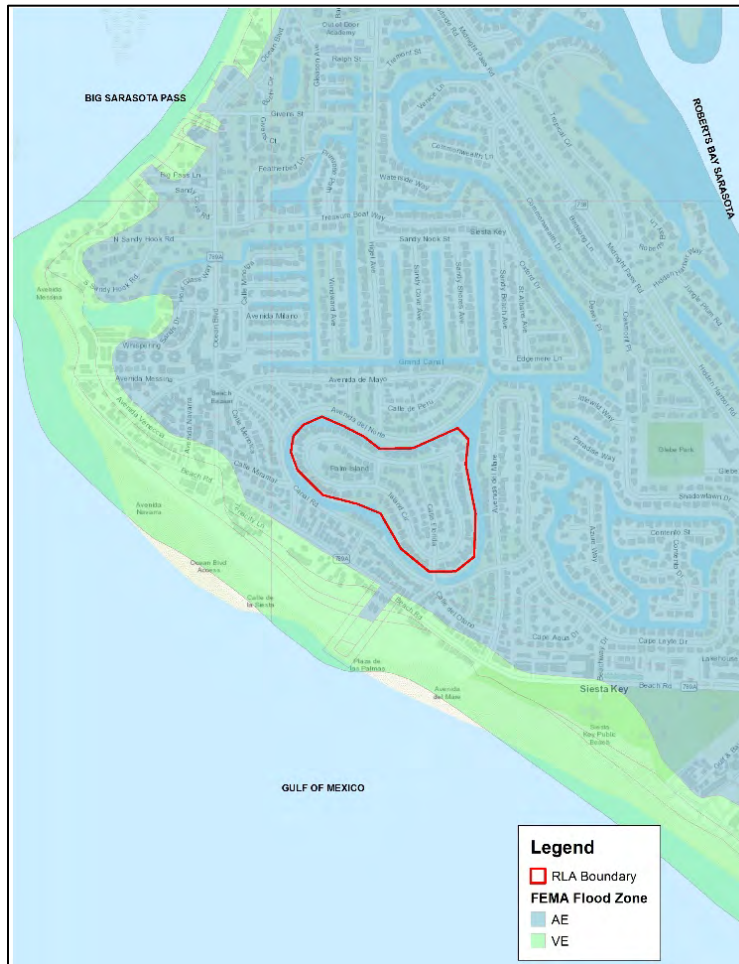
Figure 3: Spatial Distribution of Structures vs Flood Zone

Total	Repetitive Loss Data
142	Total Structures in Repetitive Loss Area
10	Total Repetitive Loss Structures in this Area
106	Properties w/Active Insurance Policies
3	Mitigated RL and SRL Properties
7	Unmitigated RL and SRL Properties
75	Insurance Claims (since 1978)
\$595.6	Total Insurance Claims (in thousands)
\$7.94	Average Insurance Claim (in thousands)

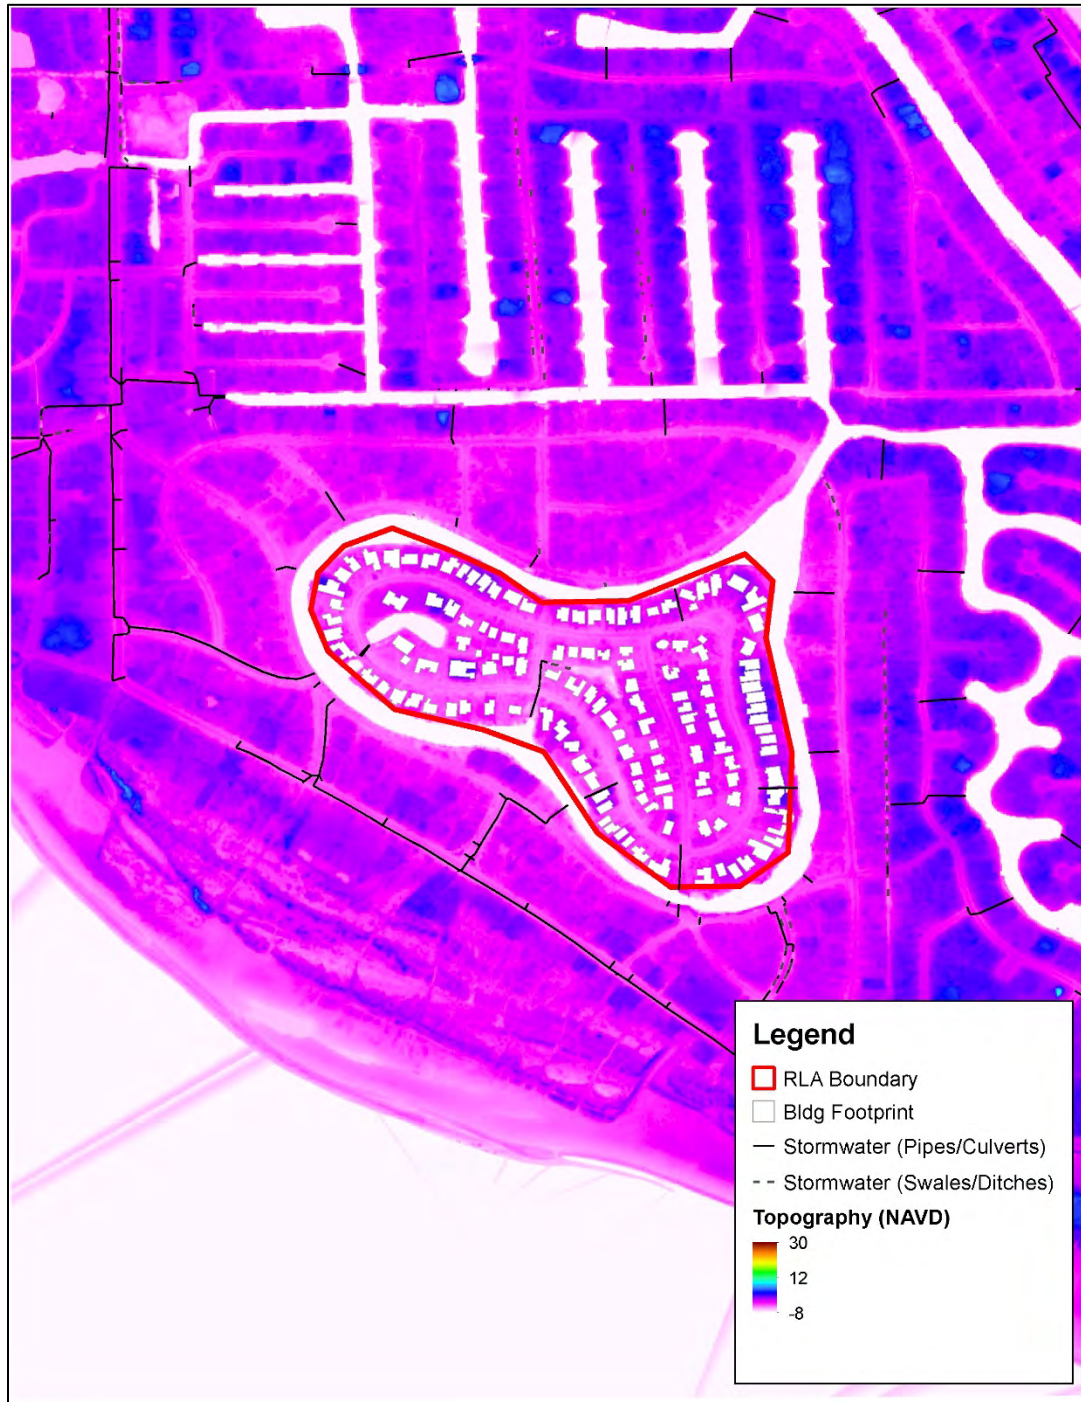
Figure 5: Topography, Drainage, and Existing Grades at Base of Structures

Review of insurance claims data reveals that flood damage coincides with storm events with 6 or more inches of rainfall, exacerbated by unusually high tides and high winds. These effects have likely caused flood inundation from the Bay and prevented normal rainfall runoff and stormwater drainage from these low elevation areas into the Bays. The extremely low elevations of the pre-FIRM structures make it unlikely stormwater improvements alone would mitigate flood risk to these structures. Figure 5 provides spatial context for the structures within the RLA in terms of topography, drainage infrastructure, and existing grades at the base of each structure.

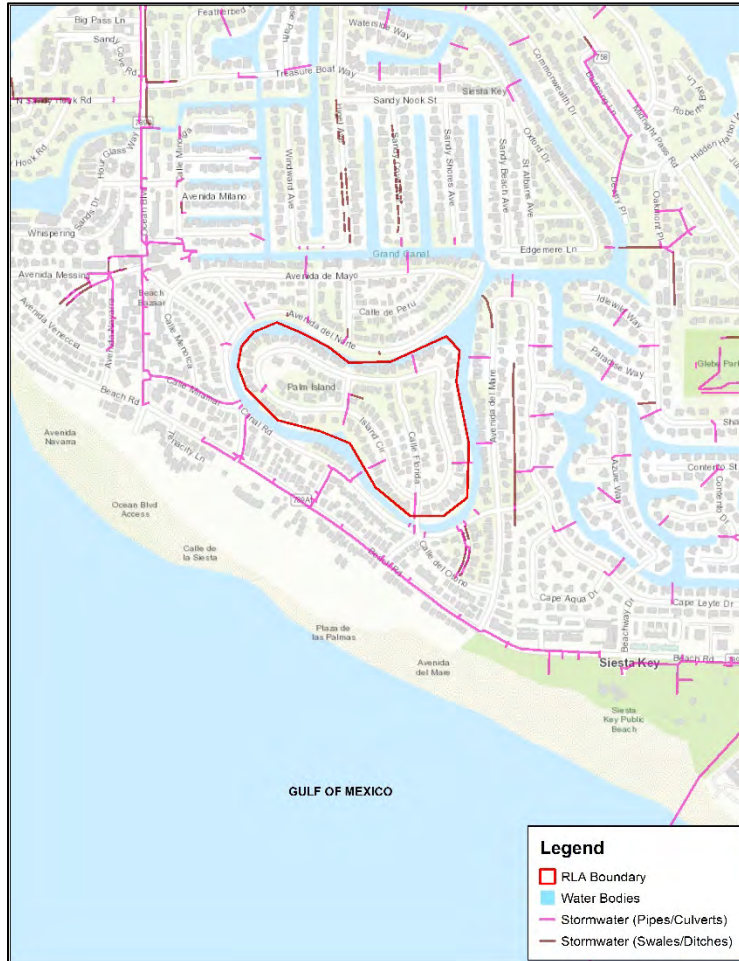
Figure 6: Distribution of Stormwater System Infrastructure

The stormwater utility infrastructure within the RLA includes a combination of swales, storm pipes, and a wet retention pond that discharges through six (6) outfall structures into the Bay Canal. Resident surveys reported no flooding in structures and limited flooding in yards. Regrading away from the structures towards the stormwater system may provide mitigation for flooding. However, with the average elevation of existing grades (2.9 feet NAVD) versus the BFE (9 feet NAVD), such improvements would not provide mitigation for flooding from major storm events.

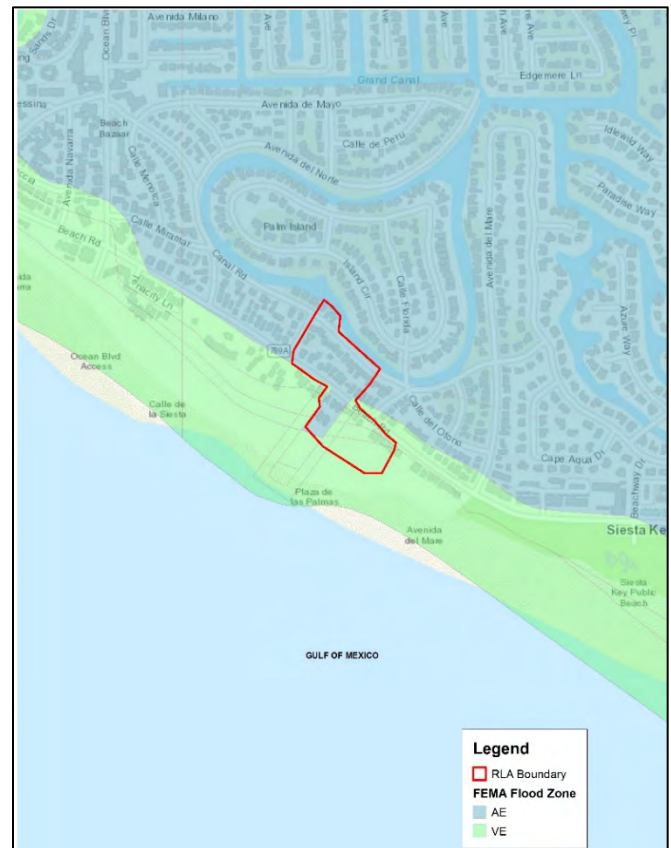
Figure 3: Spatial Distribution of Structures vs Flood Zone

Total	Repetitive Loss Data
44	Total Structures in Repetitive Loss Area
4	Total Repetitive Loss Structures in this Area
35	Properties w/Active Insurance Policies
0	Mitigated RL and SRL Properties
4	Unmitigated RL and SRL Properties
14	Insurance Claims (since 1978)
\$151	Total Insurance Claims (in thousands)
\$10.78	Average Insurance Claim (in thousands)

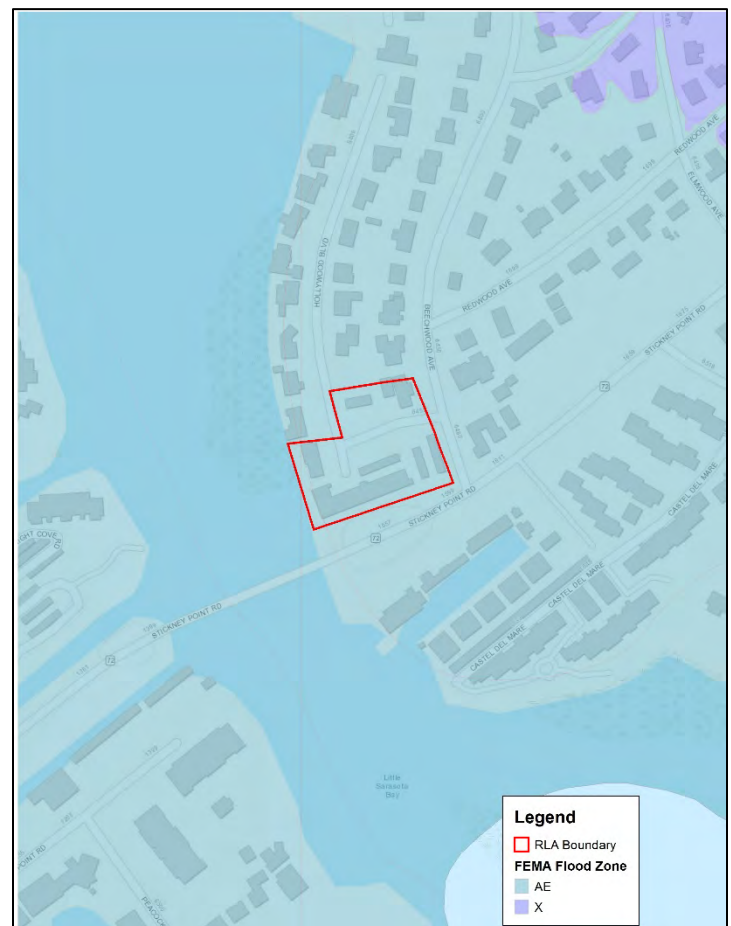
Figure 3: Spatial Distribution of Structures vs Flood Zone

Total	Repetitive Loss Data
7	Total Structures in Repetitive Loss Area
1	Total Repetitive Loss Structures in this Area
1	Properties w/Active Insurance Policies
0	Mitigated RL and SRL Properties
1	Unmitigated RL and SRL Properties
5	Insurance Claims (since 1978)
\$12	Total Insurance Claims (in thousands)
\$1.20	Average Insurance Claim (in thousands)

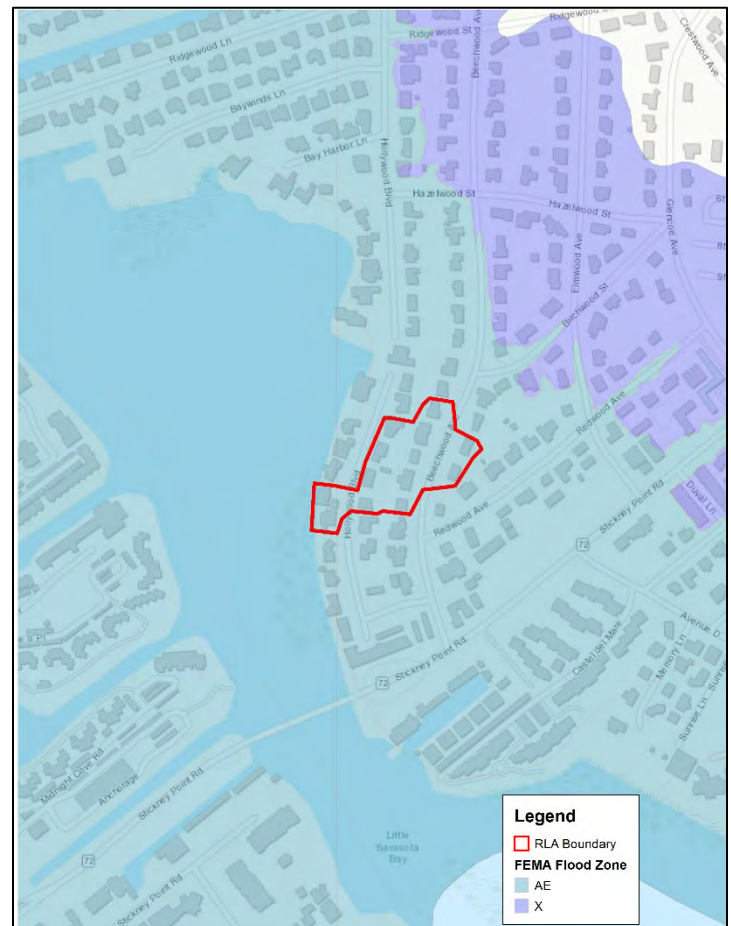
Figure 3: Spatial Distribution of Structures vs Flood Zone

Total	Repetitive Loss Data
14	Total Structures in Repetitive Loss Area
1	Total Repetitive Loss Structures in this Area
11	Properties w/Active Insurance Policies
0	Mitigated RL and SRL Properties
1	Unmitigated RL and SRL Properties
3	Insurance Claims (since 1978)
\$19.3	Total Insurance Claims (in thousands)
\$6.4	Average Insurance Claim (in thousands)

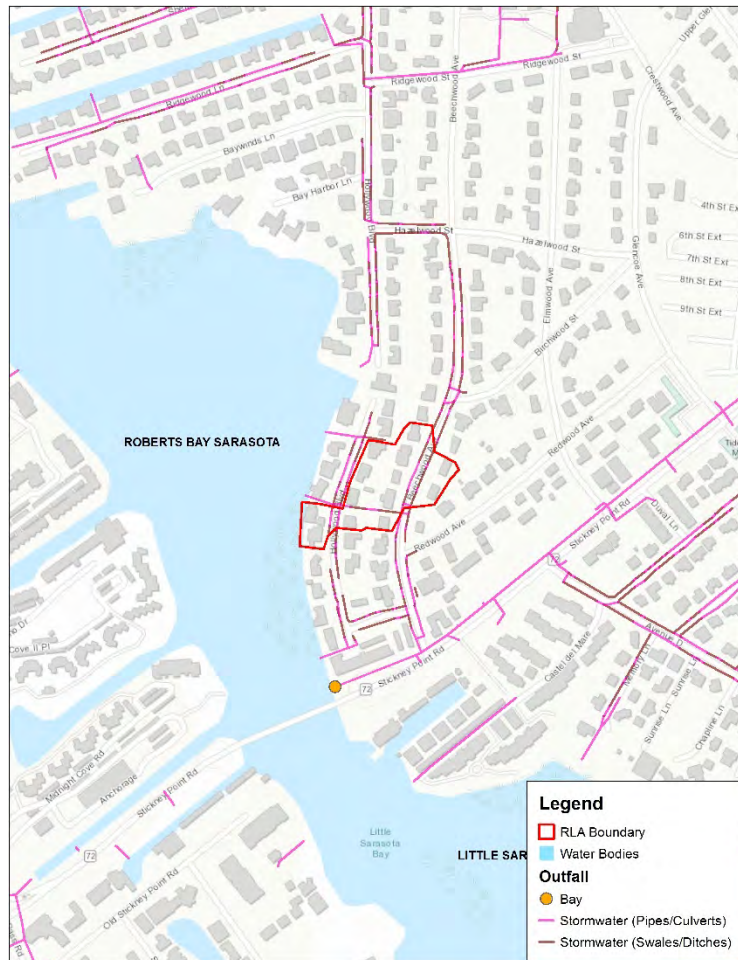
Figure 6: Distribution of Stormwater System Infrastructure

The stormwater utility infrastructure within the RLA includes a collection of swales, and storm pipes along Beechwood Ave and Hollywood Blvd that direct stormwater to one (1) outfall structure discharging into Roberts Bay. The stormwater infrastructure in this area appears to be in working condition and is part of the County's maintained systems. There is no stormwater expansion proposed as mitigation for this RLA.

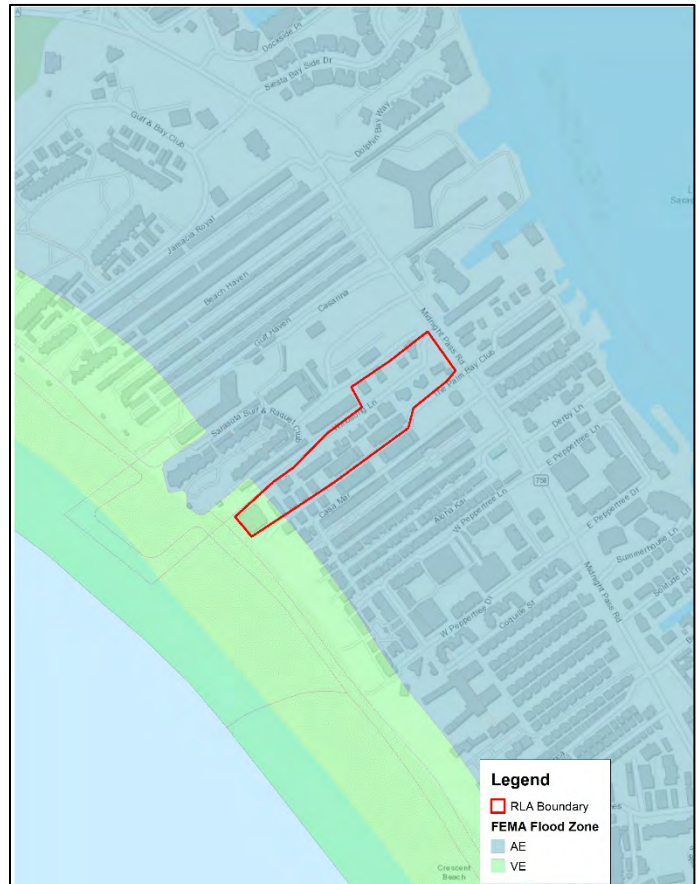
Figure 3: Spatial Distribution of Structures vs Flood Zone

Total	Repetitive Loss Data
25	Total Structures in Repetitive Loss Area
4	Total Repetitive Loss Structures in this Area
10	Properties w/Active Insurance Policies
0	Mitigated RL and SRL Properties
4	Unmitigated RL and SRL Properties
18	Insurance Claims (since 1978)
\$98	Total Insurance Claims (in thousands)
\$4.28	Average Insurance Claim (in thousands)

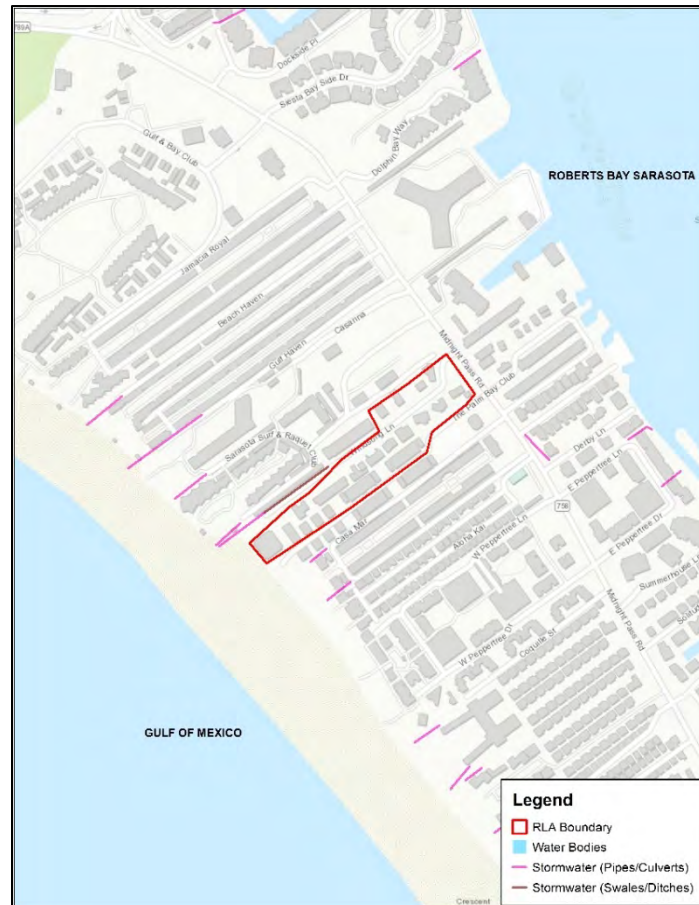
Figure 6: Distribution of Stormwater System Infrastructure

The stormwater utility infrastructure within the RLA is primarily limited to storm pipes and an outfall structure discharging stormwater directly to Gulf of Mexico. This RLA primarily consists of commercial development with private stormwater infrastructure. FEMA guidelines suggests that beach re-nourishment activities focusing on natural dune replenishment may reduce the risk of flooding and could be a mitigation alternative. However, the average elevation of existing grade relative to the BFE (4.7 feet NAVD versus 10 feet NAVD BFE), combined with the location on the beach within SFHA Zone VE, indicates stormwater system improvements and dune restoration in this area are not expected to provide flood mitigation.
