Re: Town of Longboat Key Consent Order OGC 20-1261
Evaluation Summary Follow Up

Technical Memorandum

Subject Longboat Key Sewer Leak Consent Order – Final Evaluation Summary

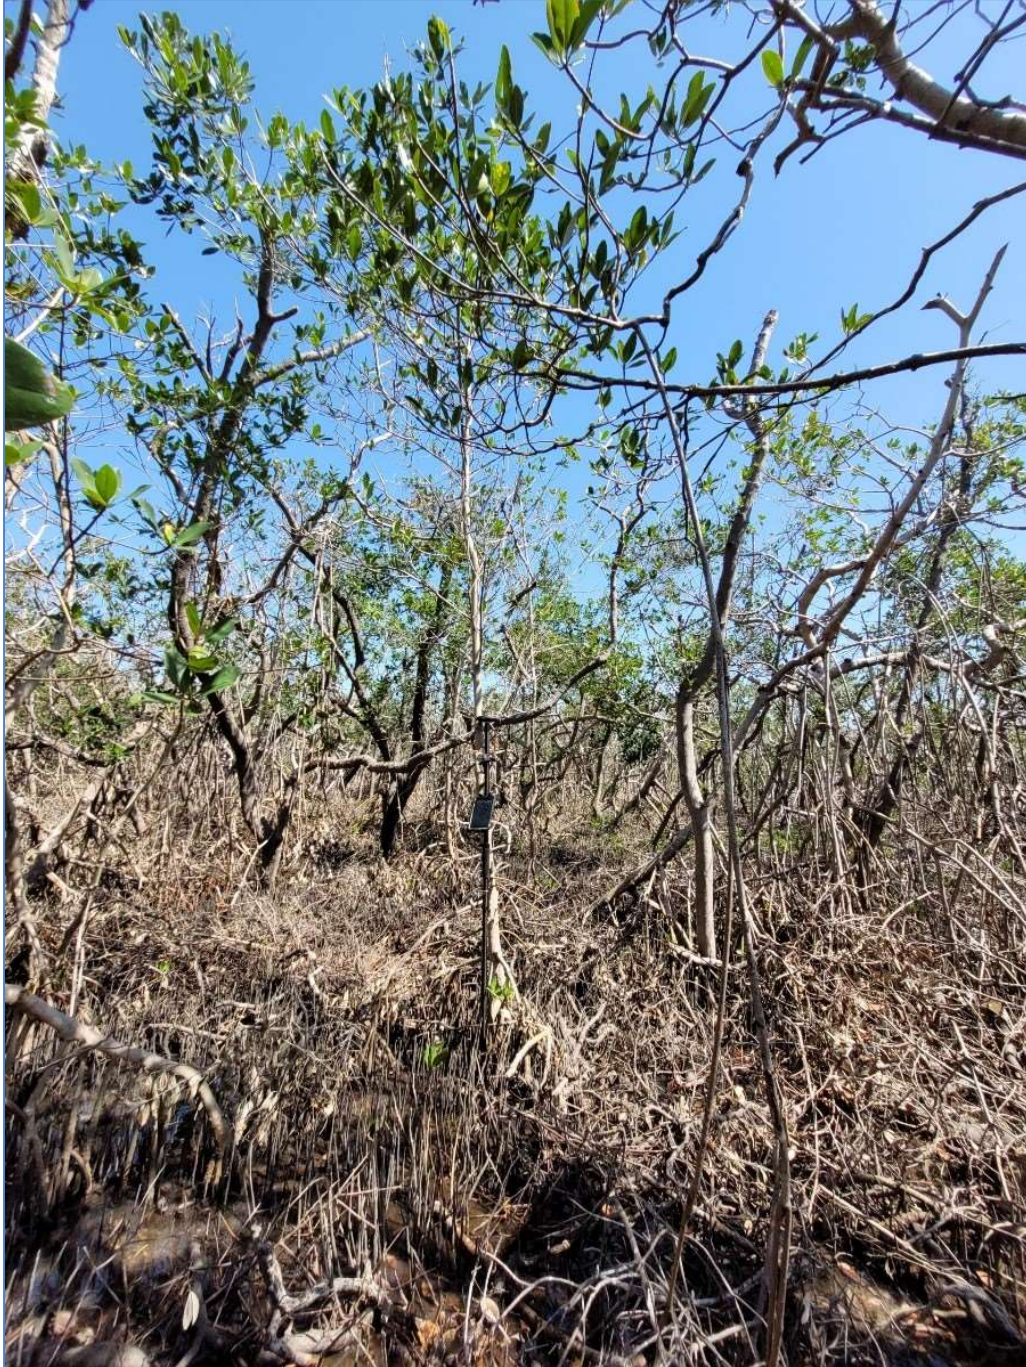
An anomalous visual signature was observed south and east of the previously delineated sewage leak impact area, and is depicted on **Figure 1**. This area was traversed in the field and quickly determined to be mangrove trees that had been trimmed and/or topped, and not an expansion of the sewage leak impact area. **Figure 2** shows a photograph of trimmed/topped mangroves in this area. The Long Bar Pointe Mitigation Bank Permit issued by FDEP authorizes mangrove trimming in this area, and the observed tree mangrove topping work is presumed to be consistent with this permit.

Figure 2 – Mangrove tree trimming/topping area southeast of the sewage leak impact area.

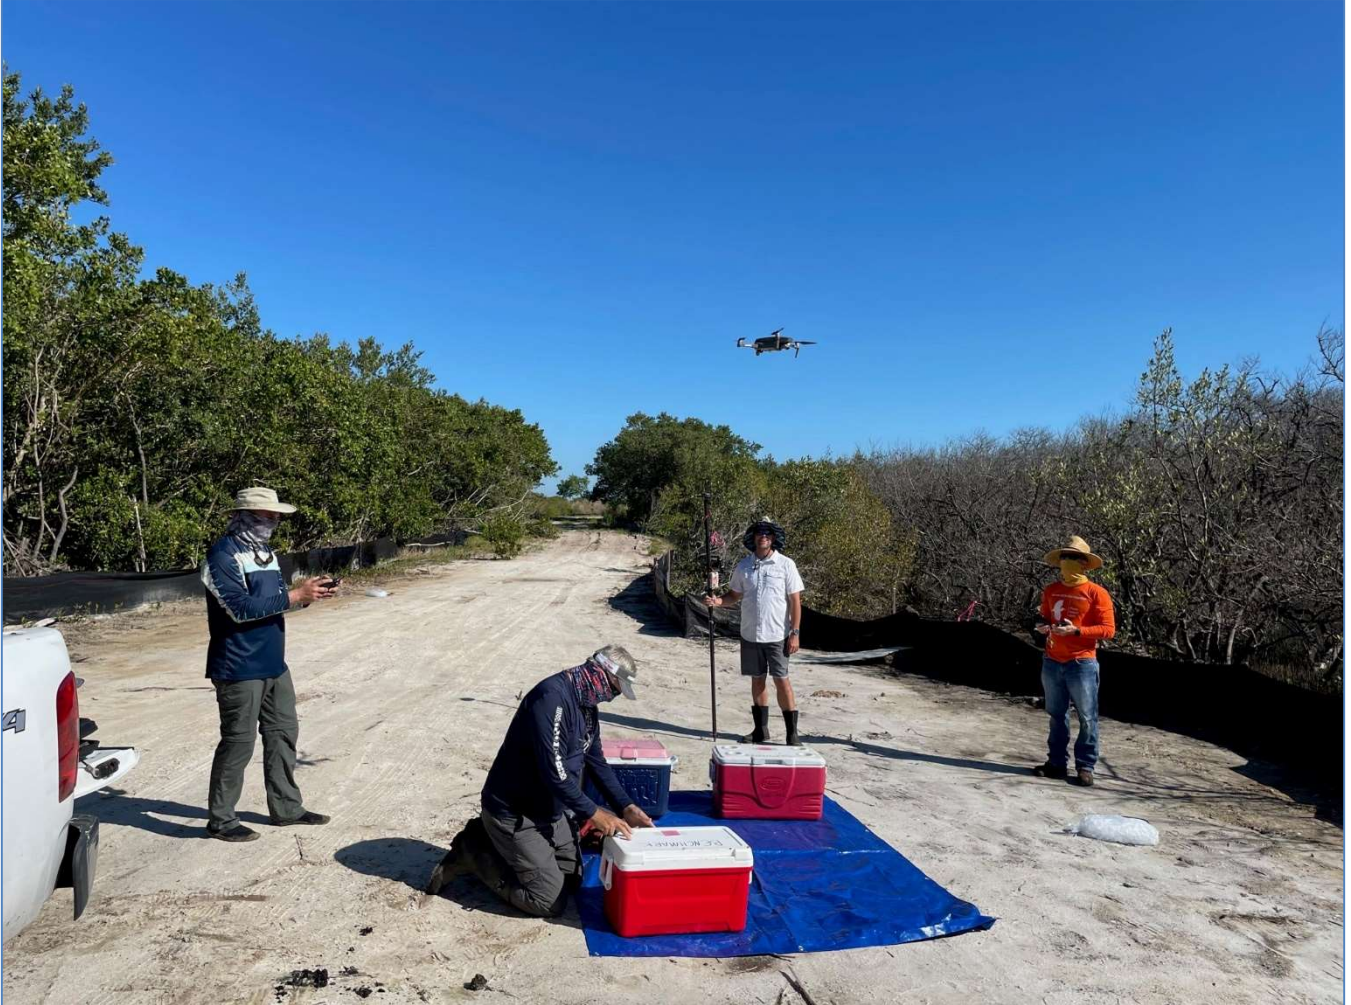
Since the sewer force main leak was repaired in July 2020, there has been no additional fill or clearing in this area. The fill road remains open and non-vegetated. Some new mangrove seedlings were observed in portions of the peripheral areas that were cleared but not filled. **Figure 3** shows a photograph of the fill road, and the ESA field team with the UAV drone in operation.

Figure 3 – ESA field team mobilizing on the access fill road with the UAV drone in flight.

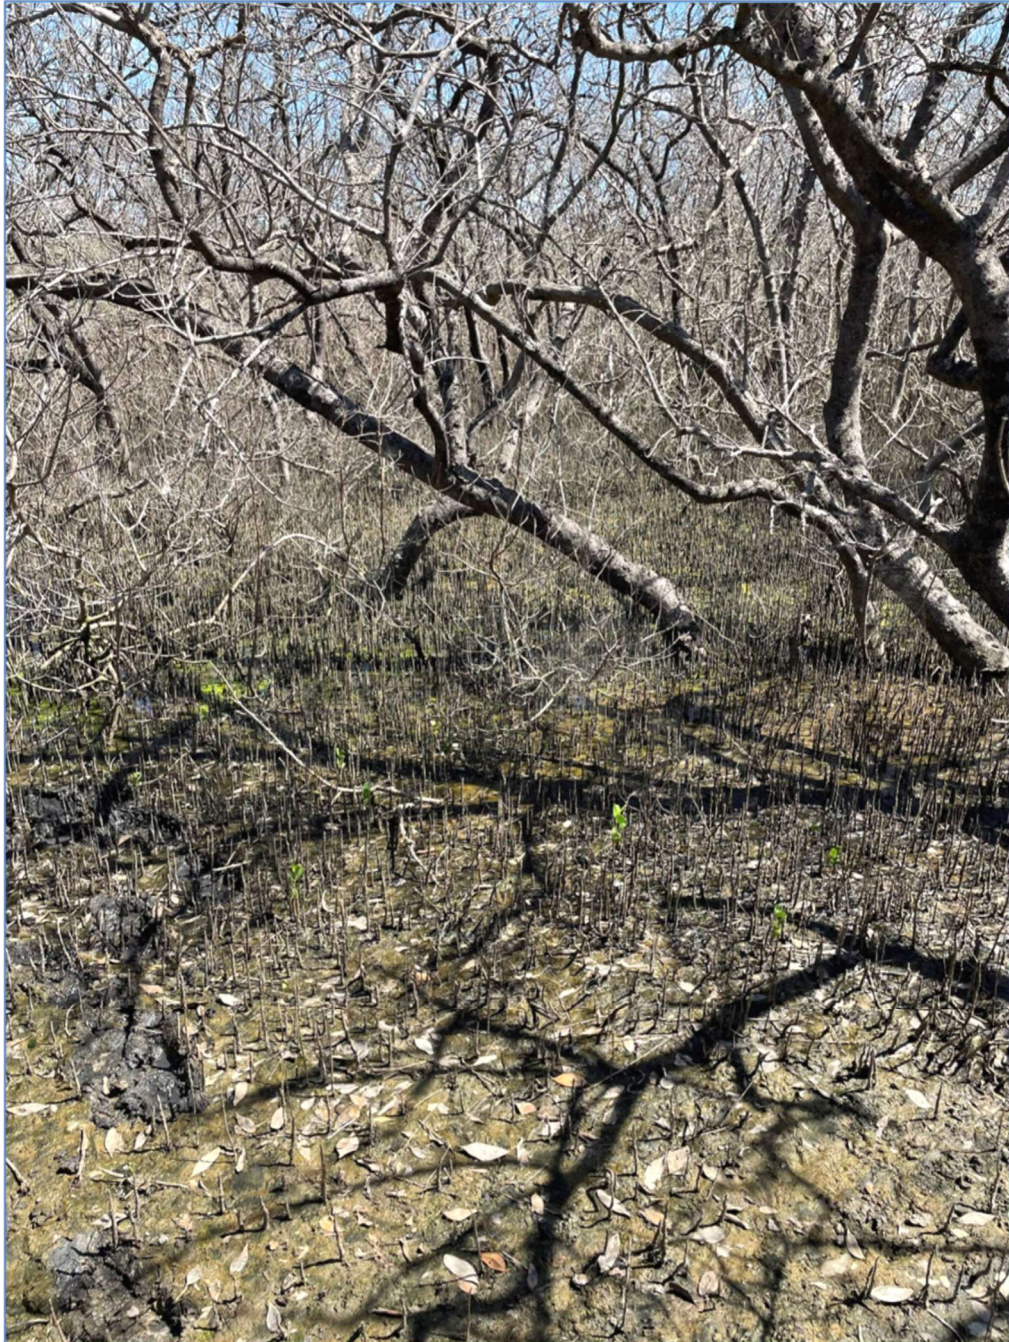
The limits of the sewage leak impact area appeared to be unchanged from that observed in September 2020 when ESA conducted the initial impact assessment. While traversing the sewage leak impact area, a Sulphur-like odor was detected, and portions of this area had a thin algal mat on the sediment surface. Virtually all mangrove trees within the center of the sewage leak impact area were dead or fully defoliated, and there was no indication of tree recovery, no recruitment of new mangrove seedlings, and no viable mangrove propagules in the majority of this area (**Figure 4**). There was also no growth or recruitment of halophytic herbaceous plant species, which often occurs in treefall or canopy loss gaps in mangrove forests.

Figure 4 – Sewage leak mangrove impact area.

It is recommended that the sewage leak impact area be restored using the following measures:

- Topping of dead mangrove trees to allow for greater sunlight exposure;
- Planting of 1-gallon nursery-grown mangroves on 3-foot centers distributed according to the pre-impact zonation of red, black and white mangroves; and
- Excavation of a shallow swale(s) hydrologically connecting the sewage leak impact area to Sarasota Bay, constructed within the existing force main easement, to increase tidal circulation and flushing, and to enhance natural recruitment of mangrove propagules.

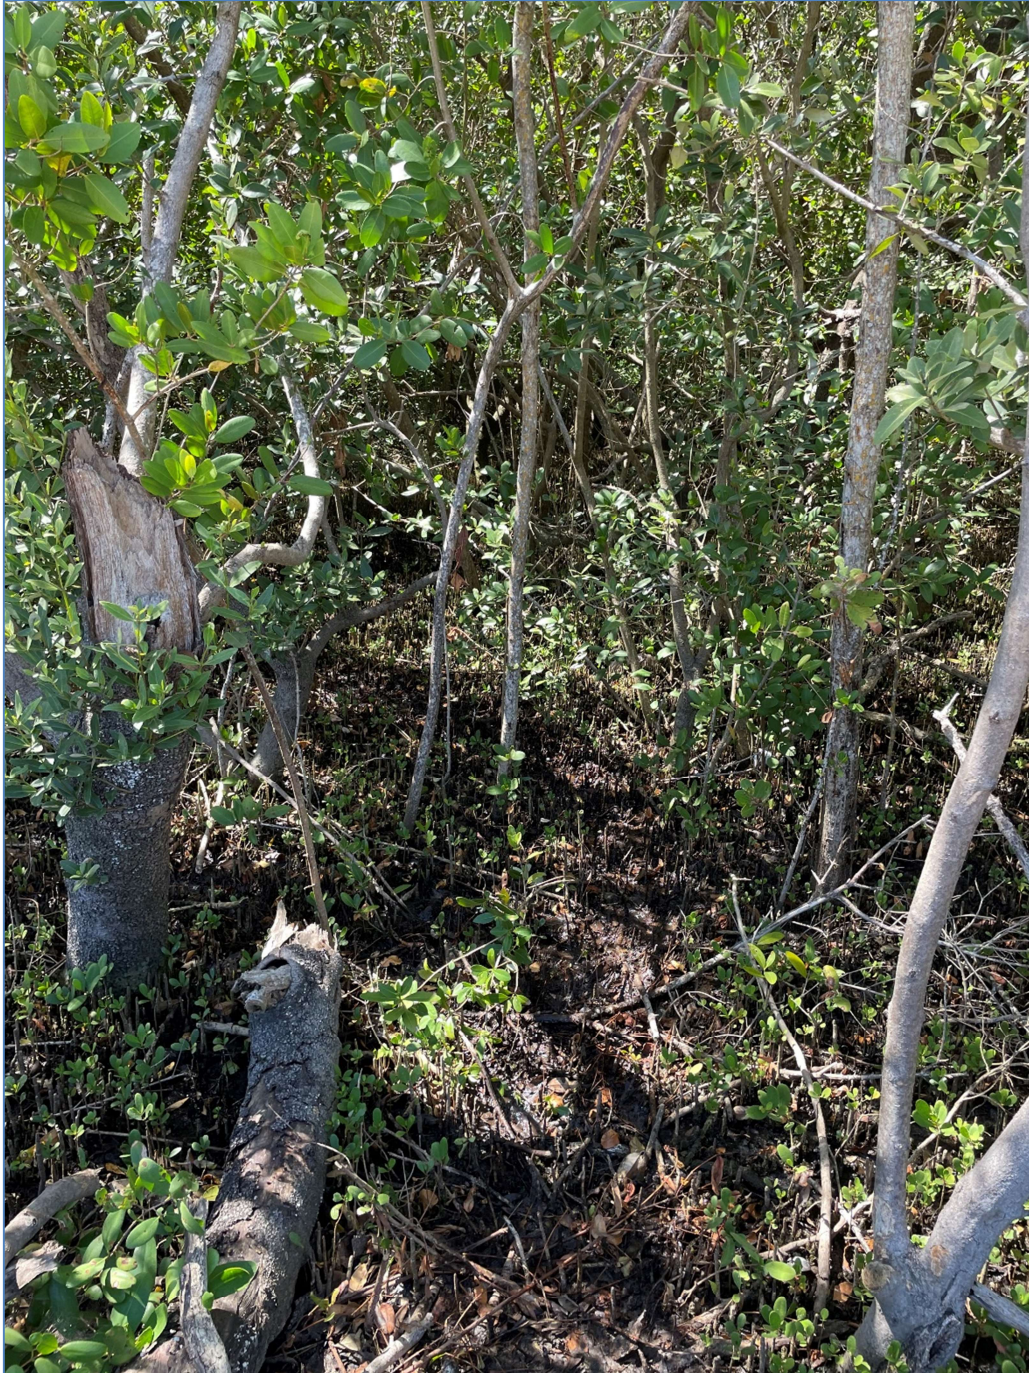
Compared to the un-impacted mangroves immediately west of the fill road (**Figure 5**), the sewage leak impact area was completely defoliated with no canopy cover and few or no healthy pneumatophores.

Figure 5 – Un-impacted mangrove control area.

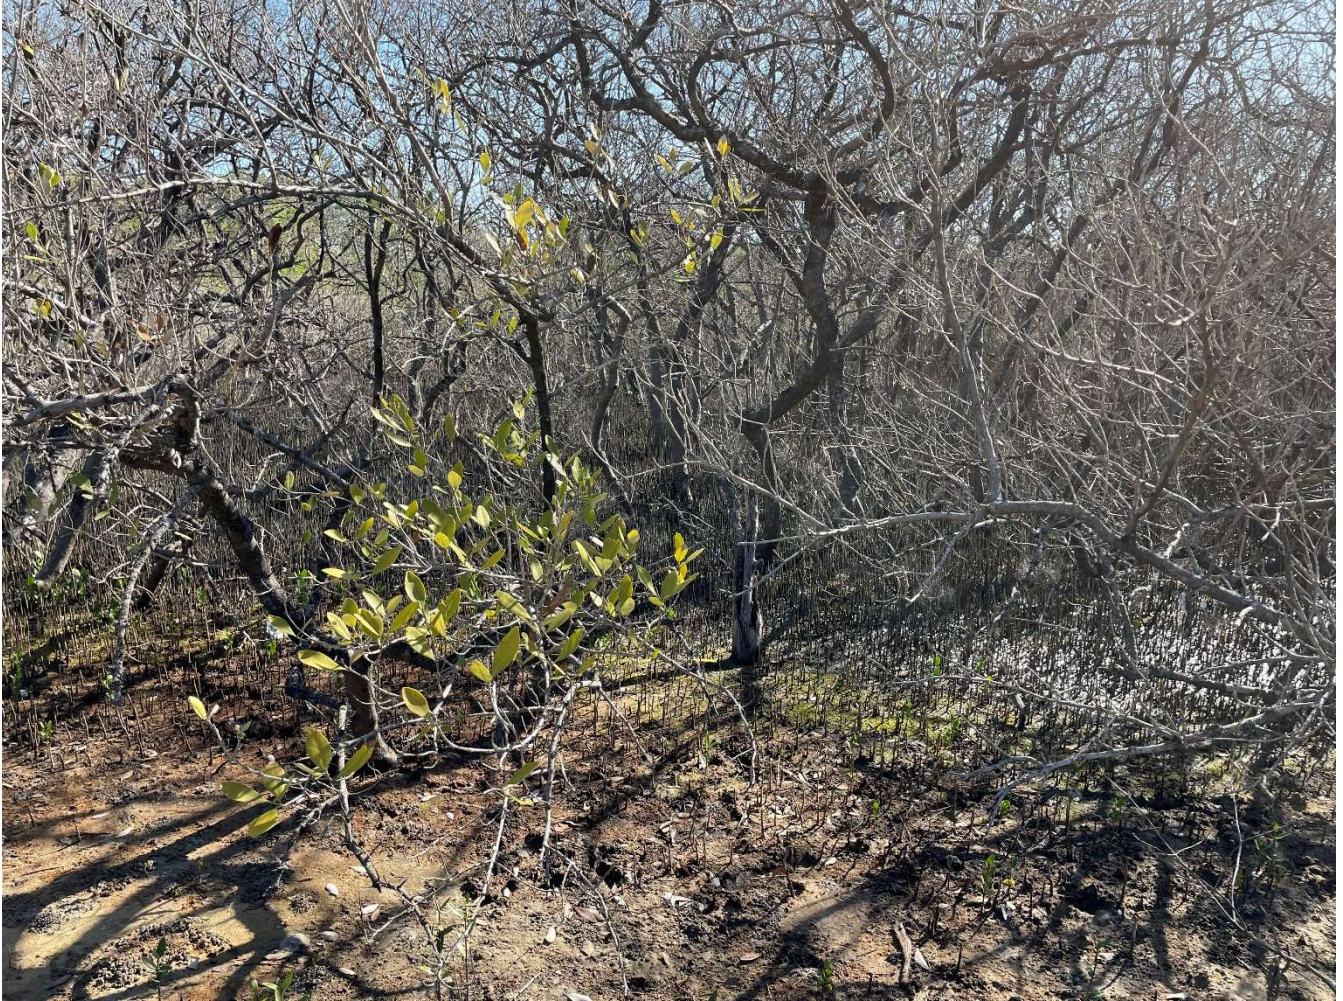
However, some smaller mangrove trees on the periphery of the sewage leak impact area, mostly on slightly elevated hummocks, did appear to be recovering with new leaves observed (**Figure 6**). The boundary between the sewage leak impact area and adjacent live mangroves could be clearly seen, both on the aerial imagery and on the ground (**Figure 7**).

Figure 6 – Recovering mangrove is sewage leak impact area.

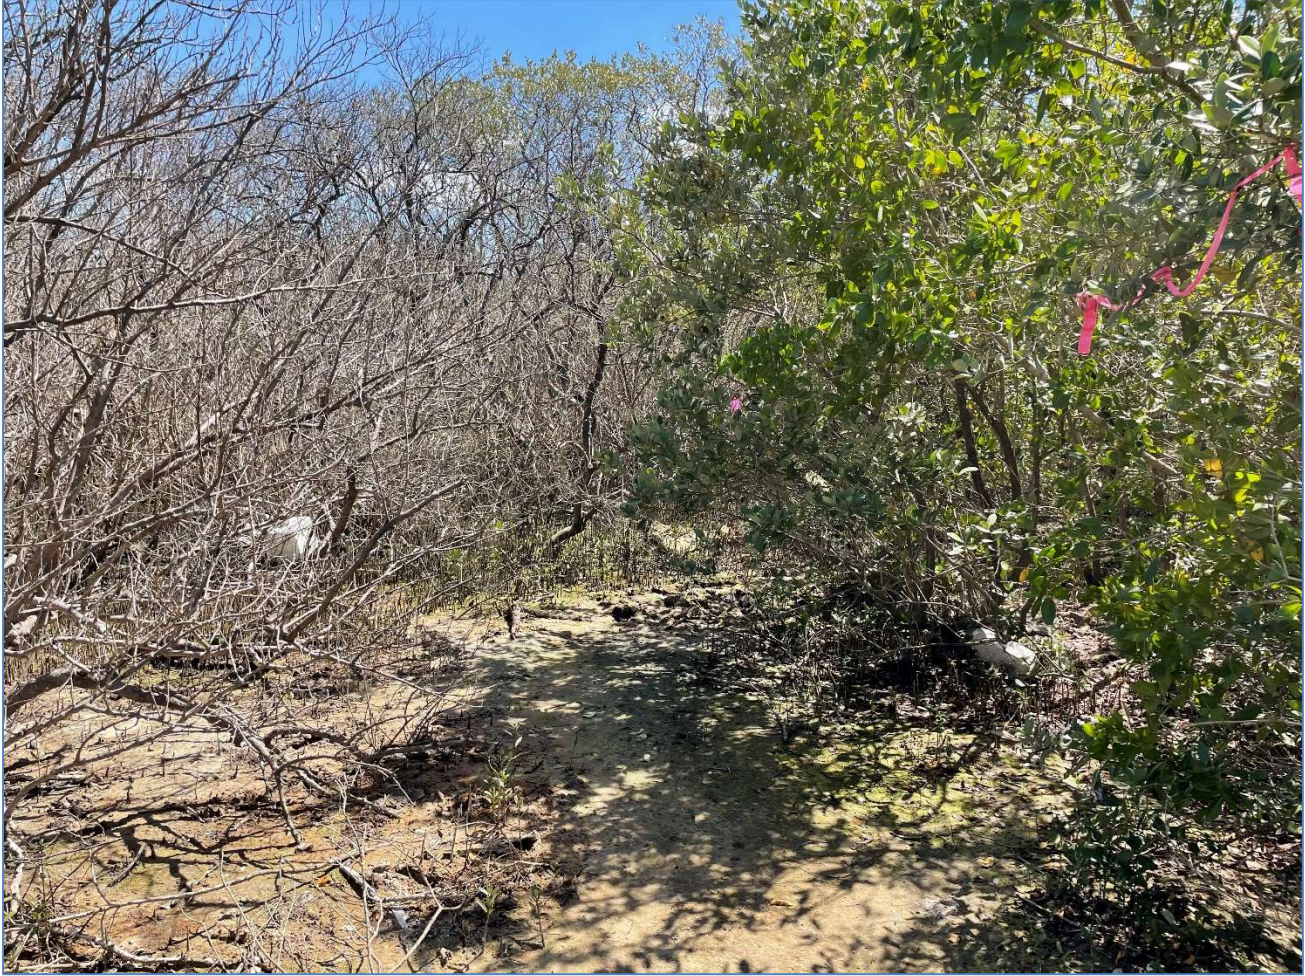
Figure 7 – Boundary of sewage leak impact area and un-impacted mangroves.

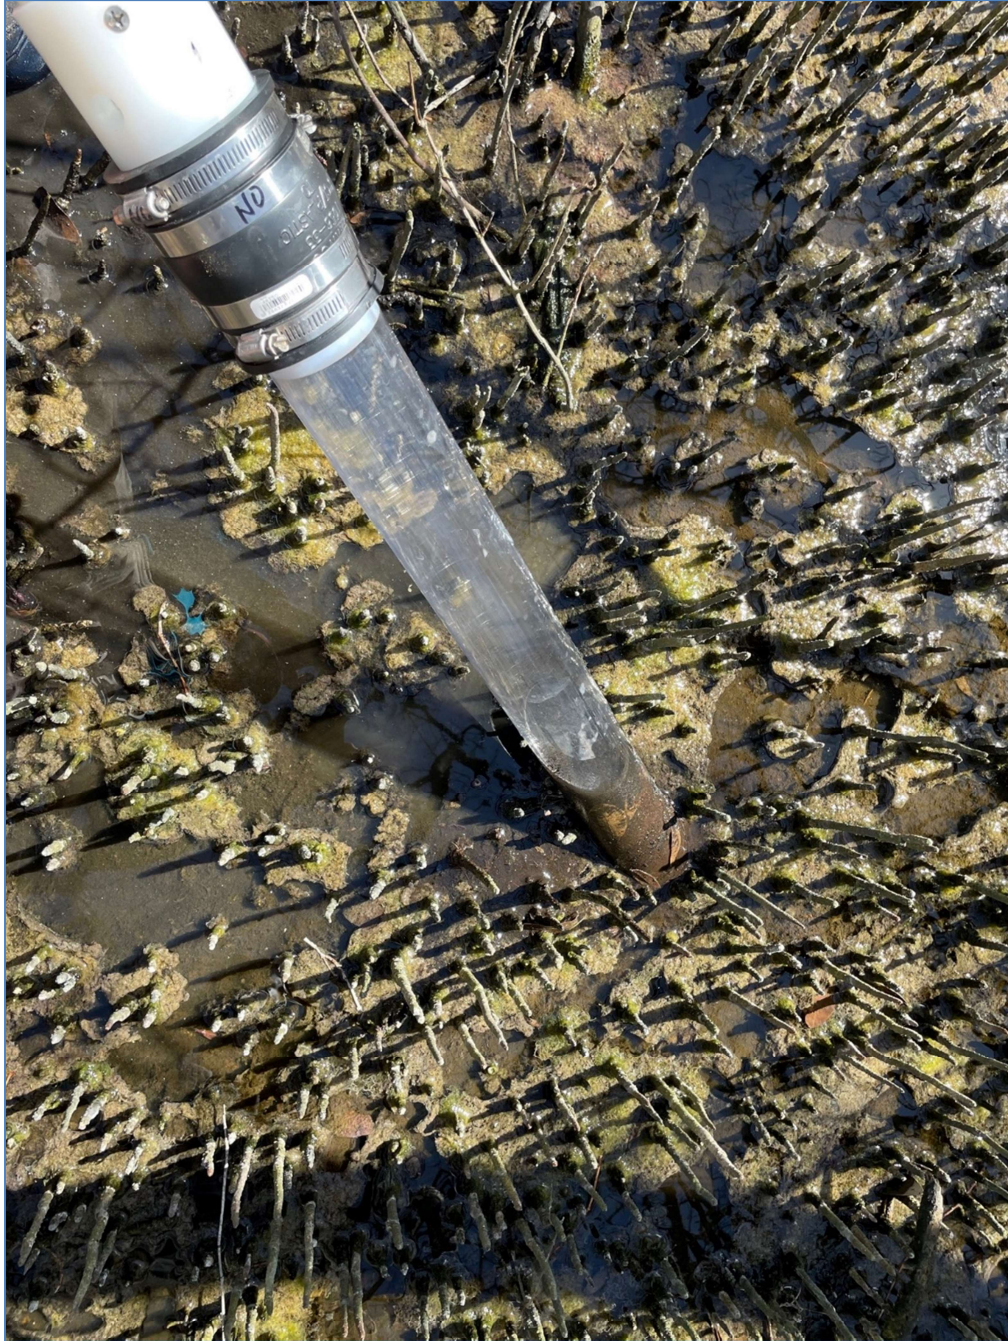
Sediment samples were collected using a 3-inch diameter polycarbonate suction sediment corer, as shown in **Figure 8**. The coring device was pushed into the surface sediments, between mangrove pneumatophores where feasible, until resistance was attained. Each sample typically collected the top 6-8 inches of sediments. Each sediment core sample was generally a mixture of: 1) wet black wet muck; 2) dense dark brown fibrous peat; 3) decomposing mangrove roots and pneumatophores; and 4) larger living and recently dead mangrove roots and pneumatophores. At each sampling location 2-3 core samples were composited and mixed in a clean metal bowl. Sample containers were then filled with the mixed sediment material. The sediment samples were immediately delivered to Benchmark Environmental Analytical Laboratory in Palmetto, Florida, for analysis. The parameters analyzed included:

Figure 8 – Sediment corer with sample from sewage leak impact area.

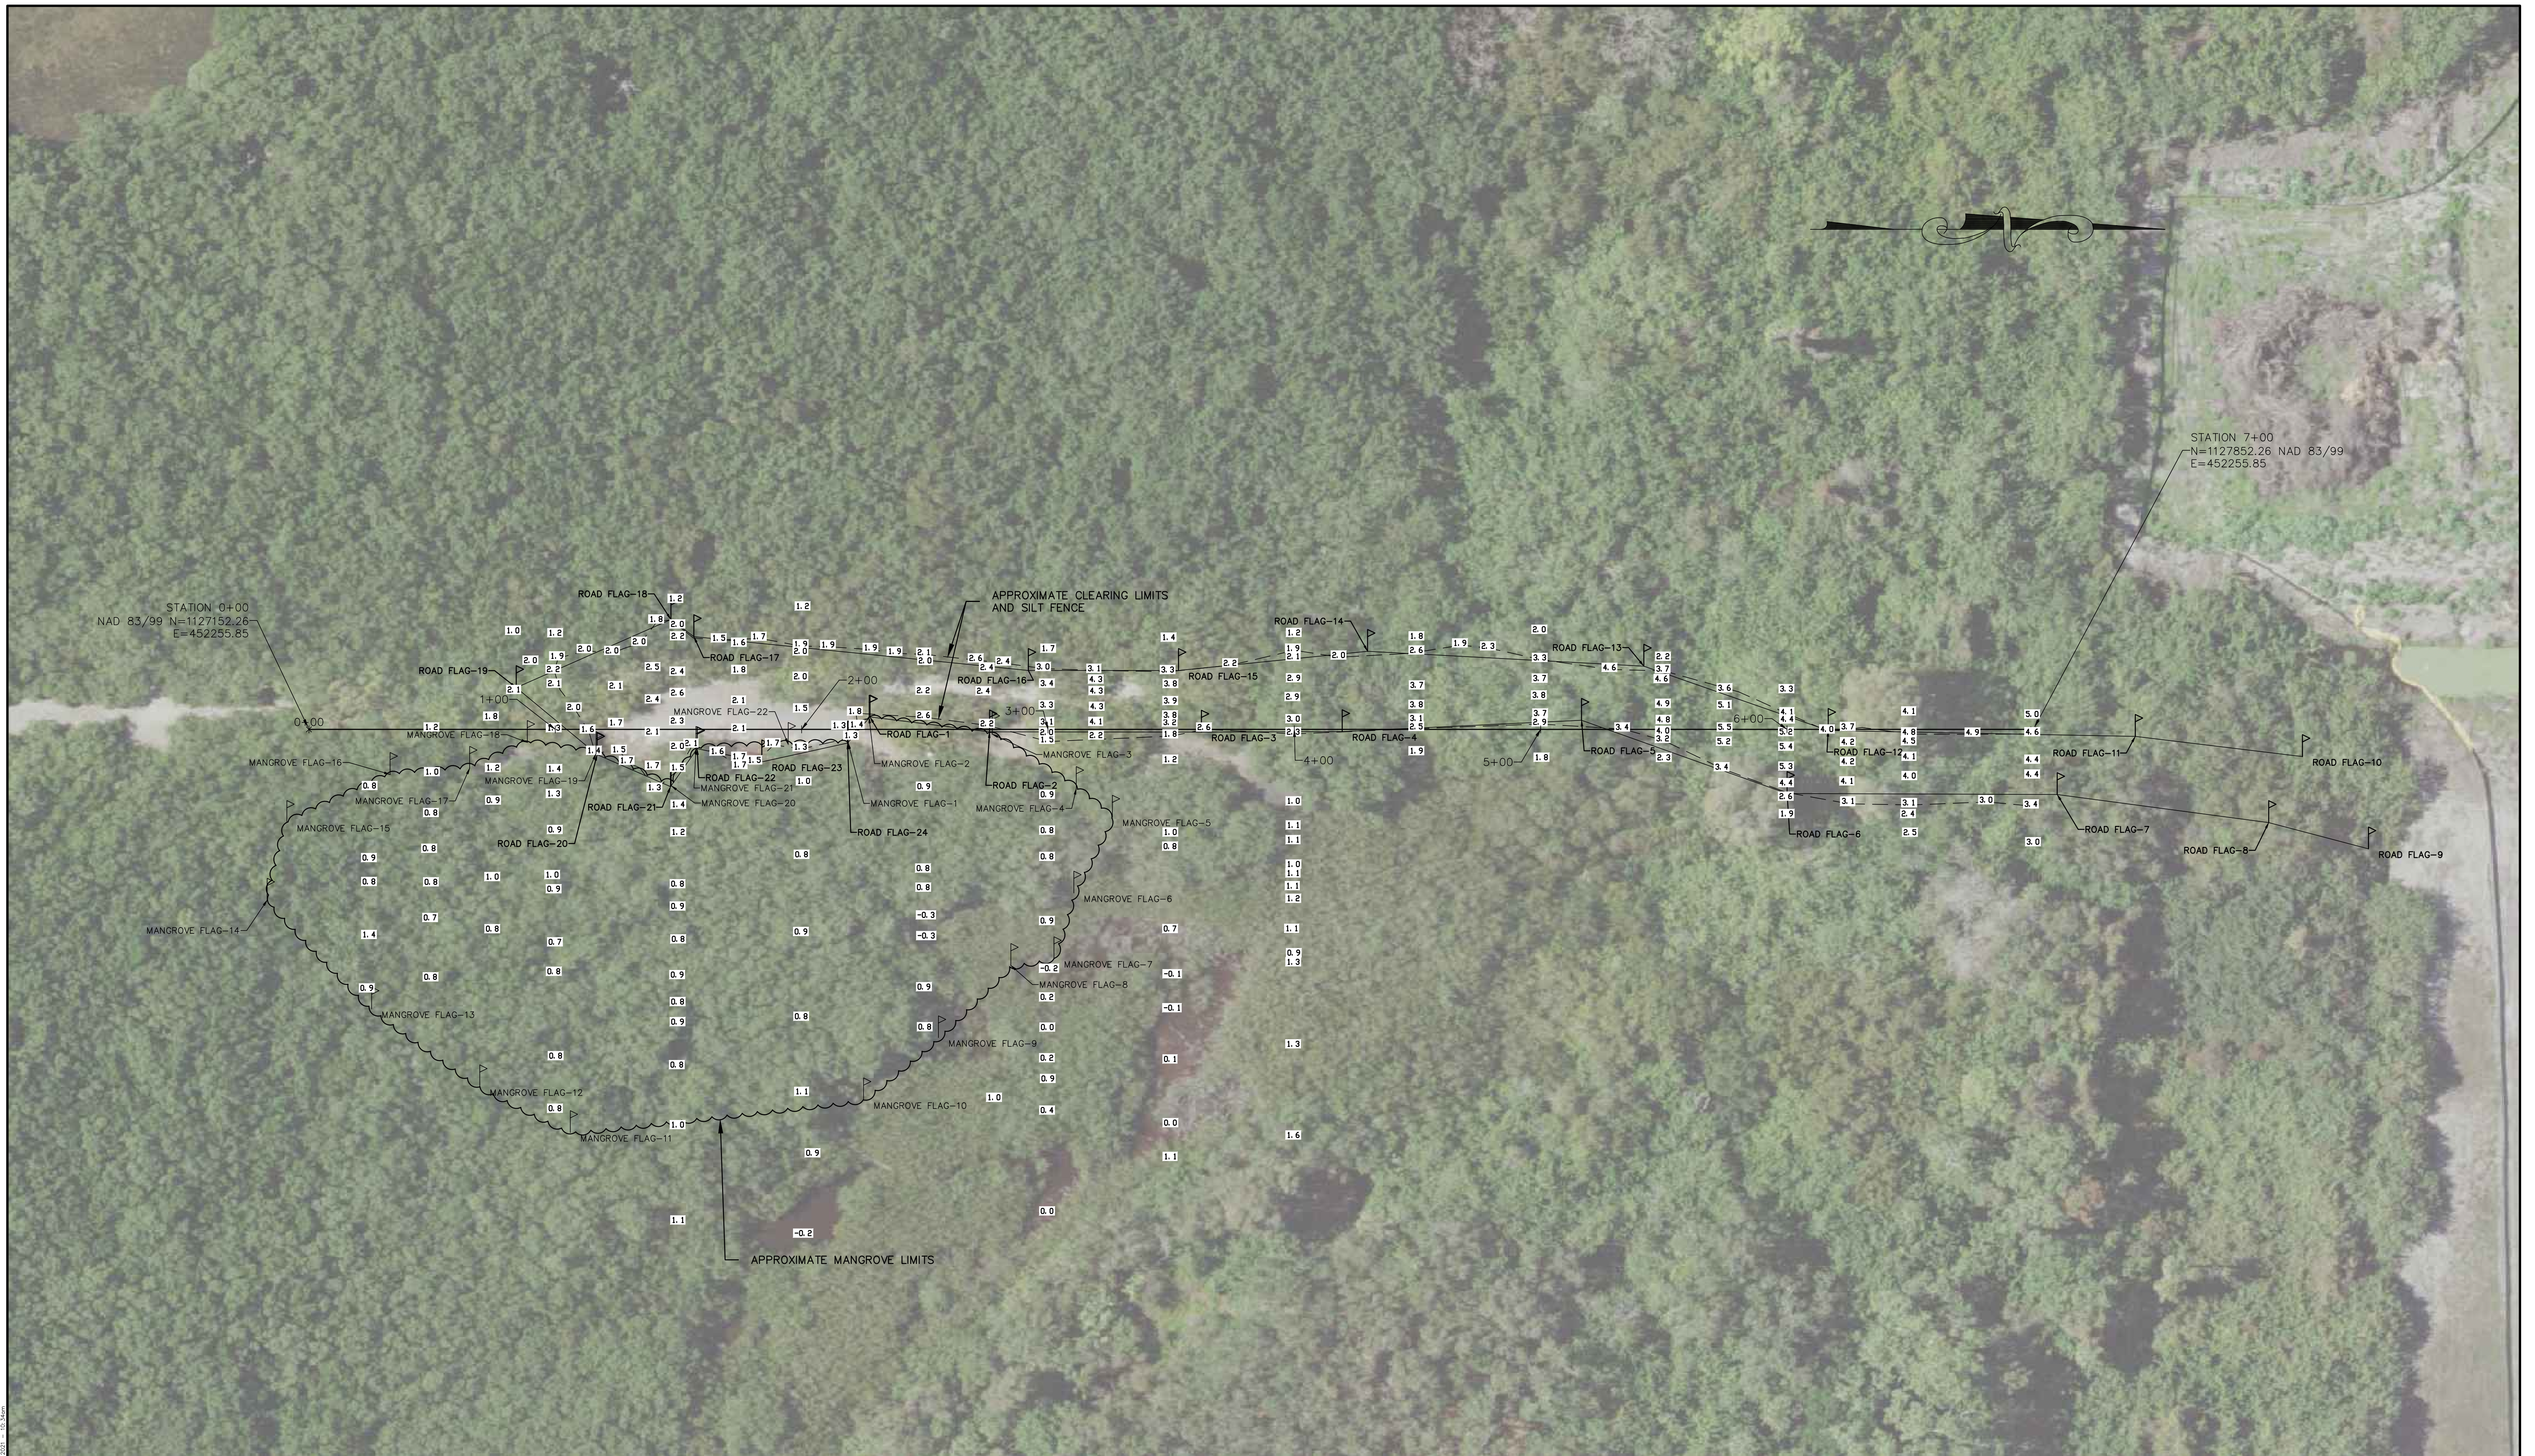
ELEVATION DATA (NAVD 88)				COMMISSION NO. 35665-3
TOPOGRAPHIC SURVEY				SCALE 1" = 30'
MANGROVE RESTORATION				DATE 3/30/21
TOWN OF LONGBOAT KEY, FLORIDA				SHEET 2 OF 5
- FOR - ENVIRONMENTAL SCIENCE ASSOCIATES				
DRAWN BY LFP	CHECKED BY DWC	FIELD BOOK PAGE NO.	SEE COVER	DATE OF SURVEY 3/25/21

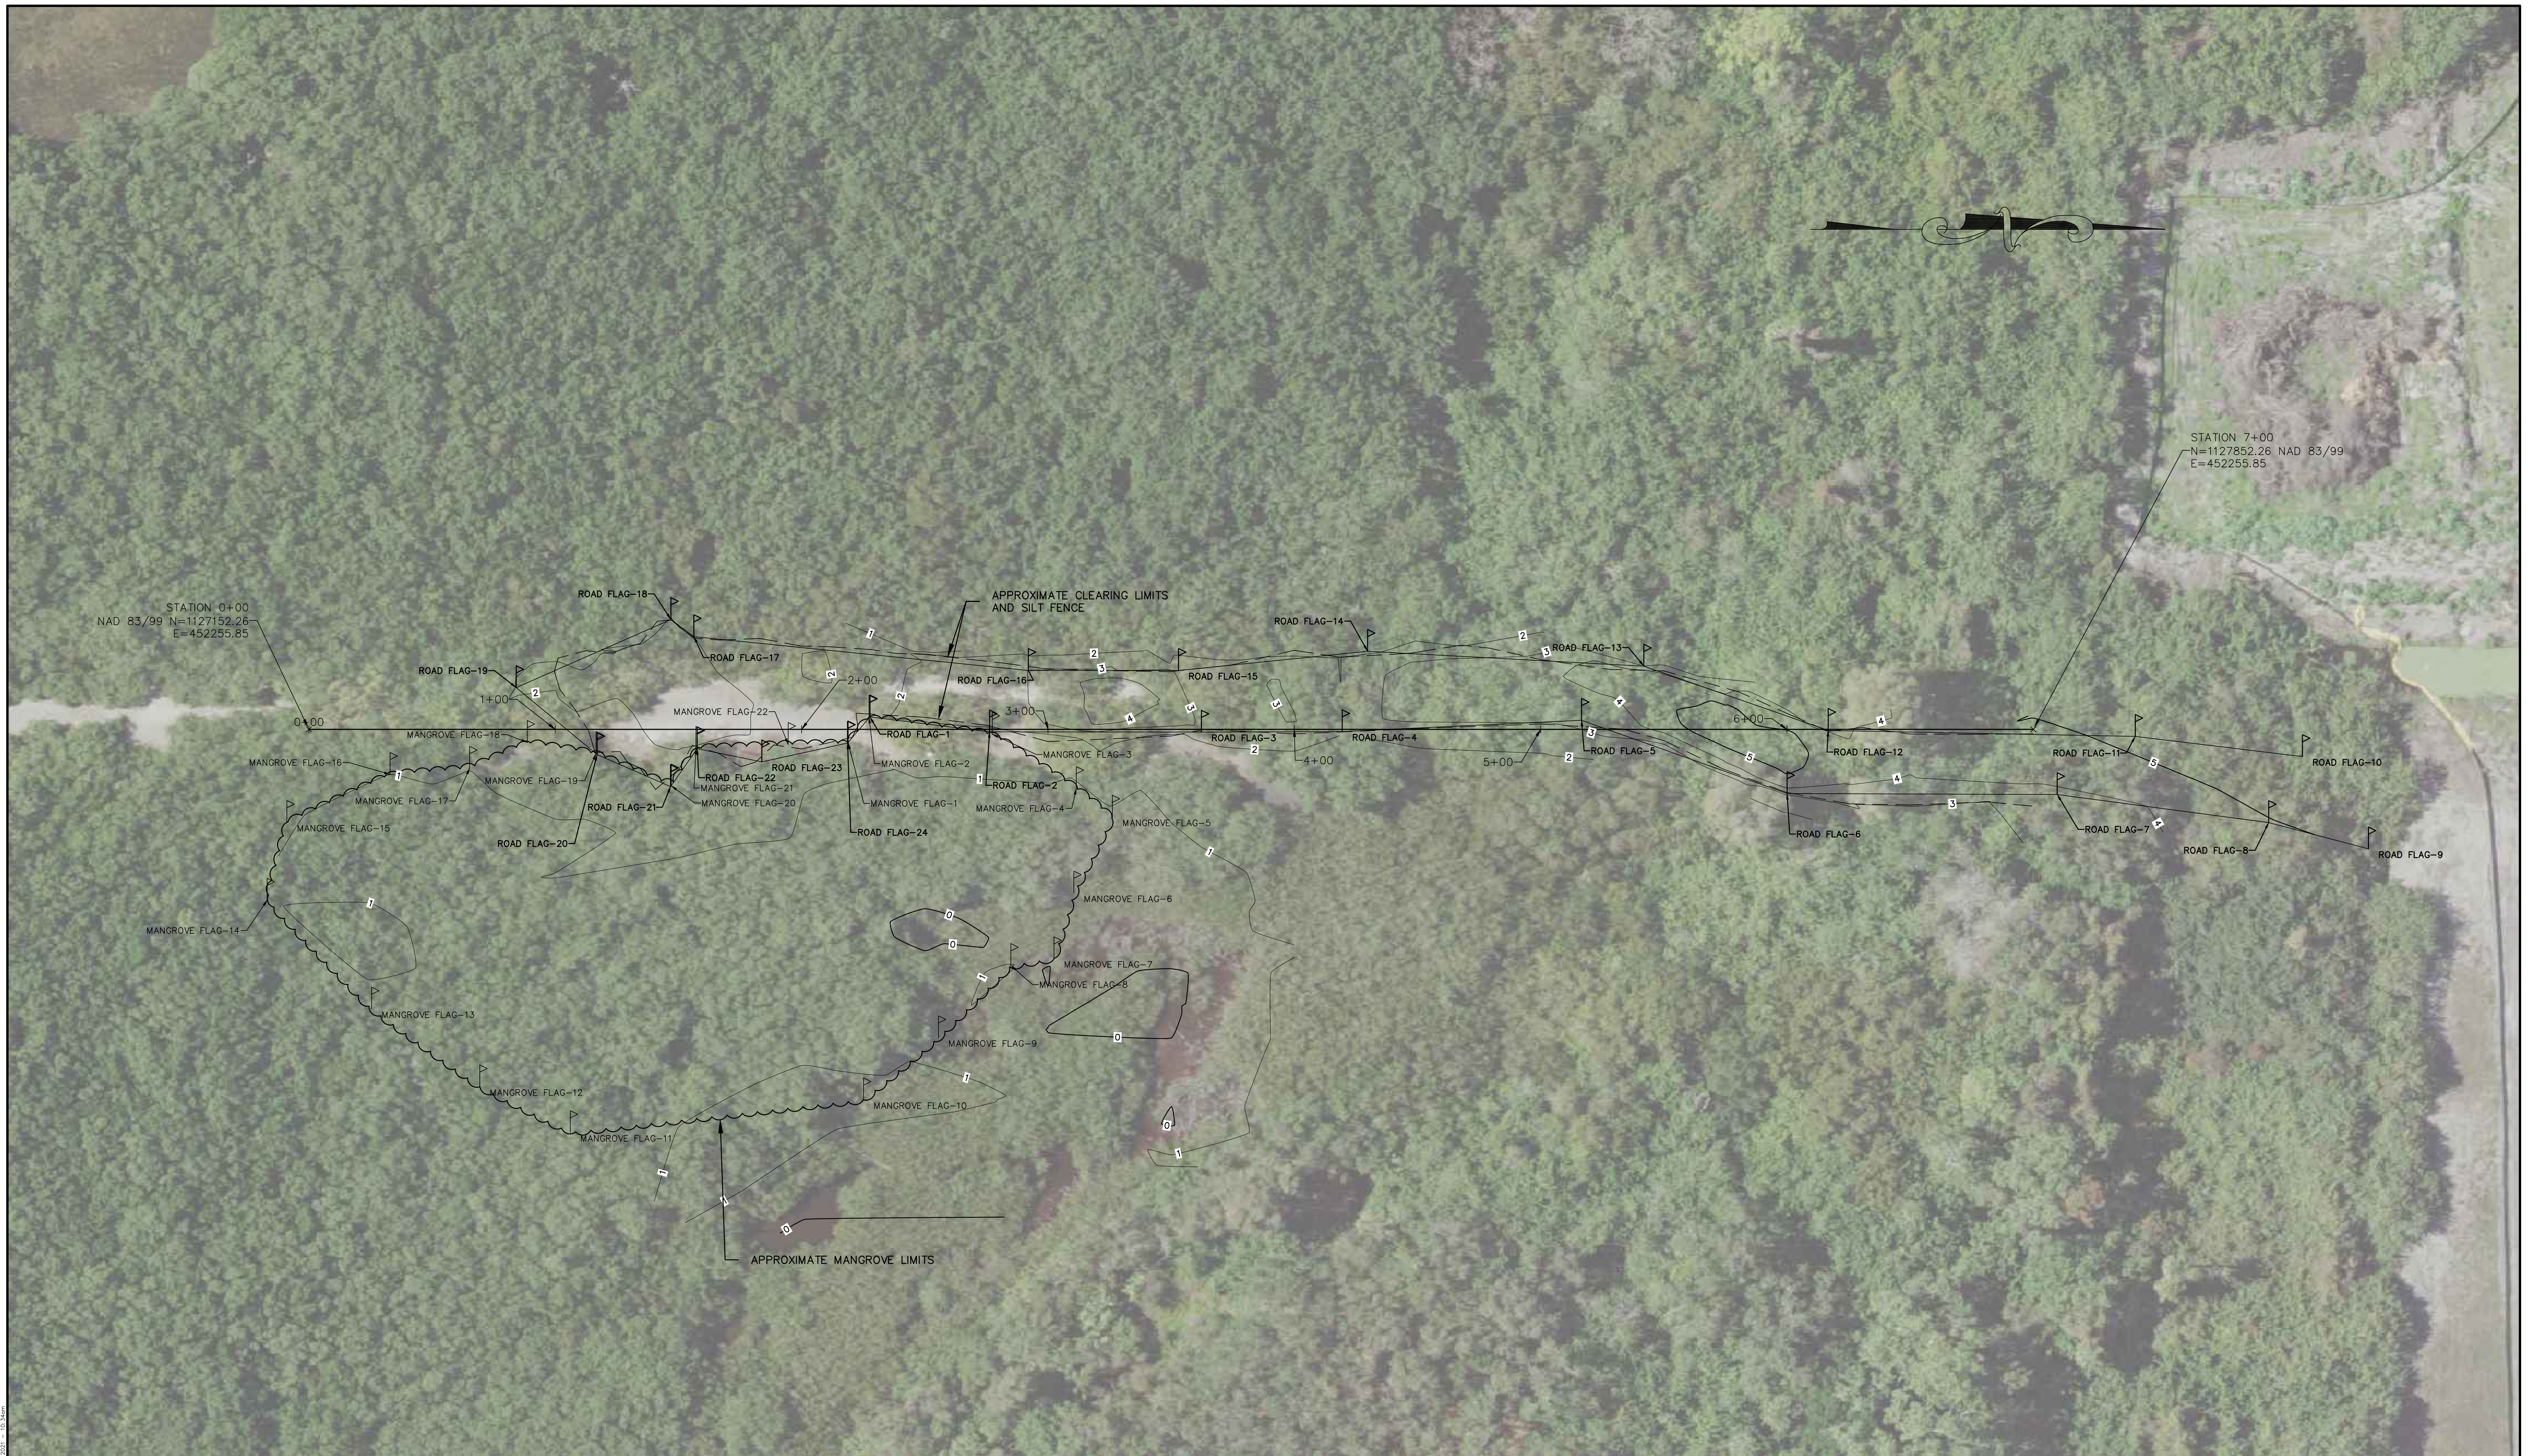
<p>SEE SHEET 1 FOR NOTES</p>	<p>DRAWN BY LFP</p> <p>CHECKED BY DWC</p> <p>FIELD BOOK PAGE NO.</p> <p>SEE COVER</p> <p>DATE OF SURVEY 3/25/21</p>	<p>SHEET 3 OF 5</p>

<p>HORIZONTAL SCALE: 1" = 30' INTENDED DISPLAY SCALE</p>	<p>Morgan & Eklund Inc.</p> <p>PROFESSIONAL SURVEY CONSULTANTS</p> <p>4909 US HIGHWAY #1 VERO BEACH, FL 32967 PHONE: (772) 388-5364 FAX: (772) 388-3165</p> <p>1001 NORTH AMERICA WAY SUITE 211 MIAMI, FL 33132 PHONE: (305) 364-5158 LB #4298</p>	<p>CERTIFICATE OF SURVEYOR - I HEREBY CERTIFY THAT THE INFORMATION SHOWN HEREON IS IN ACCORDANCE WITH A RECENT FIELD SURVEY MADE UNDER MY DIRECTION, AND THAT IT IS TRUE AND CORRECT TO THE BEST OF MY KNOWLEDGE AND BELIEF, AND MEETS THE STANDARDS OF PRACTICE AS SET FORTH BY THE FLORIDA BOARD OF PROFESSIONAL LAND SURVEYORS IN CHAPTER 61-17, FLORIDA ADMINISTRATIVE CODE, PURSUANT TO SECTION 472.027, FLORIDA STATUTES.</p> <p>DAVID W. COGGIN, PLS PROFESSIONAL LAND SURVEYOR #63359 STATE OF FLORIDA</p>	<p>ELEVATION CONTOURS (NAVD 88)</p> <p>TOPOGRAPHIC SURVEY</p> <p>MANGROVE RESTORATION</p> <p>TOWN OF LONGBOAT KEY, FLORIDA</p> <p>- FOR -</p> <p>ENVIRONMENTAL SCIENCE ASSOCIATES</p>		<p>COMMISSION NO. 35665-3</p> <p>SCALE 1" = 30'</p> <p>DATE 3/30/21</p>

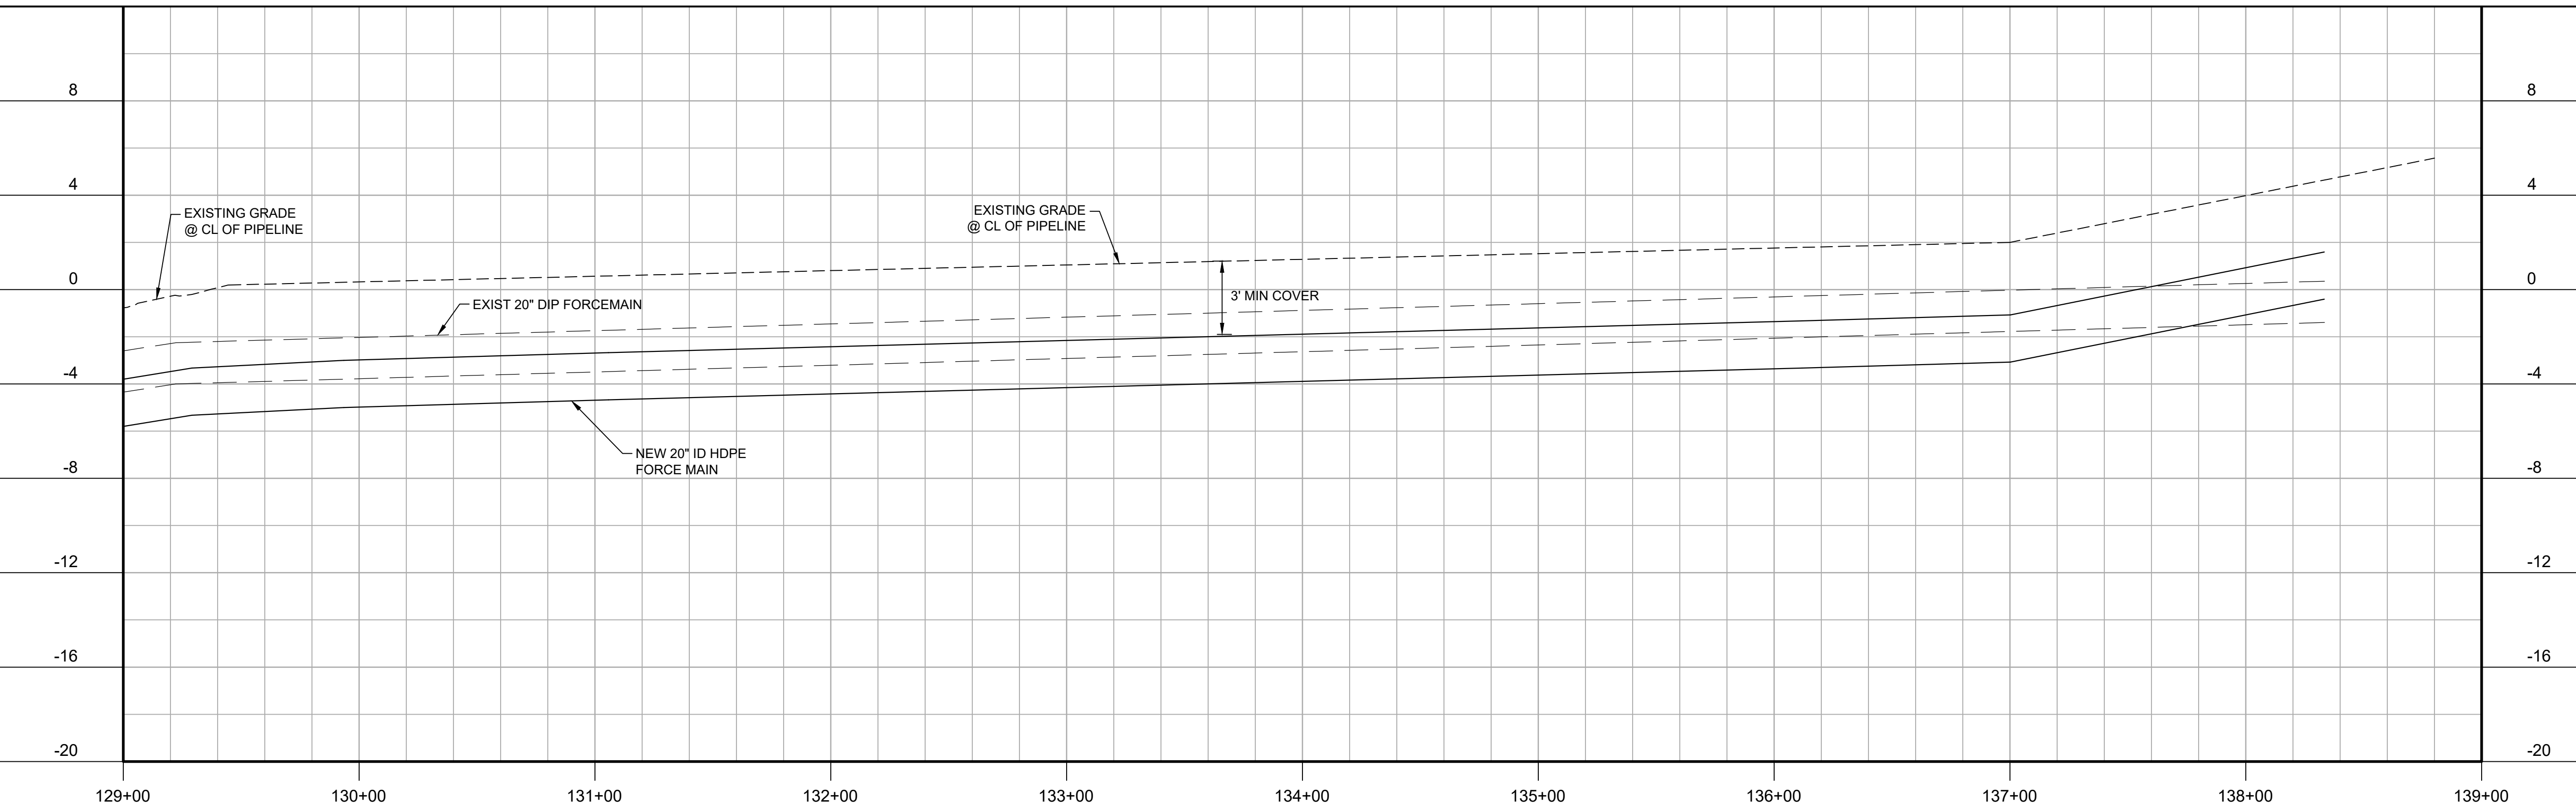
- 50' FROM CL OF NEW 20" ID HDPE FORCE MAIN (FM) PIPE TO EXISTING 20" DIP FORCE MAIN.
- EXISTING 20" DIP FM SHOWN IN PROFILE AS REFERENCE ONLY.
- THE EXISTING FORCE MAIN IS TO REMAIN IN PLACE FOR FUTURE CONDITION ASSESSMENT AND POTENTIAL REHABILITATION. AFTER REHABILITATION, EXISTING FORCE MAIN MAY BE USED AS A REDUNDANT FORCE MAIN OR FOR BRINGING RECLAIMED WATER TO THE TOWN.

TOWN OF LONGBOAT KEY
ENVIRONMENTAL PERMITTING FOR
SUBAQUEOUS FORCE MAIN
CIVIL
PLAN AND PROFILE
STA 129+00 TO 138+34±

main is shown in **Attachment 3**. This plan exhibit indicates that the majority of the temporary road fill/clearing impact area will be cleared and temporarily filled during the construction of the new force main.
