## Longboat Key Stormwater Atlas Aerial Map

**Figure 6**

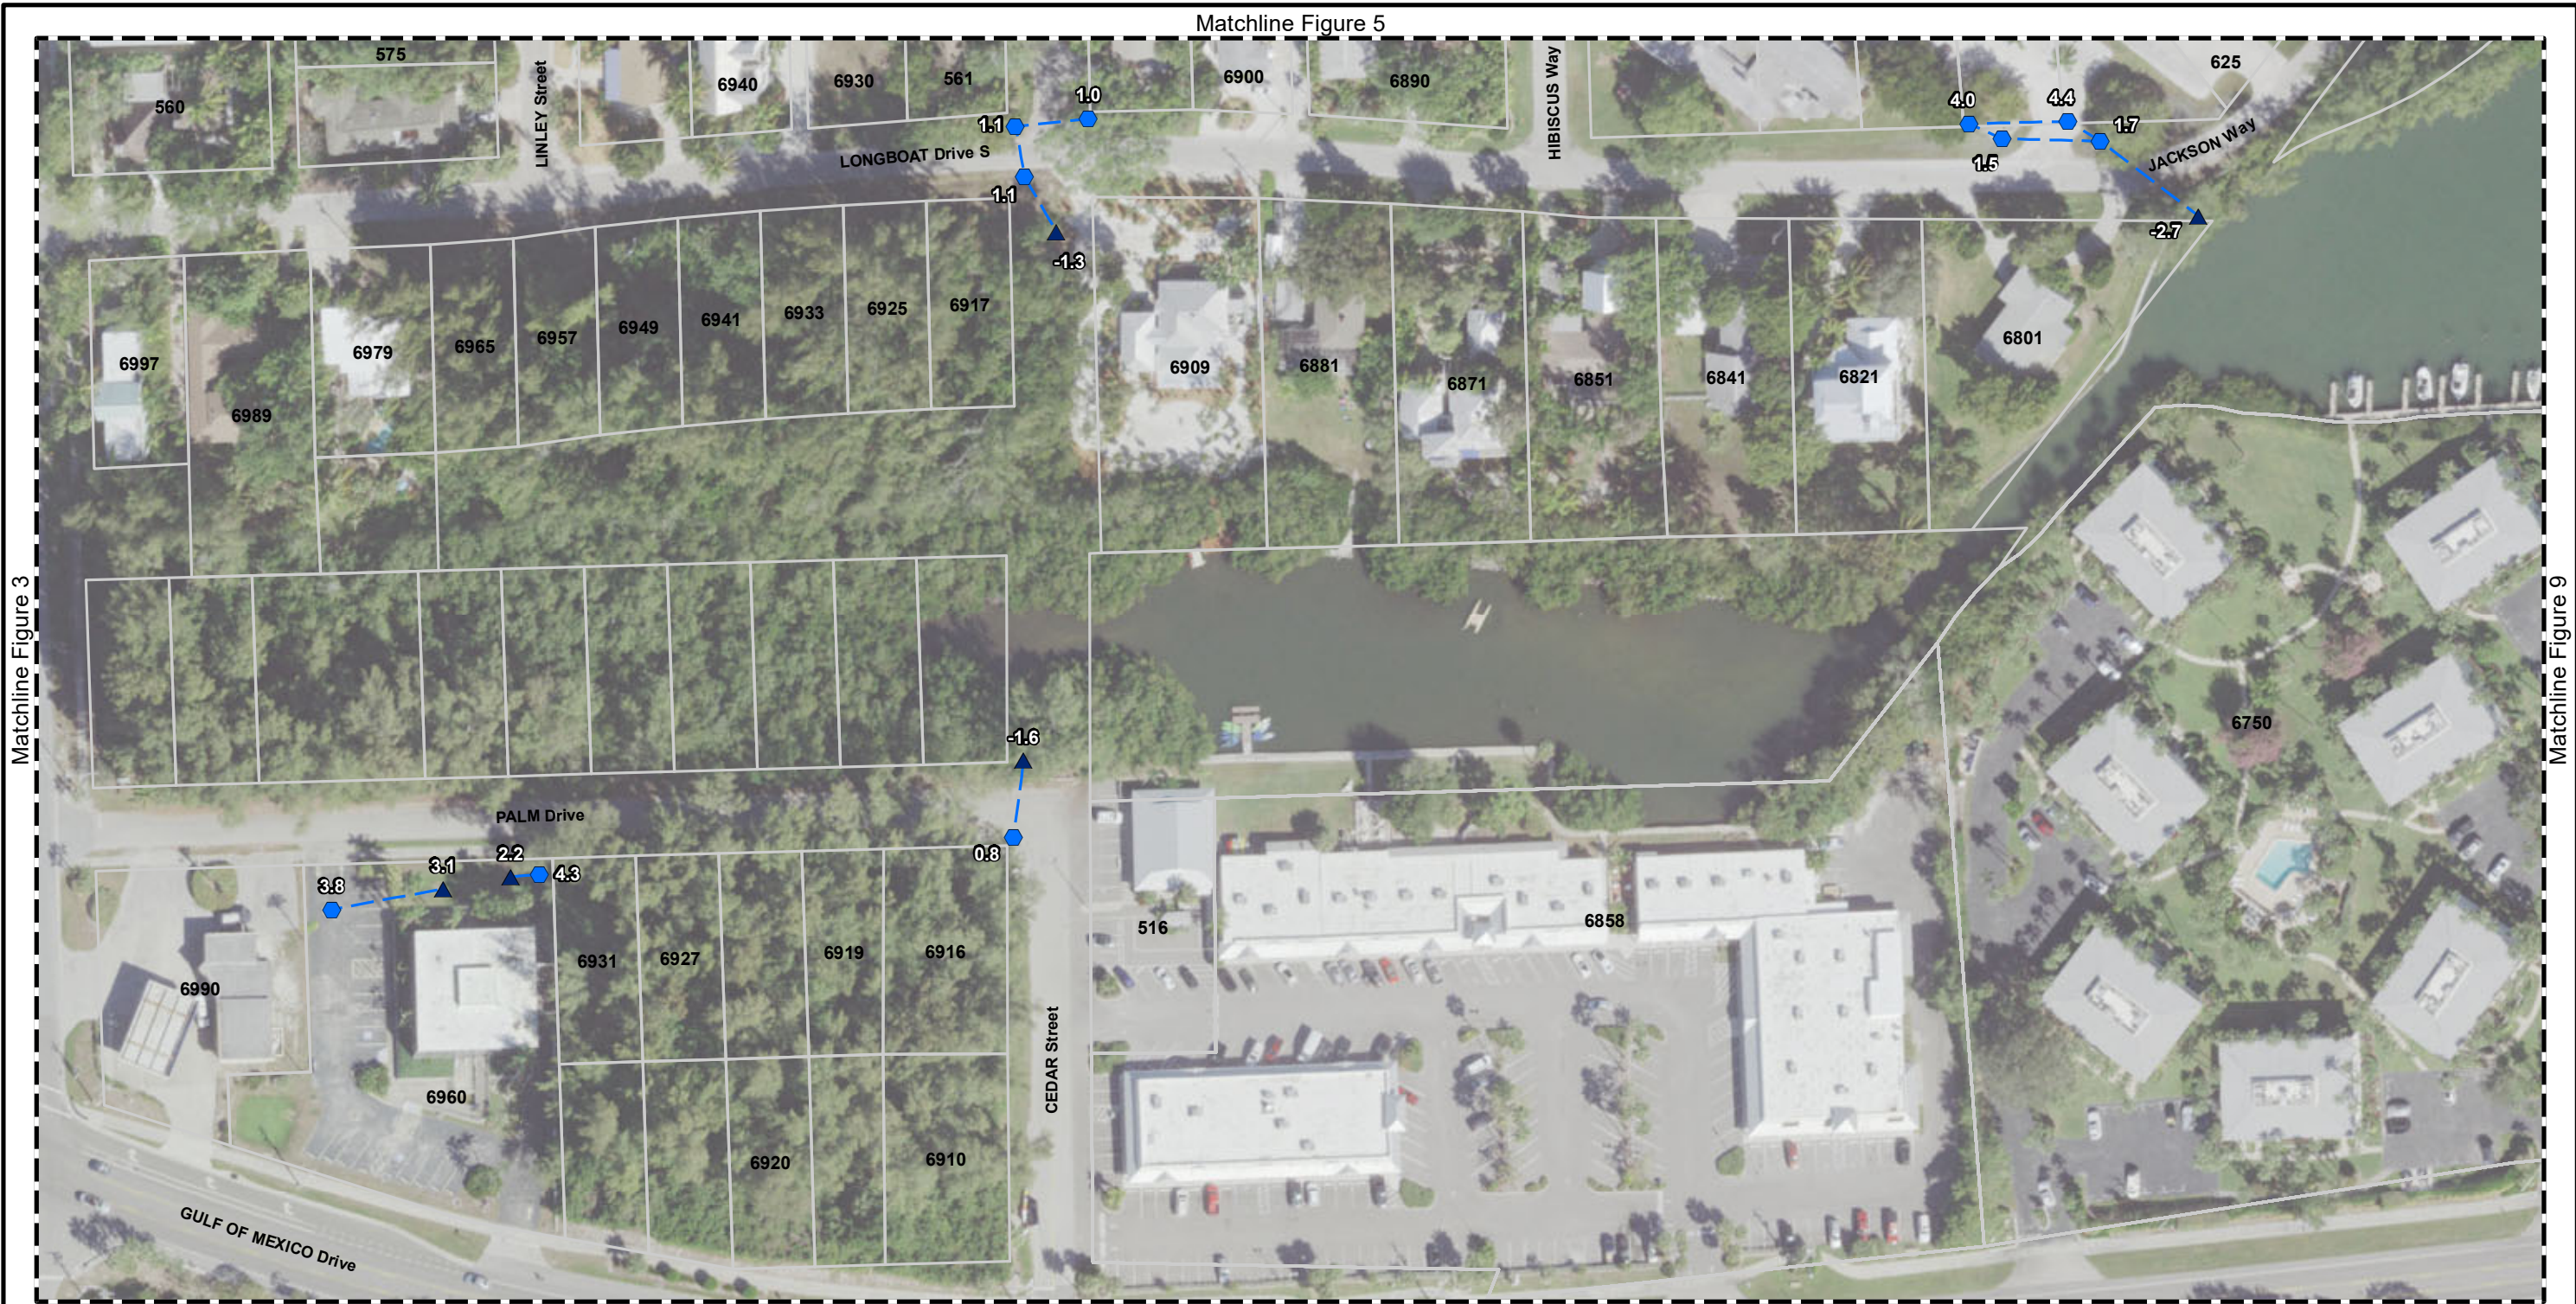
- Data were collected by APTIM on the following dates:  
 October 29 through November 1, 2019  
 November 18 through November 21, 2019  
 December 17 through December 19, 2019  
 March 23 through March 27, 2020
- Dashed lines represent interpreted subsurface pipelines and were not surveyed in the field.
- Elevations are in feet NAVD88.
- Background imagery is ESRI's World Imagery basemap.
