BEST MANAGEMENT PRACTICES

**WESTON POINTE
 LONGBOAT KEY**
 SARASOTA COUNTY, FLORIDA
BEST MANAGEMENT PRACTICES

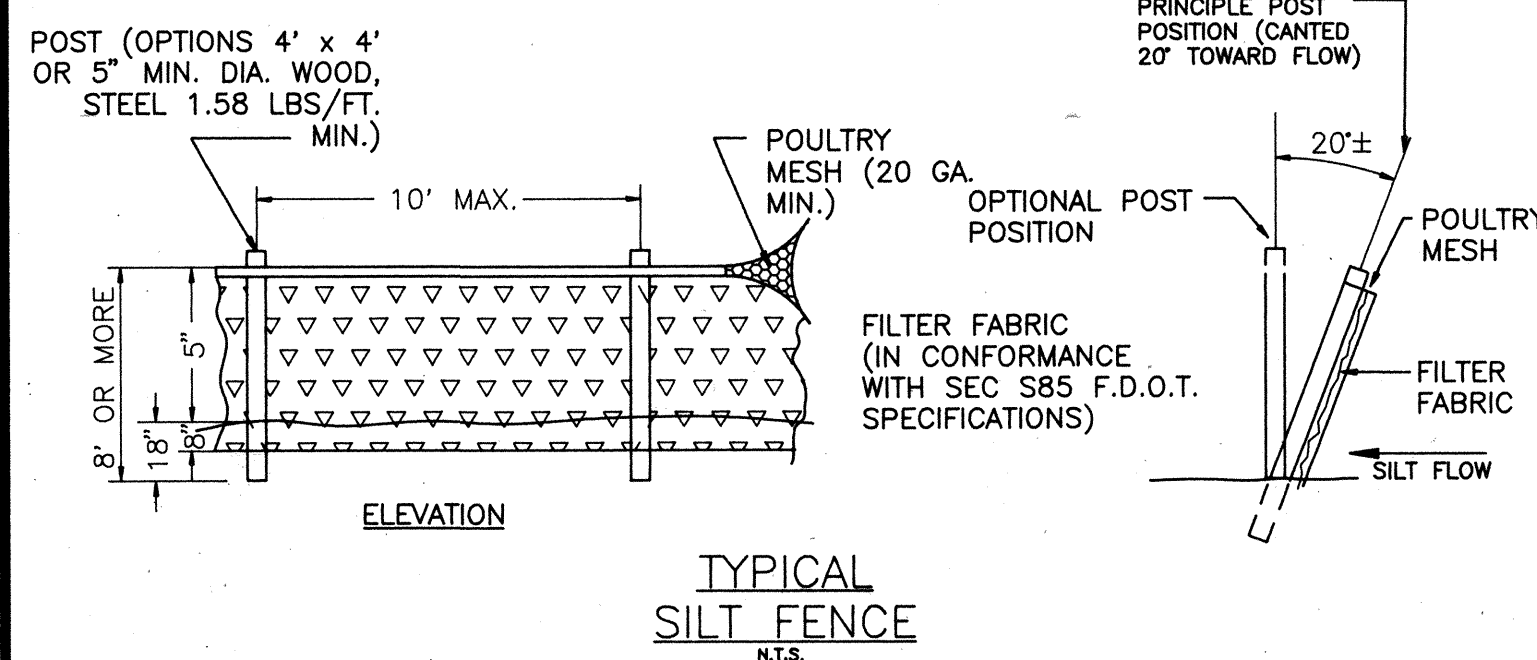
FIGURE 2

TYPICAL SILT FENCE
N.T.S.

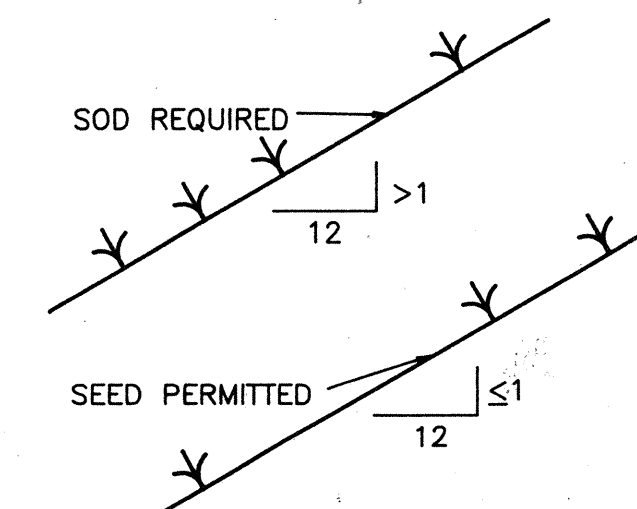
FIGURE 4

GRASS SLOPES
N.T.S.

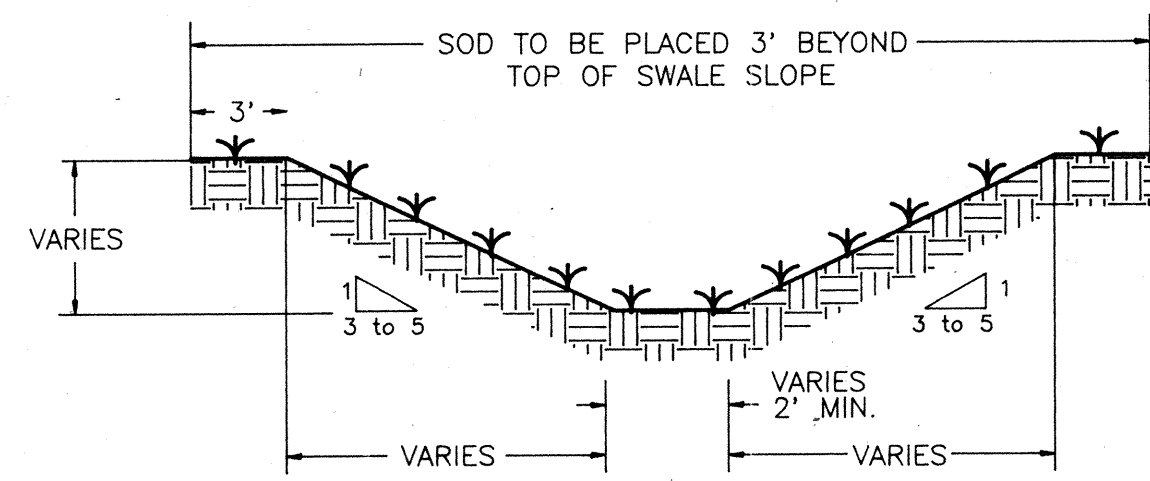
FIGURE 5

TYPICAL SWALE SECTION
N.T.S.

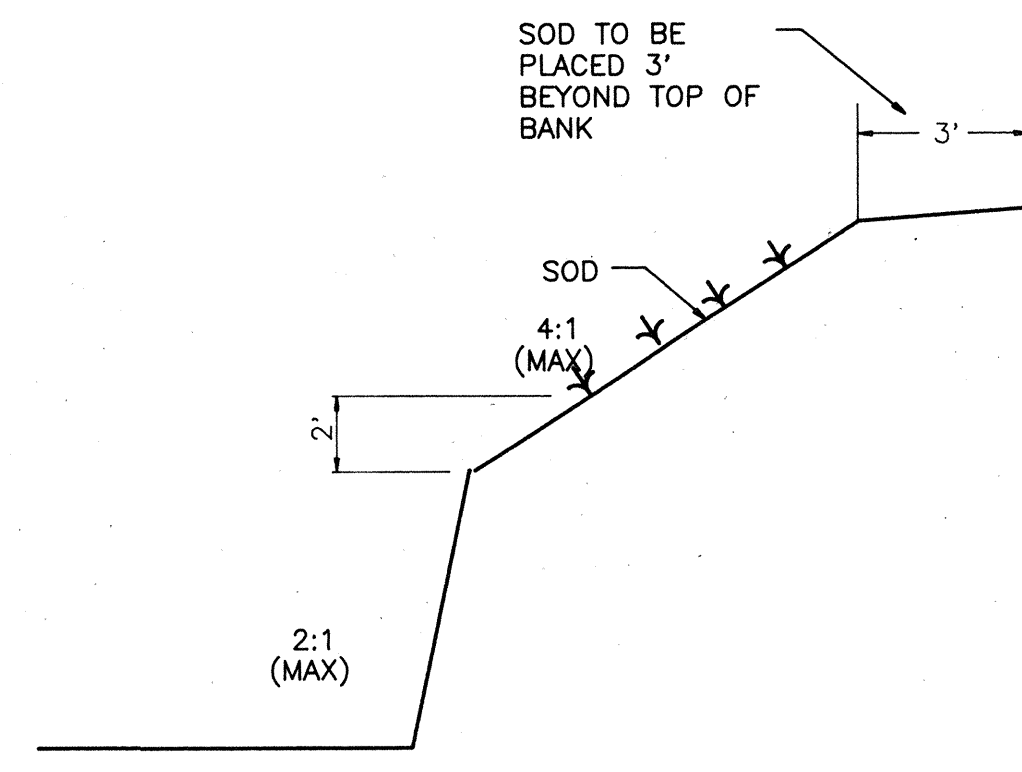
FIGURE 6

TYPICAL RETENTION/DETENTION
POND SECTION
N.T.S.

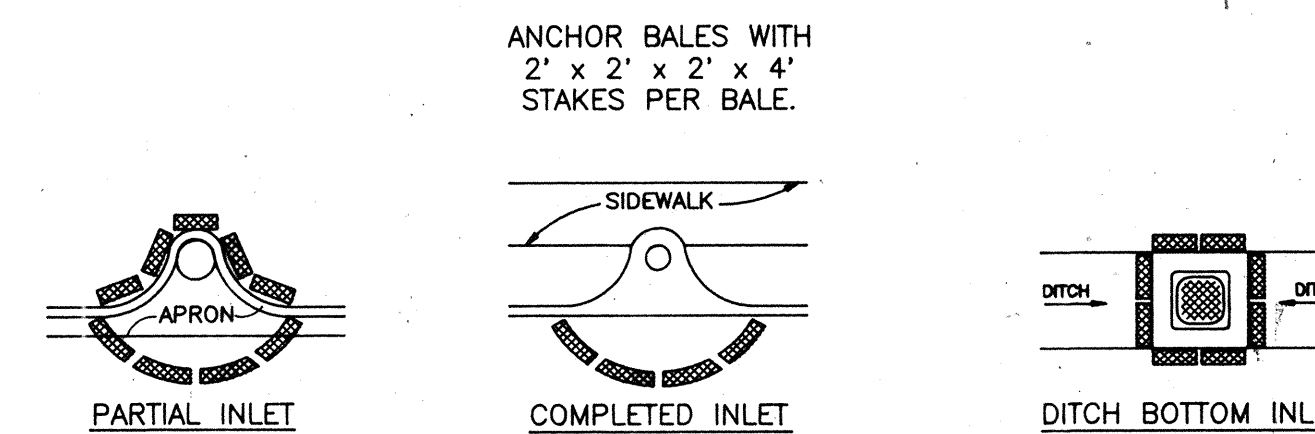
FIGURE 7

PROTECTION AROUND INLETS OR SIMILAR STRUCTURES
N.T.S.

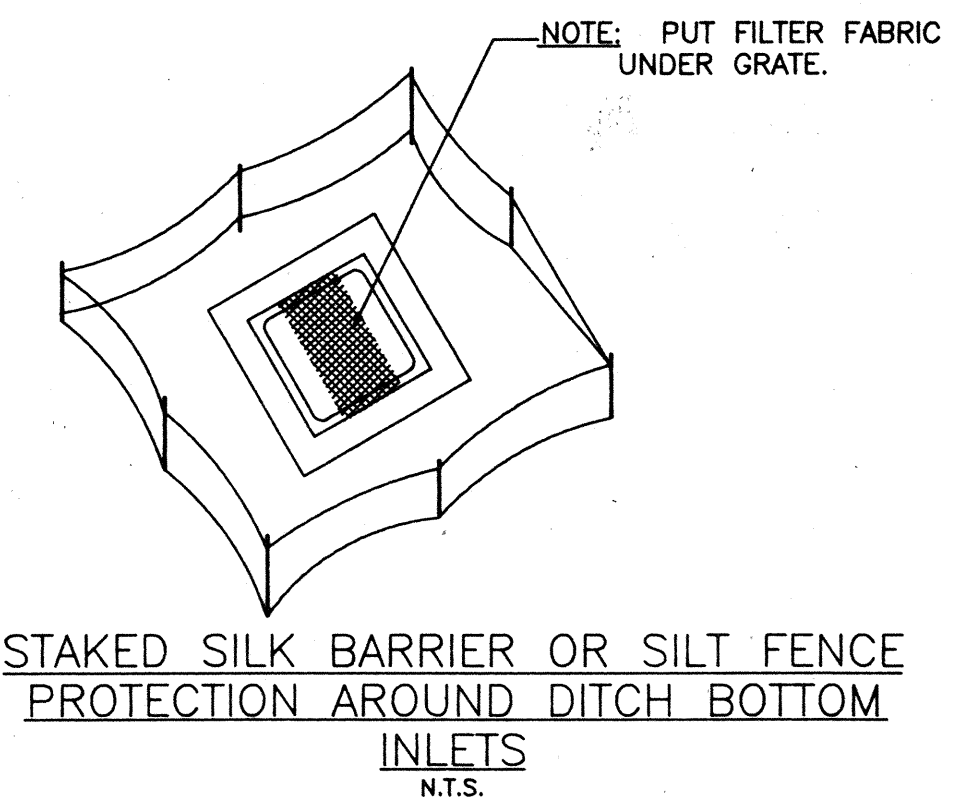
FIGURE 8

STAKED SILK BARRIER OR SILT FENCE
PROTECTION AROUND DITCH BOTTOM
INLETS
N.T.S.

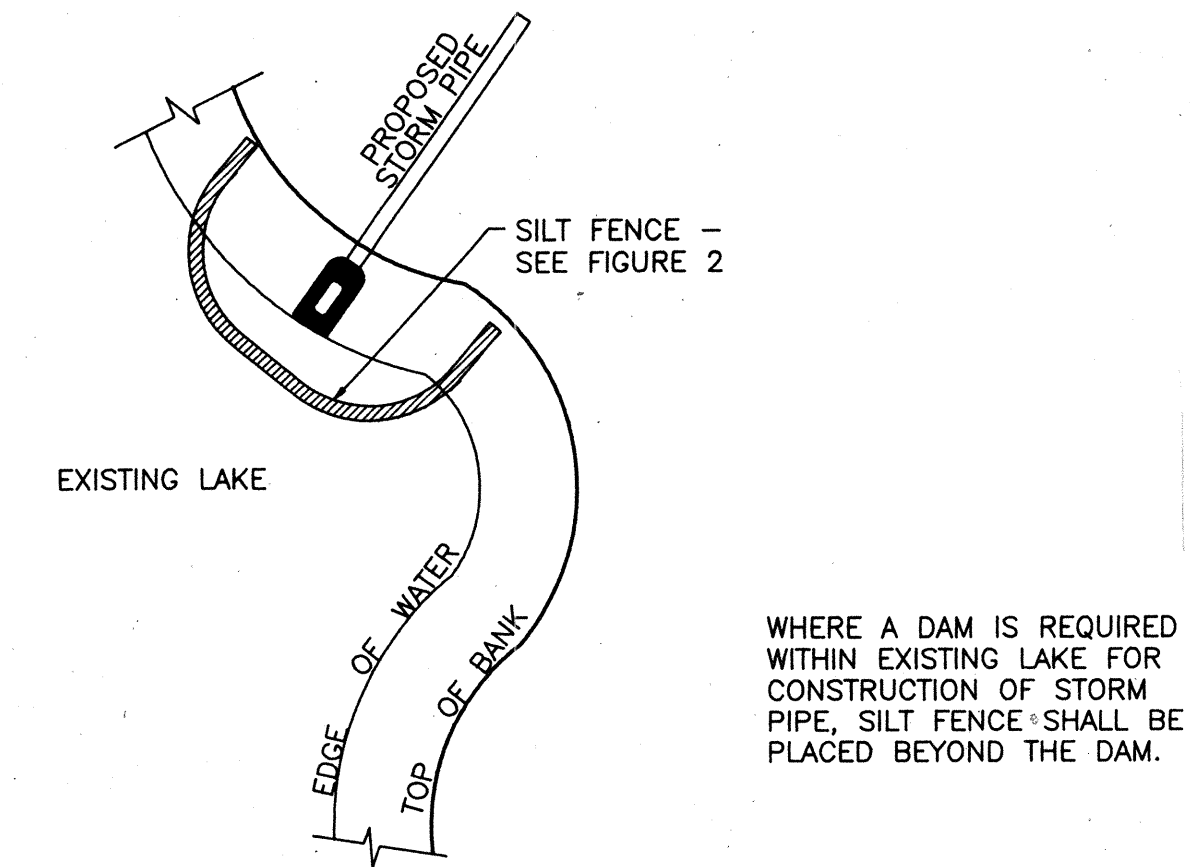
FIGURE 9

SILT BARRIER AT CONNECTION OF
STORM PIPE TO EXISTING LAKE
N.T.S.

WHERE A DAM IS REQUIRED WITHIN EXISTING LAKE FOR CONSTRUCTION OF STORM PIPE, SILT FENCE SHALL BE PLACED BEYOND THE DAM.

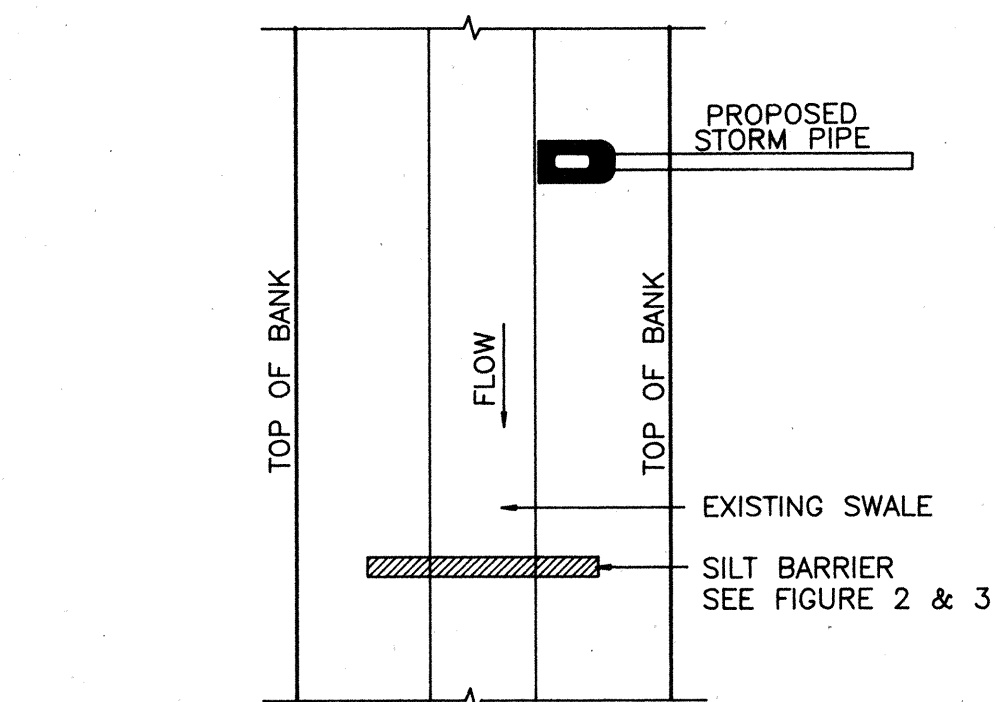
FIGURE 10

SILT BARRIER AT CONNECTION OF
STORM PIPE TO EXISTING SWALE
N.T.S.

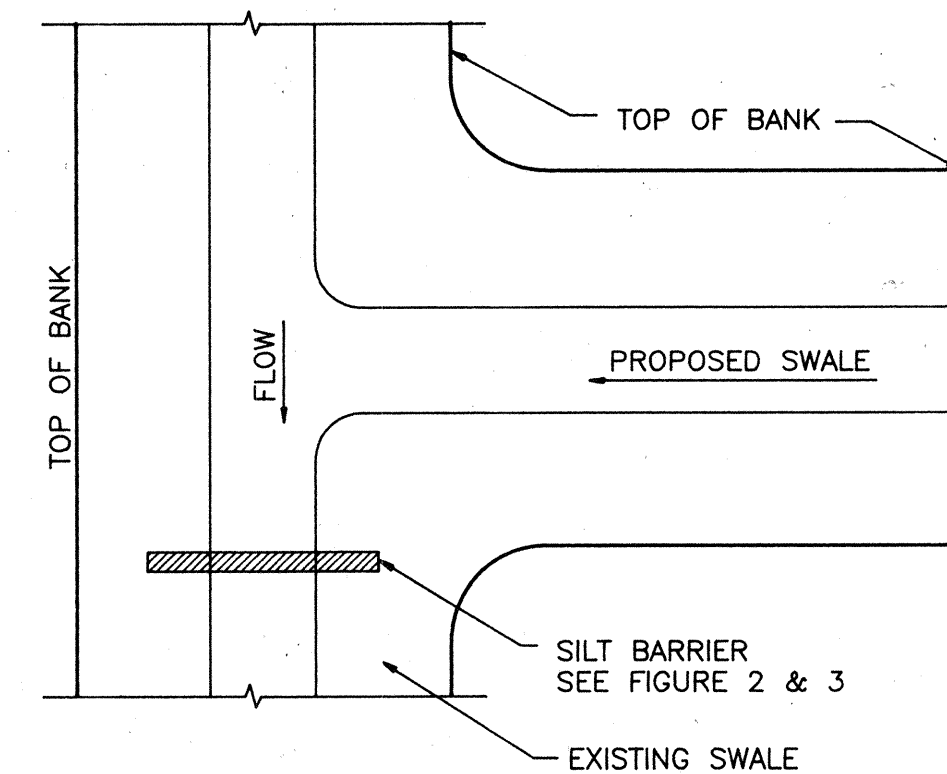
FIGURE 11

SILT BARRIER AT CONNECTION OF
SWALE TO EXISTING SWALE
N.T.S.

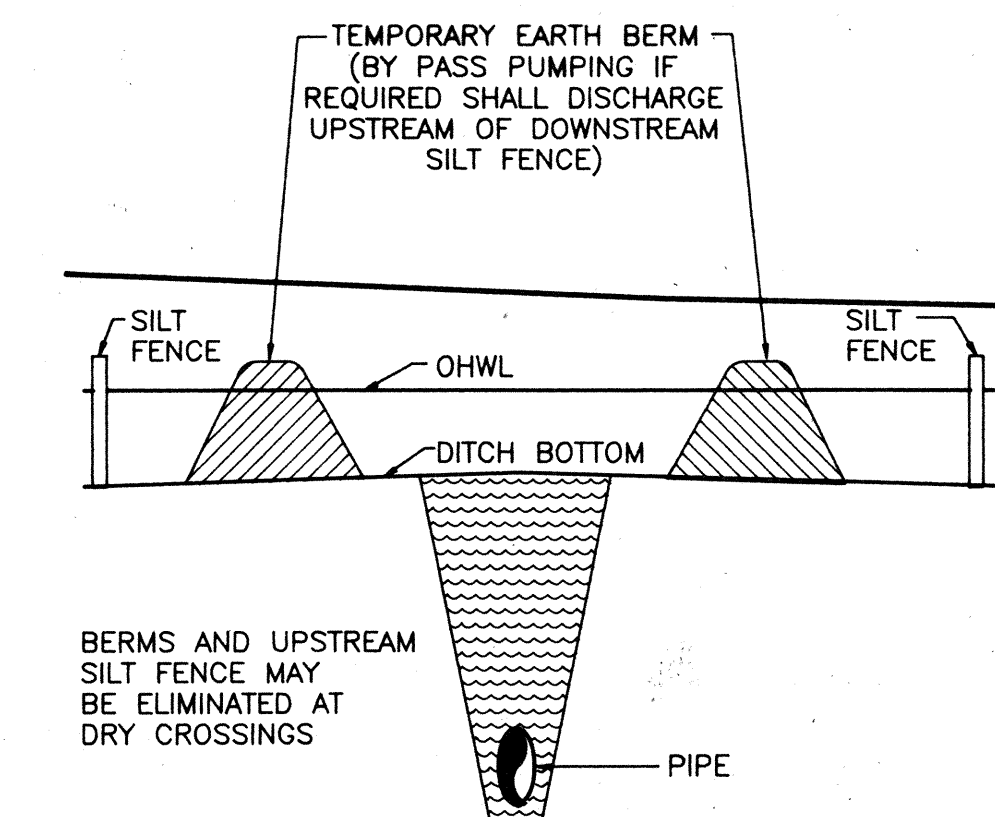
FIGURE 12

UNDERGROUND PIPE CROSSINGS
N.T.S.

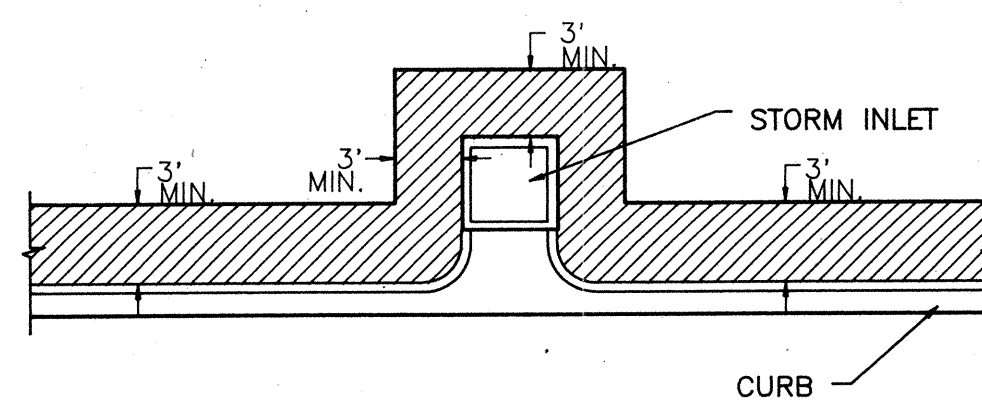
FIGURE 13

SOD ALONG CURB AND AROUND INLET
N.T.S.

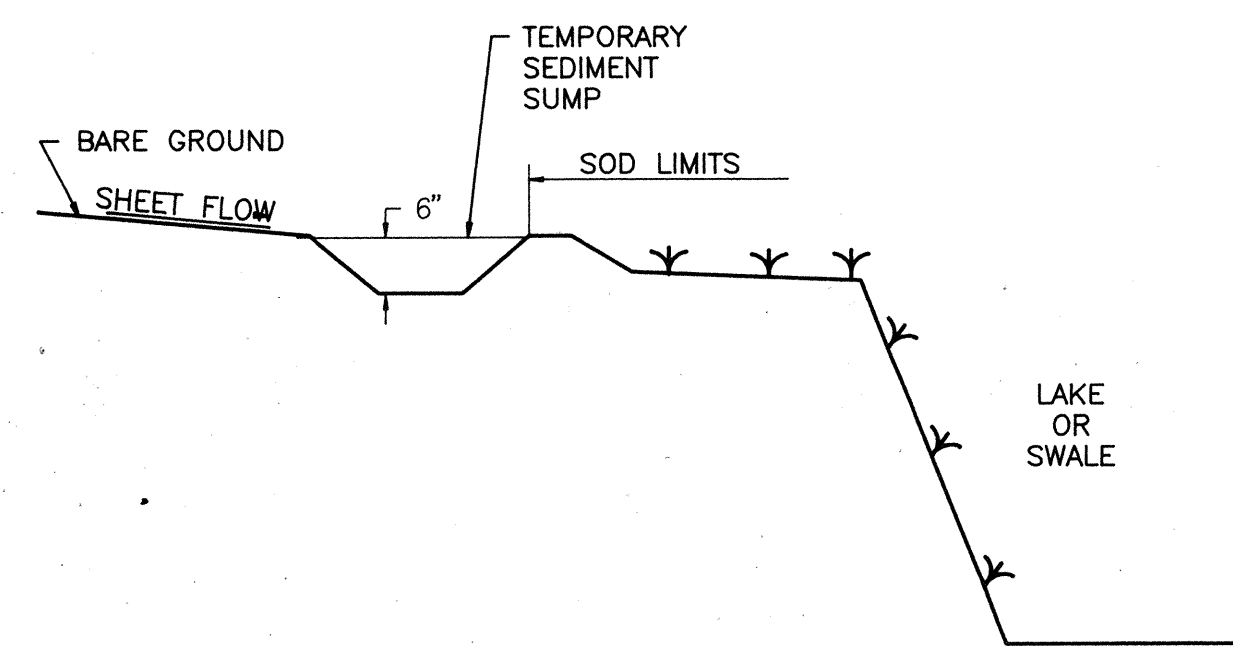
FIGURE 14

TEMPORARY SEDIMENT SUMP
N.T.S.
